To: Mayor and City Council
From: Andy Agle, Director of Housing and Economic Development
Subject: Trees at Mountain View Mobile Home Park

TREE REPORT

Mountain View Mobile Home Park
1930 Stewart Street, Santa Monica, CA 90404

May 20, 2011

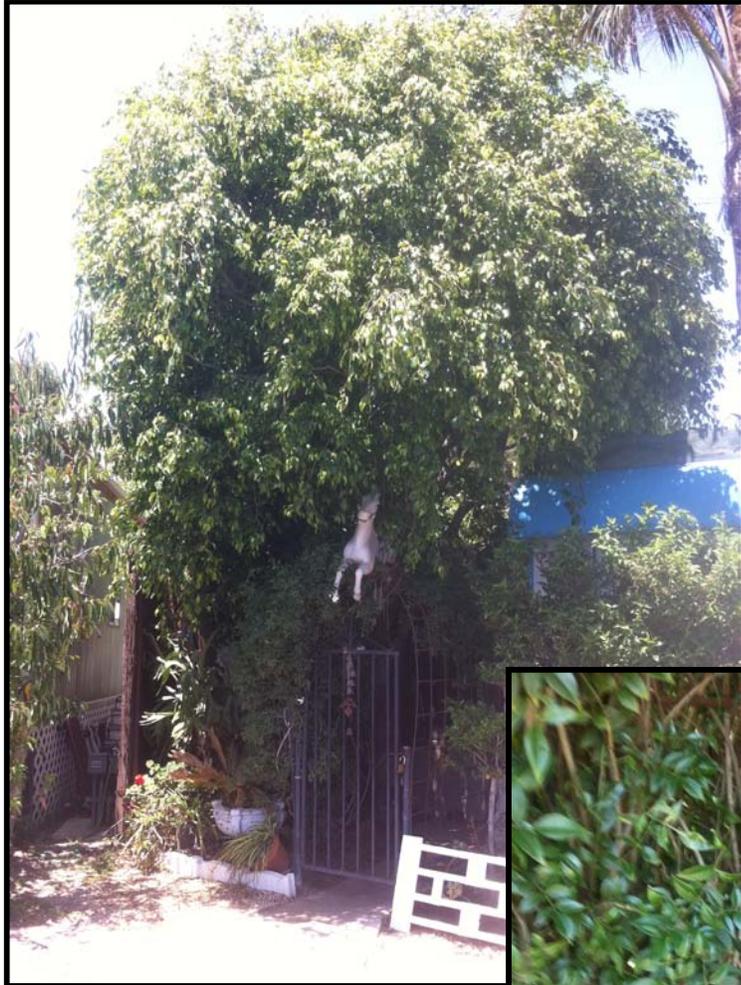
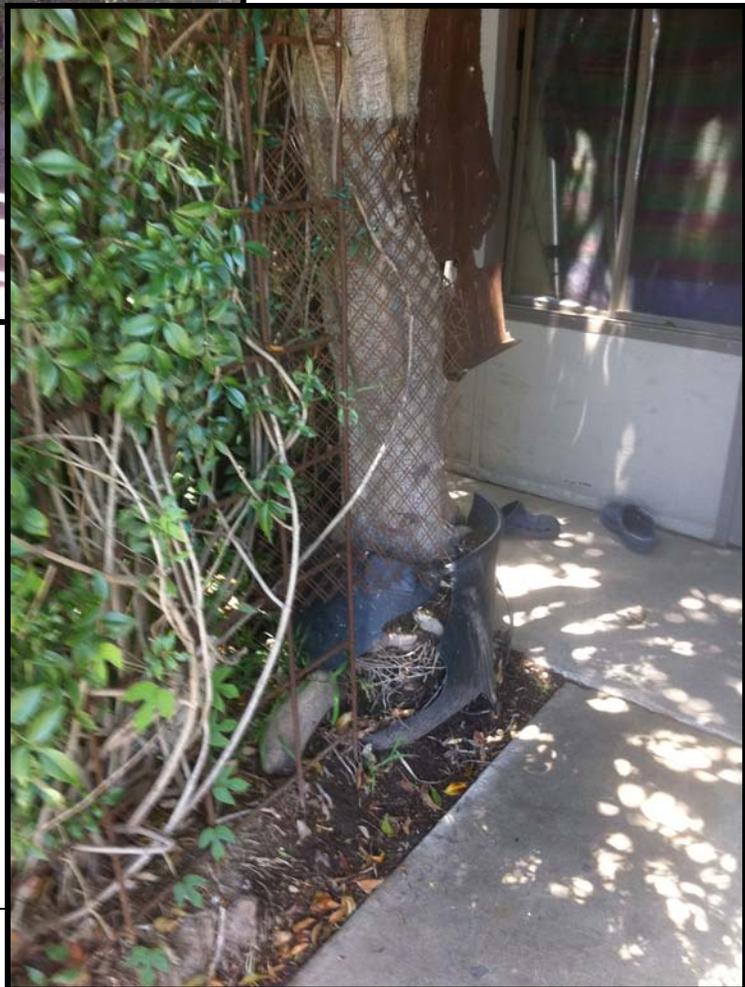
UNIT #49-50

- This tree has an approximate 8” DBH (Diameter at Breast Height).
- The tree has outgrown its plastic grow container and is now rooted into the native soil.

- The poor rooting and lack of trunk flare will always compromise the long-term stability of this tree as it matures.
- If the plastic grow container were removed, the tree would still have a portion of its trunk above grade and compromise the required stability of this broad canopied tree.

- The visible root system appears to have been deflected by the combination of the plastic grow container and the adjacent cement walkway/patio. This has further reduced the quality of the root system and the overall quality of this tree as a possible transplant candidate.

Ficus benjamina tree located in front of these units is a poor candidate for transplanting due to its current growing conditions. The tree has outgrown its plastic nursery container and is now girdled. The trees root system will not provide the needed structural support as it matures.

- Transplanting costs and replacement are higher, I highly recommend this tree for removal.

- This tree is an extremely poor candidate for transplanting and the root pruning required to box up the tree would further damage the already compromised root system.
- See photos at end of report.

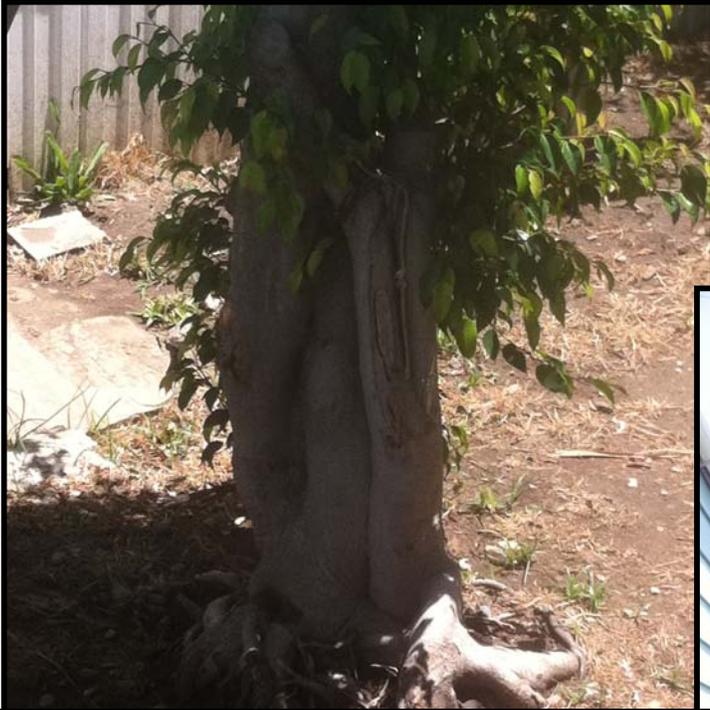
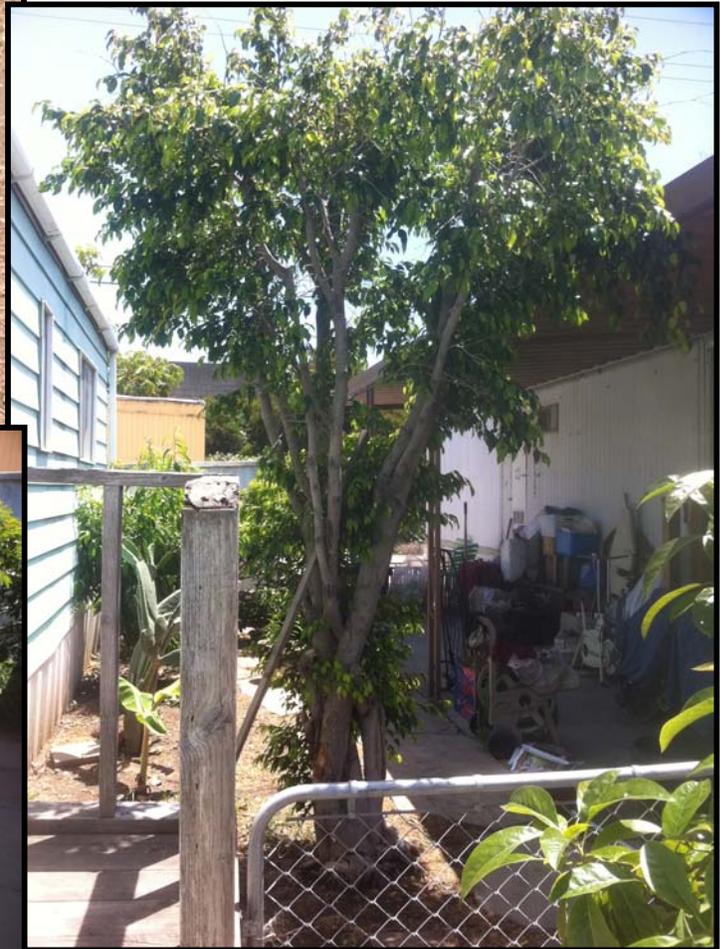
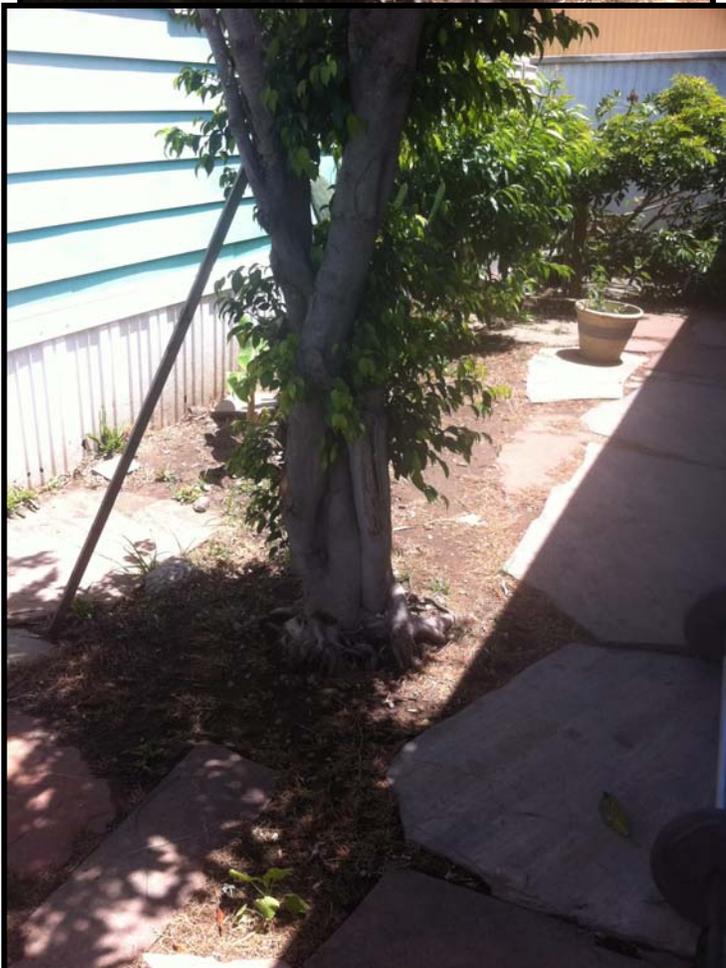
UNIT #66

- This tree has three small trunks emanating from the base.
- It has an approximate total 8" DBH (Diameter at Breast Height).
- This tree appears to have been originally growing in a small container where the roots became girdled, yet it was eventually planted into the ground.

- The lack of a proper root flare, due to the extended time in the grow container, has encouraged the root system to grow downward and in a spiraling direction, instead of a natural flare, that will provide structural support when the tree matures.

- When the tree is young and juvenile, as in this case, the poor root system is not as problematic. But, as the tree matures, this unstable root system may cause the tree to fail at the root plate, or cause additional stress to the tree as the roots ultimately strangle the main trunk and cause die-back.

- In addition to the extremely poor root system, the upper canopy shows extensive die-back from previous topping pruning.
- A new tree in the 15-gallon size container would cost less than \$100 from a nursery. If a new tree were purchased that was comparable in size to the current tree, it would cost approximately \$300 for the tree and installation.

Ficus benjamina tree with poor root structure from extended time in grow container. Also canopy has been topped in past, causing decay in canopy and some twig-dieback.

- This tree is an extremely poor candidate for transplanting and the root pruning required to box up the tree would further damage the already compromised root system.

- This tree is highly recommended for removal. This will allow installation of a new tree with more appropriate rooting and quality of canopy structure in a more suitable location.

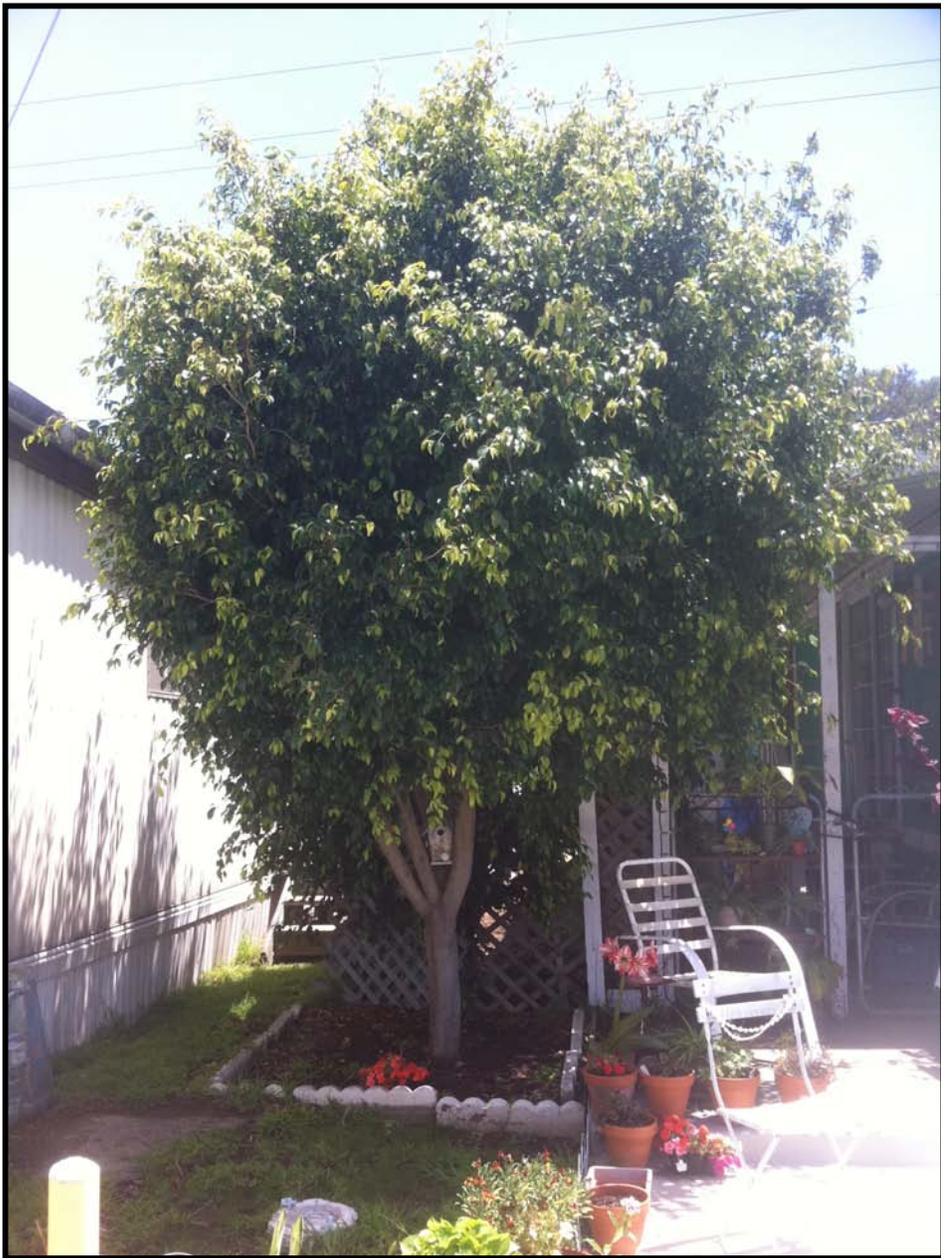
UNIT #68

- This tree has an approximate 6.5" DBH (Diameter at Breast Height).
- This tree is in relative good health and vigor. It appears that the tree was planted appropriately, allowing the root system to properly expand.
- There is mulch placed below the tree, improving the soil condition and encouraging the trees health and vigor.
- This tree may be a more tolerant candidate for transplanting. Any transplanting should retain as much of the root system as possible to increase the potential for survival. Some transplanting guidelines are included in this report.
- The cost of a new tree in a 36" Box size, which would be similar in size to the current tree, would be approximately \$750.

Ficus benjamina tree
This tree has a more appropriate trunk and root flare, indicating it may have been planted appropriately. The canopy appears mostly uniform and healthy. Although transplanting may be an option, the costs associated may be much more than installation of a new tree.

- Transplanting costs would be higher. The decision to retain this tree and transplant, or to remove the tree and replace may be determined by factors beyond the scope of this report.
- See photos below.

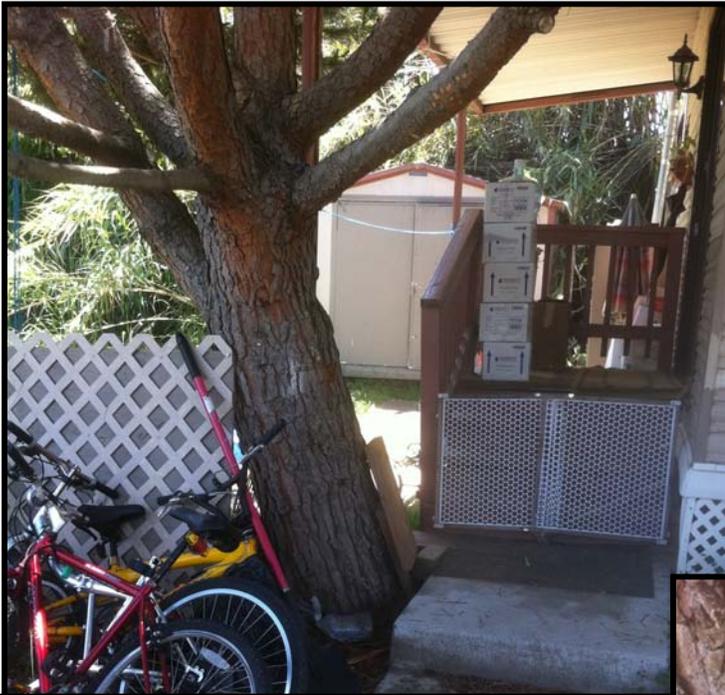
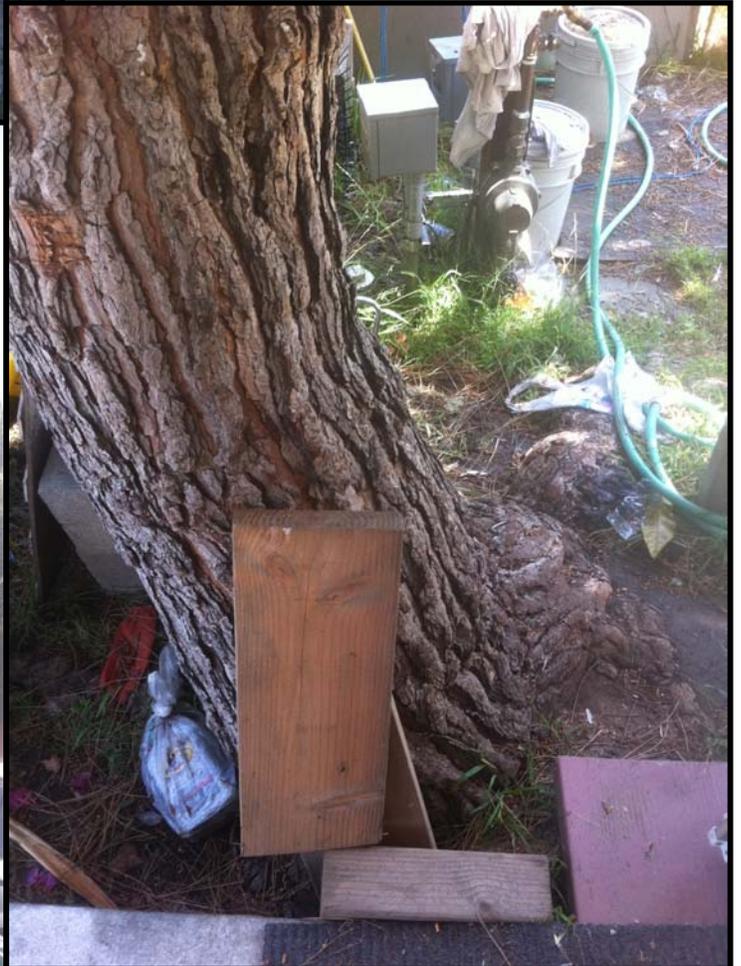
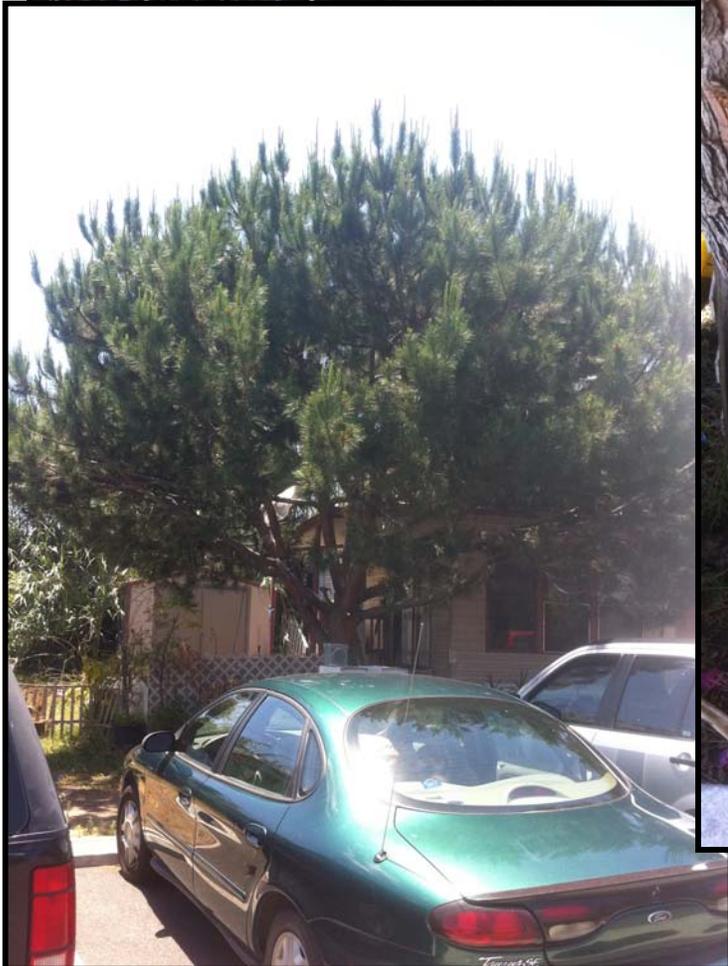
UNIT #36

- This tree has an approximate 14" DBH (Diameter at Breast Height).
- This juvenile Stone Pine appears to have grown as a volunteer in this location.
- As the tree has grown, its root system is now in conflict with the adjacent concrete sidewalk. This has contributed to a slight lean in the trunk.

- Additionally, there is a large surface tension root on one side of the tree, which has created uneven rooting and may be a result of the lean in the tree.

- The canopy of the tree appears healthy and vigorous, as this tree is still juvenile and is not yet impacted by its growing environment, or any unforeseen rooting conditions that could potentially encourage root plate failure in the future.

- This is based on the species rating of 90%, a condition rating of 75% due to the poor root system and slight lean, and a location rating of 60%, due to the site, contribution and placement of the tree.

- Although this tree has a uniform canopy, with good needle color, canopy coverage and scaffolding limbs, the compromised root system makes it a poor candidate for transplanting.

Italian Stone Pine

This tree has a slight lean and is poorly rooted. The tree may not be tolerant of the required root pruning to transplant this juvenile/semi-mature pine tree.

Note in photo below the large surface root on the right side of the trunk flare.

This tension root may be a result of the lean or adapting to a potential girdling root that is below grade level.

- Additionally, pine trees can be more sensitive to the root pruning required for transplanting, thus reducing their transplant survival rate.
- I recommend this tree be replaced with a more quality standard nursery specimen.

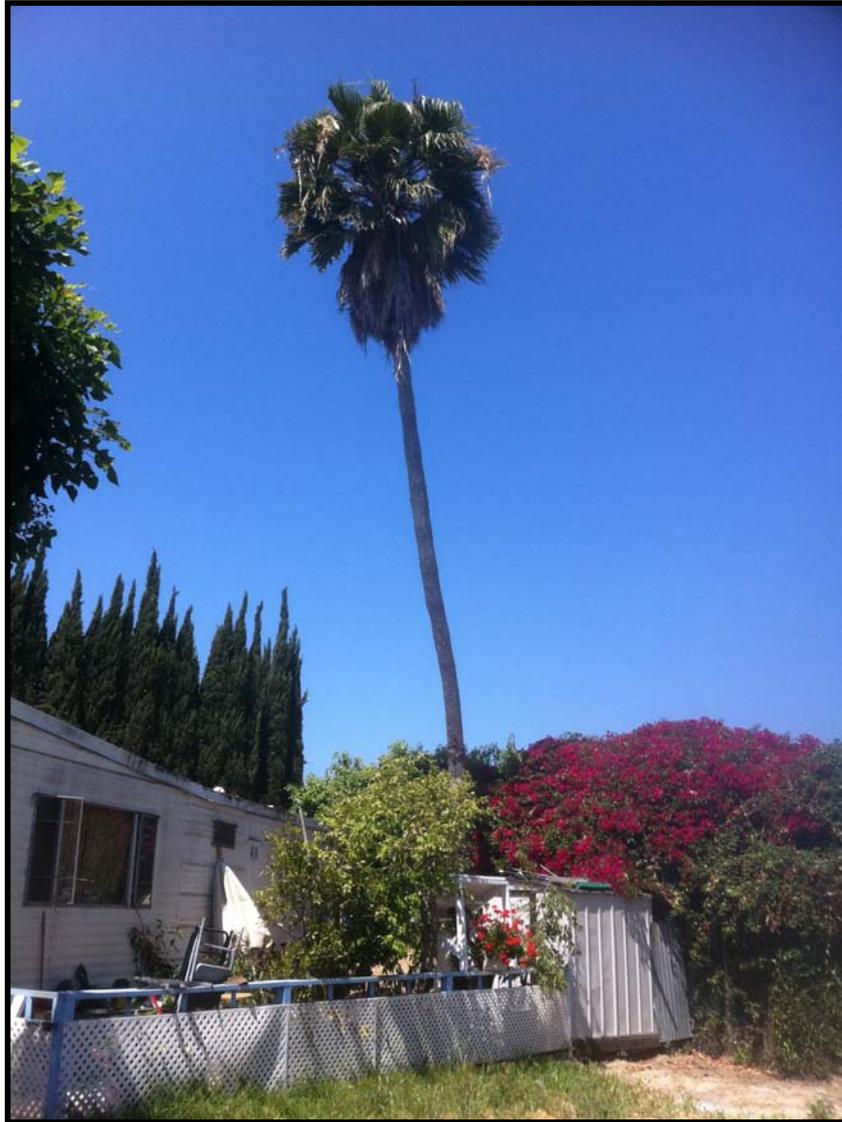
UNIT #37

- This tree is over 60 feet tall and is located in the furthest corner of the mobile home park.
- This specie of palm is readily found throughout Southern California. However it is not commonly planted due to its lack of trapping air pollution or providing shade, and other maintenance reasons.
- It is not feasible to transplant this palm due to the challenging location and lack of access for the required equipment to support a palm of this height.

Washingtonia robusta - This Palm is located in the rear corner of the mobile home park. There is limited access in this last cul de sac. The height of this palm would require extremely large equipment to adequately support its length. It is not feasible to transplant this palm.

- I recommend this palm be removed and replaced with a more appropriate specie.
