Santa Monica Pier

Architectural Conditions Assessment

submitted by
Wallace Roberts & Todd, LLC

February 8, 2008

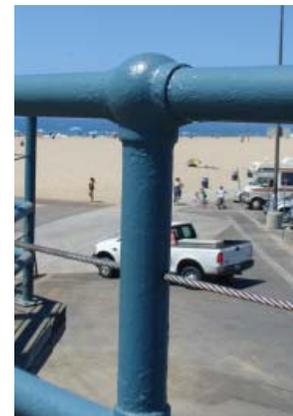
Rail Type 1: Socket

Materials: The railing is constructed of 3 (sometimes 4) horizontal 2" diameter steel pipe rails, with 2" diameter steel tube posts and fittings. All metal tubing is painted blue and appears to have been painted multiple times. Stainless steel cables have been added in the horizontal direction, centered between metal rails to create the 4" minimum clearance required by code. However, code has been updated and vertical barriers at minimum 4" O.C. have not been added. Joints vary in different sections of the railing; some are welded, while others are assembled with metal tees.

Maintenance: Paint has been chipped and repainted multiple times. Rust appears where paint is missing, most typically in areas of concentrated fishing activity. Metal rails require constant repainting to prevent rust, as rust can form wherever metal is exposed.*

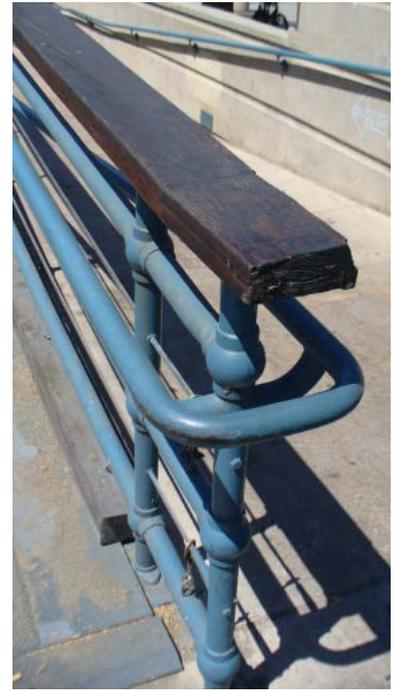
Rail Type 2: Wooden Railing

Materials: The railing is similar to Type 1 with the addition of a 2x8 wooden top rail. The railing is made of 3 (sometimes 4) 2" diameter horizontal metal tubes, with 2" diameter tubular metal posts. The top rail is a stained and coated wooden 2x8 plank, heavily worn, and supported by a bracket underneath. All metal tubing is painted blue and appears to have been painted multiple times. Stainless steel cables run horizontally only, centered between metal tubes to reduce the opening size to 4" in one direction. Joints vary in different sections of railing; some are welded while others are assembled with tees and sockets.

Maintenance: In general, the paint covers the metal railing consistently. Paint is worn and chipped in limited areas of high use especially along ramps, with rust observed where metal has been exposed. Metal tubing must be painted to prevent rust as wear requires. Wood is teak and requires pressure washing and re oiling annually in the spring. *

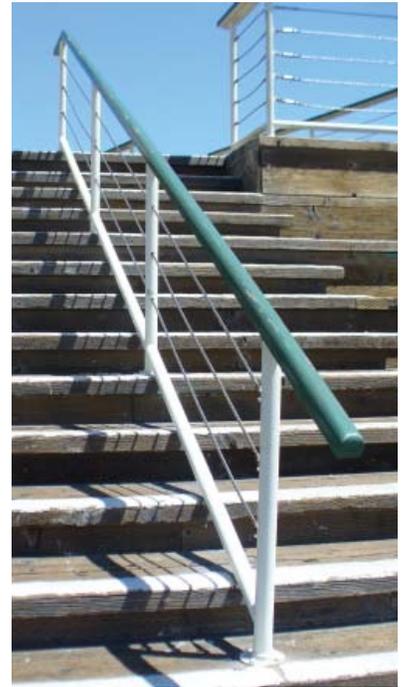
Rail Type 3: Green Top Rail

Materials: This metal rail is quite different than the other two rails and occurs only in a limited area at the Observation Deck at the west end of pier. The rail is made of 2" diameter painted steel posts and bottom rail, with a painted green wooden top rail. Horizontal stainless steel cables and turnbuckles have been added in the horizontal direction to limit size of openings.

Maintenance: In general, the paint covers the metal railing consistently. The paint is worn and chipped in limited areas of high use but rust was not observed. The painted wood top rail is worn and raw wood is exposed in some areas.

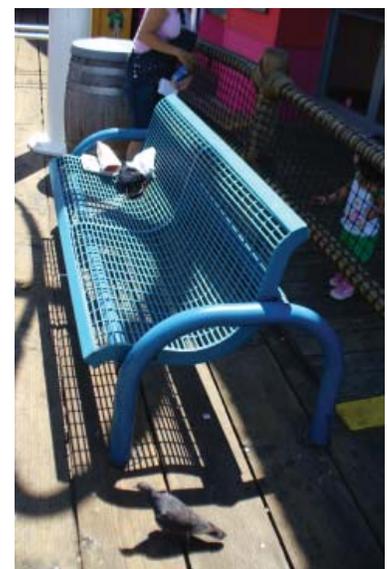
Bench Type 2

Maintenance: Routine repainting is required to prevent rust; removal from site is required if powder coating needs to be reapplied, per manufacturer’s directions. The open metal seat prevents water from ponding on the surface.

Durability: Rust was observed at base and near welds where the metal has been exposed.

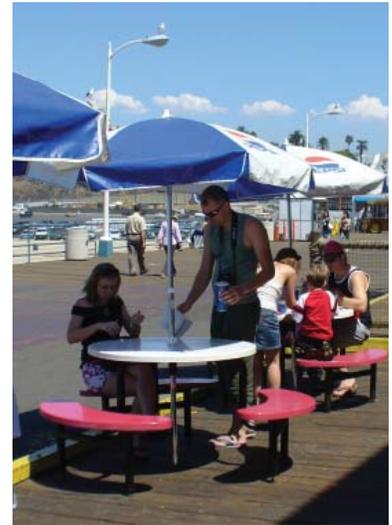
Table Type 2

Maintenance: The metal finish is chipped and limited rust was observed.

Durability: The round metal tables have some rust.

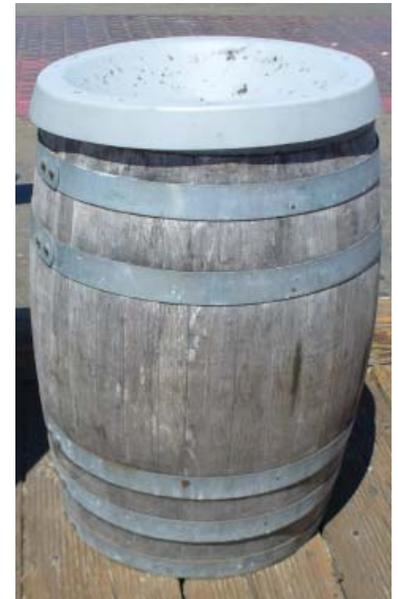
Trash Receptacle 1: Barrel

Functionality/Placement: The plastic funnel lid helps to keep trash in the barrel and hidden from view; however, it is not very aesthetically pleasing. Visually, this receptacle does not match any other site furnishings found on the pier.

Durability: The metal straps around the outside of the barrel have small amounts of rust, and the screws holding these straps are rusted.

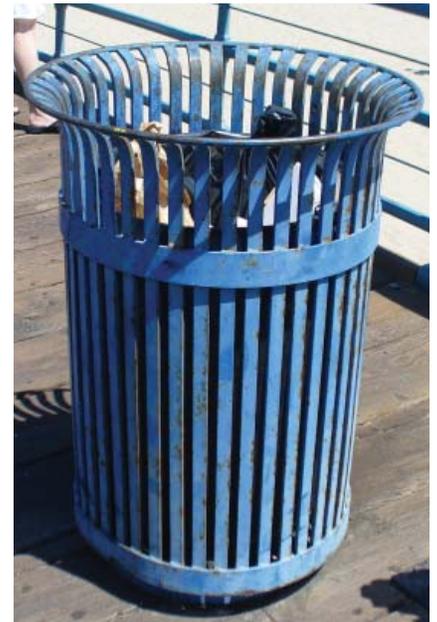
Trash Receptacle 3: Blue Metal

Maintenance: The receptacle is very rusted, faded and appears dirty.

Durability: Rust is forming where the paint has failed. Metal looks unsubstantial for the use and marine environment.

Sustainability: No sustainable elements are associated with this product. A recycled metal alternative should be considered in the event of replacing such furnishings.

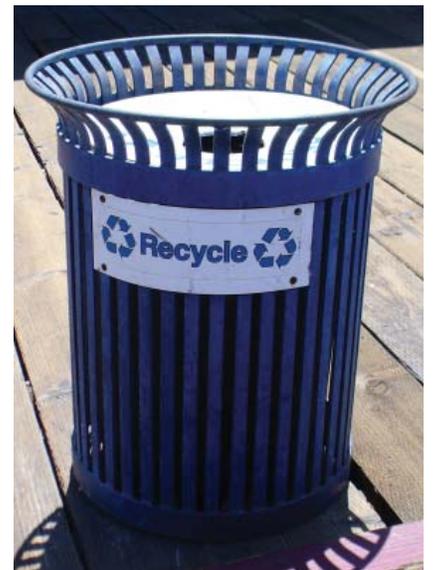
Trash Receptacle 3: Blue Metal Recycling

Maintenance: The container was worn and not clean. Regular repainting is required.

Durability: Rust is forming where the paint has failed, but with routine repainting this is a durable option.

Sustainability: No sustainable elements are associated with this product. A recycled metal alternative should be considered in the event of a replacement.

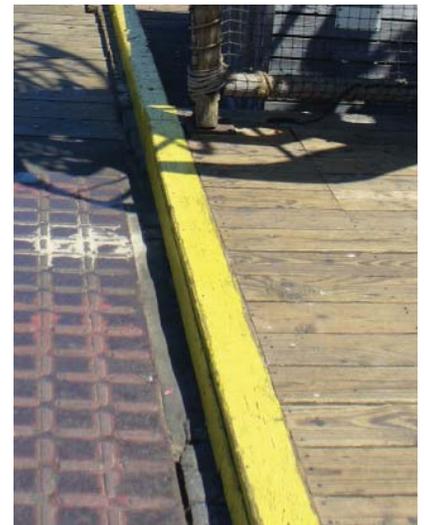
Curb Type 1: Yellow

Functionality/Placement: This curb defines the maintenance/fire lane. This curb offers no aesthetic benefit to the pier experience and could pose a tripping hazard.

Durability: The timber appears durable enough to satisfy function though edges of wood are becoming worn and repainting is necessary to maintain color.

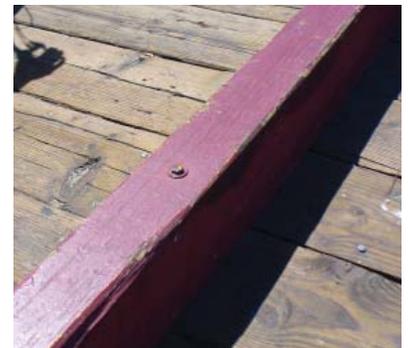
Curb Type 2: Red

Functionality/Placement: Curb required for traffic management and directs vehicular traffic into parking lot. These curbs offer no aesthetic interest to pier experience and pose a tripping hazard for pedestrians.

Durability: The timber appears durable enough to satisfy function though edges of wood are becoming worn and repainting is necessary in places.

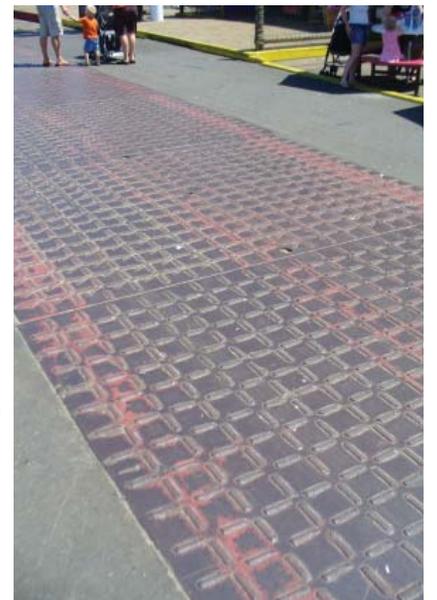
Decking Type 2: Asphalt

Durability: The asphalt was cracking and showing signs of wear.

Note: Asphalt covered decking and corrugated metal panels are scheduled to be removed and replaced with wood decking.*

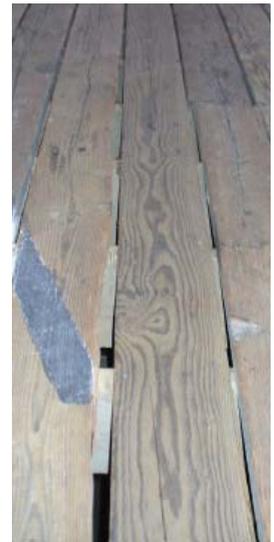
Decking Type 3: Parking Lot

Functionality/Placement: The parking deck planks appear uneven and worn when compared to "pedestrian only" areas. The boards are spaced further apart and in many cases greatly exceed 1/4" between floor boards.

Durability: The vehicular decking is significantly more worn than pedestrian decking due to heavy and constant use. Raised knots and nails were observed. Typical challenges of wood decking include dealing with variability of wood products, twisting, warping, splitting, etc. .

Maintenance: These areas appear to have been replaced at different times. Decking should be replaced where cracks and gaps pose a hazard. Re-striping should also occur on a regular basis to ensure a cohesive flow within the lot.

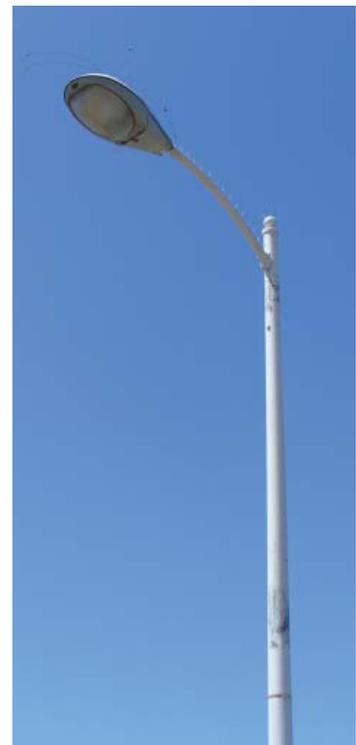
Lighting Type 1: Cobra Head

Durability: Many of the Cobra head light poles are severely rusted and the bases are weakened by the corrosive environment.
