CAROB ASSESSMENT
City of Santa Monica

PREPARED FOR:
City of Santa Monica
Public Landscape Division
2600 Ocean Park Blvd.
Santa Monica CA 90405

PREPARED BY
HortScience, Inc.
2150 Rheem Drive, Suite A
Pleasanton CA 94588

March 2008

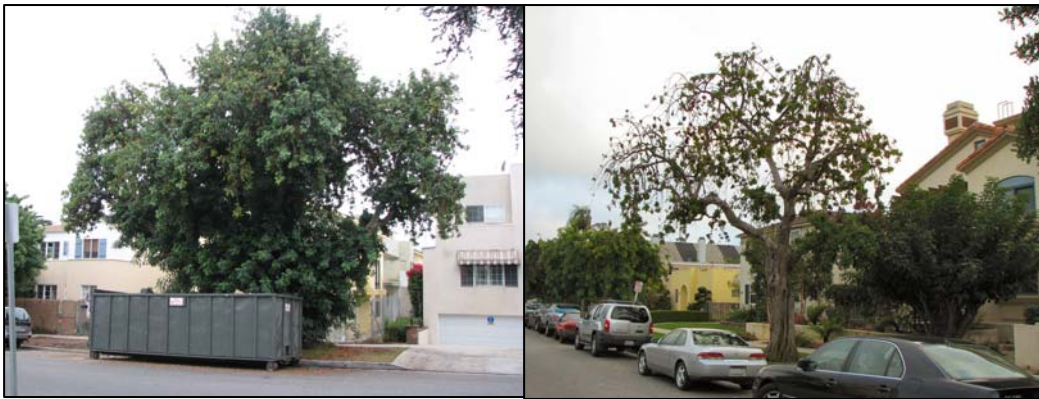
Photo 1. Examples of carobs in Santa Monica. **Below left:** tree #955 was in good condition with a full, dense crown. Note absence of irrigated lawn & sprouts along lower trunk. **Below right:** tree #791 was in poor condition with sparse foliage & twig dieback.

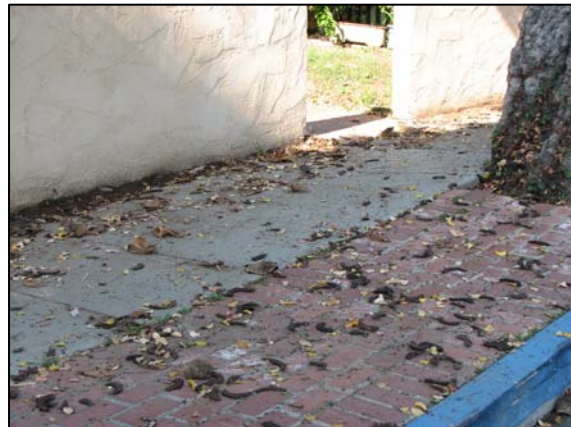
Photo 2. Flower & fruit litter beneath canopy of carob.

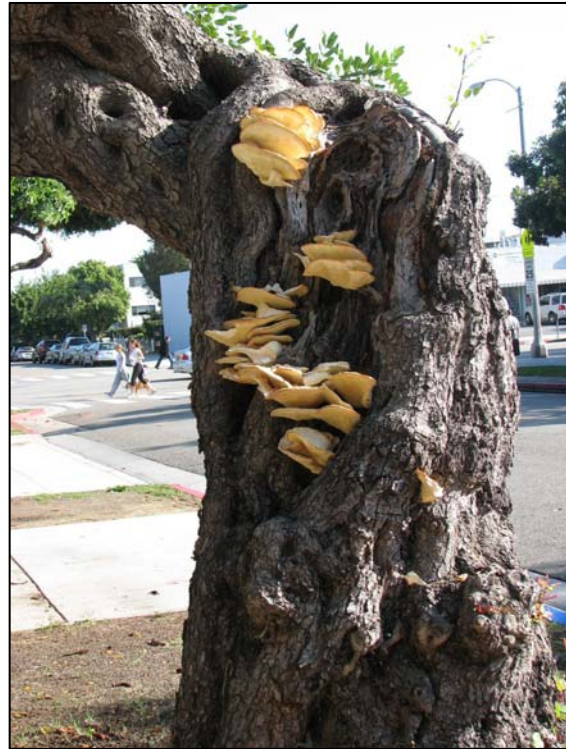
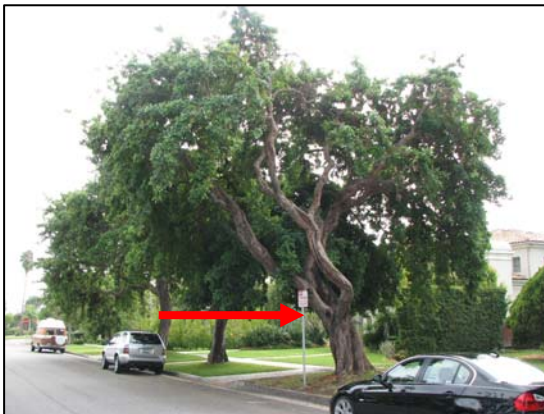
Approximately two-thirds of trees (186 of 268) in poor condition and had visible signs of decay, either fruiting bodies or cavities. A number of trees had both (Photo 3). I identified three decay organisms: sulfur fungus and two species of ganoderma (*Ganoderma applanatum* and *G. lucidum*). It is likely that two root decay organisms, oak root fungus and phytophthora (*Phytophthora* sp.), were also present in some trees. The presence of fruiting bodies indicates that decay is extensive and has been present in the tree for a long period of time.

Photo 3. Tree #792 was in poor condition with extensive decay including conks as well poor form and structure.

There was a clear relationship between overall tree condition and viability. Trees in poor condition, such as #792 (Photo 3), were more likely to have viability of less than 2 years. In contrast, trees in fair condition, such as #707 (Photo 4) were more likely to have viability between 2 and 15 years. Trees in good and excellent condition can be expected to survive more than 15 years.

Trees selected for testing had some indications of decay. The development of a fruiting body such as sulfur fungus (Photo 3) was a clear indication that decay is not only present but extensive. For this reason, trees such as #792 were not tested.

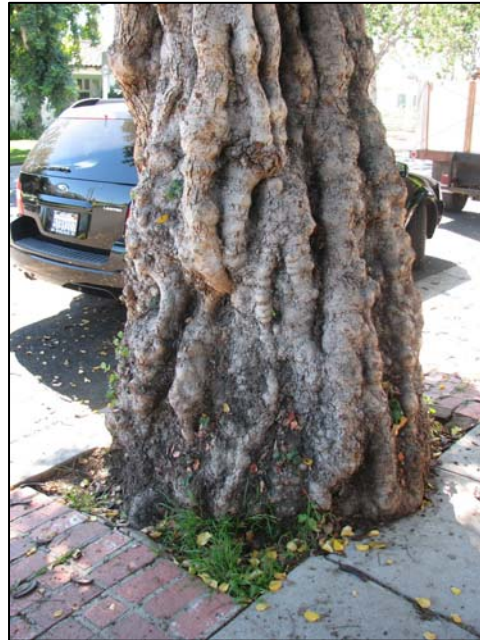
More typical of trees selected for testing was #1263 (Photo 5). The base of the trunk was unusually large and sounded hollow when struck with a hammer. There were no external indicators of decay such as fruiting bodies or cavities in this area. I drilled the lower trunk to determine if decay was present internally. Results indicated that a narrow shell of sound wood surrounded an internal center of decayed tissue (Table 2)

Photo 5. The lower trunk of tree #1263 lacked external indicators of decay. Testing revealed the presence of internal decay.

Results of the decay testing were incorporated into the assessment of failure potential. In the case of tree #1263, the testing raised the failure potential from high to severe.

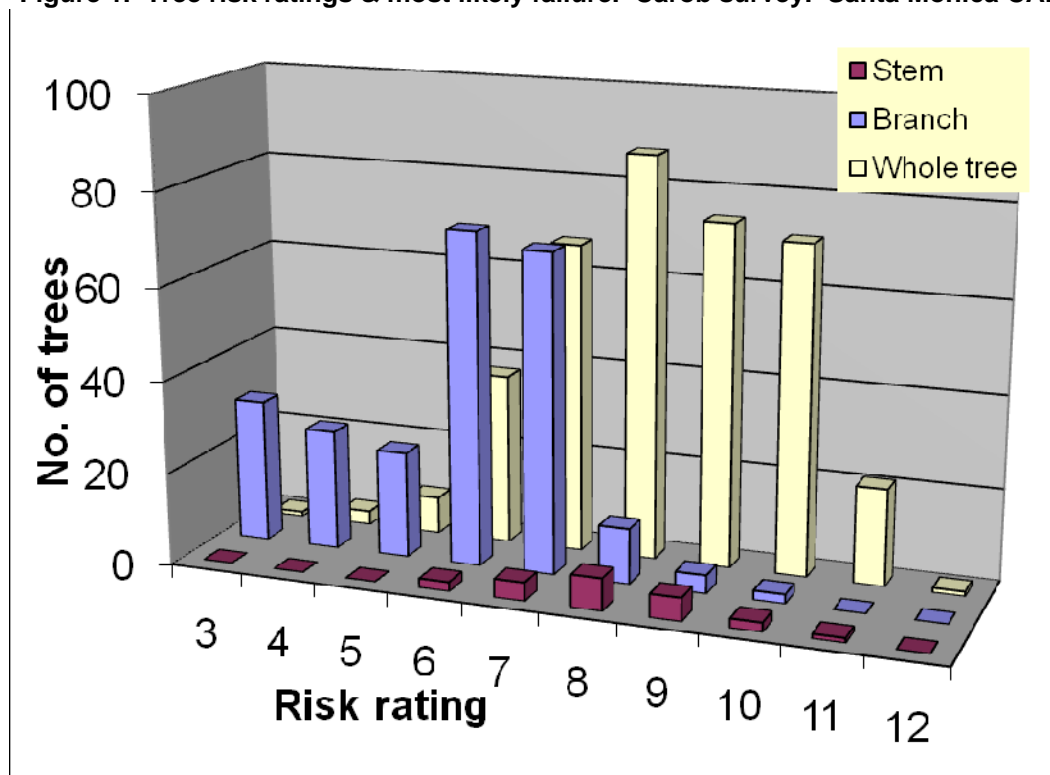
Figure 1. Tree risk ratings & most likely failure. Carob survey. Santa Monica CA.

Because each of the three factors could be scored from 1 to 4, the potential range of tree risk ratings was 3 to 12 (Figure 1 page 8). Slightly over half (54%) of the trees evaluated had ratings of 7 or lower. For trees with these low ratings, the most common situation involved a branch as the most likely failure (note blue bars in Figure 1), with the target being the sidewalk, lawn surrounding the planting area or an adjacent parking place. Examples of trees with ratings of 7 or lower include #955 (Photo 1) and #707 (Photo 707).

In contrast, 98 trees (16%) were rated as 10 or greater. Situations with ratings of 10 or above involved the entire tree (yellow bars in Figure 1) in close proximity to a highly rated target such as parking or the traffic. For example, tree #792 (Photo 3) received a rating of 10 based on its imminent potential to fail (rating of 4), the size of the stem that would most likely fail (diameter >30", rating of 4) and the target that would be struck (the adjacent driveway). Tree #1263 (Photo 5) received a rating of 11 due to its imminent danger of failing (extensive decay at the base), its large size and the presence of parking beneath the canopy.

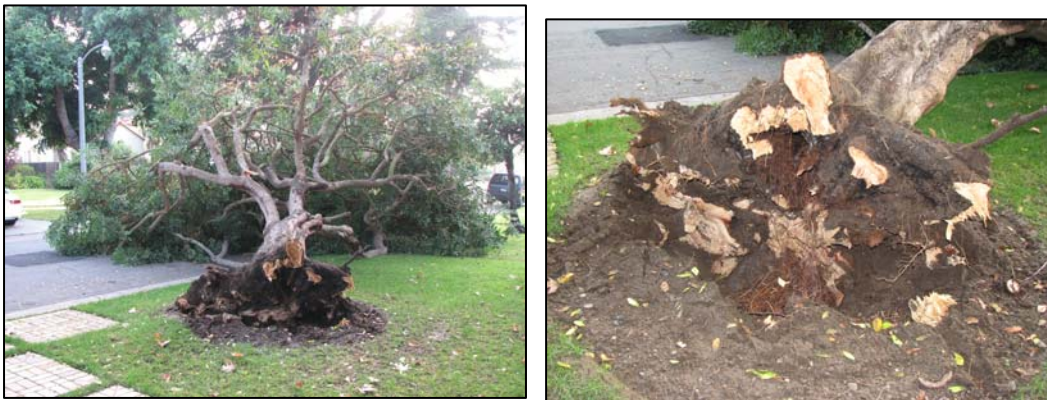
Photo 6. Tree #978 failed the day after it was inspected. Although the 20" diameter was vigorous, almost all of the major roots were decayed, a defect that was not visible.

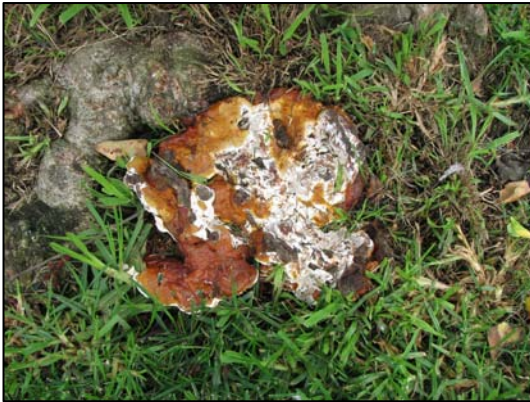
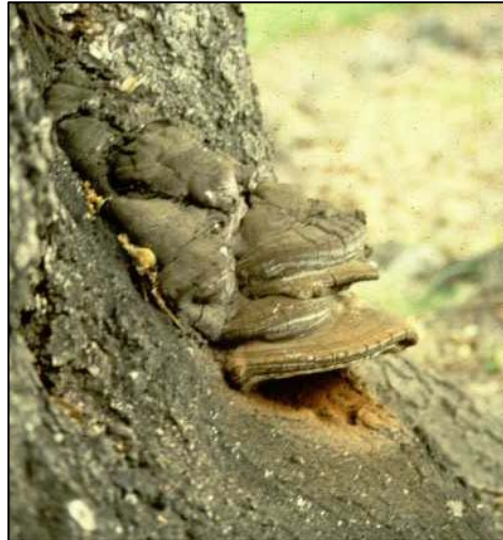
Ganoderma fruiting structures. Right: old *G. applanatum*. Below: new *G. lucidum*.

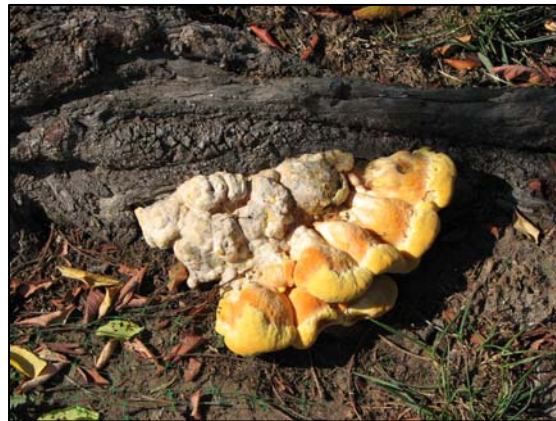
- Presence of fruiting bodies of sulfur fungus (*Laetiporus sulfureous*). Look for orange-yellow conks on the lower trunk and old wounds. Conks fade to an ivory color with a chalky consistency.
