ROSA LOWINGER & ASSOCIATES

Chain Reaction, Paul Conrad – Santa Monica

Interim Notes – November 18, 2011

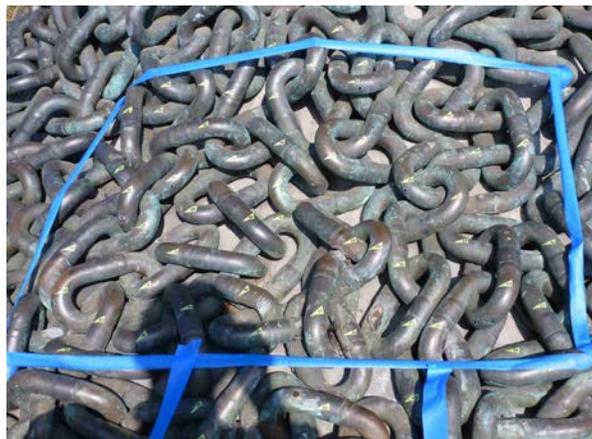
Image: Selected areas for brass link removal with labeling system.

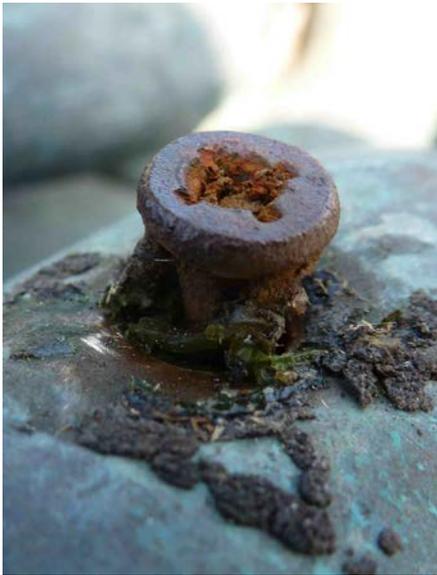
The majority of the visible screw heads had been previously cut off or were severely corroded and/or stripped to the point where they could not be removed with a screwdriver or power drill. Conservators removed the heads of two screws using a Dremel and then attempted to slip the brass links over the shank and thread. Unfortunately, this was not possible in either case since the screw shank/thread had corroded and was fused to the brass link(s). Conservators then attempted to cut the shank/thread in between the brass links and/or the bottom link and fiberglass, but there was not enough space between the two surfaces to fit a Dremel, or other cutting tool, without damaging the links. Conservators then attempted to gently pry the links from the surface of the fiberglass, using a small crowbar padded with foam. This attempt was also unsuccessful in liberating the links and was abandoned in fear of cracking/breaking the fiberglass if continued and excessive force was used.

Image: Corroded screw.

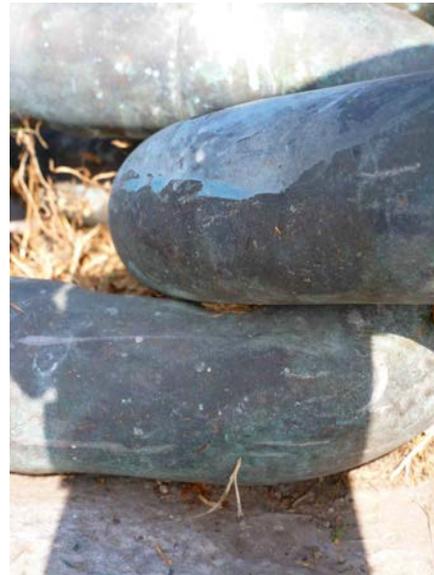
Image: Limited or no space between materials in order to cut the screw.

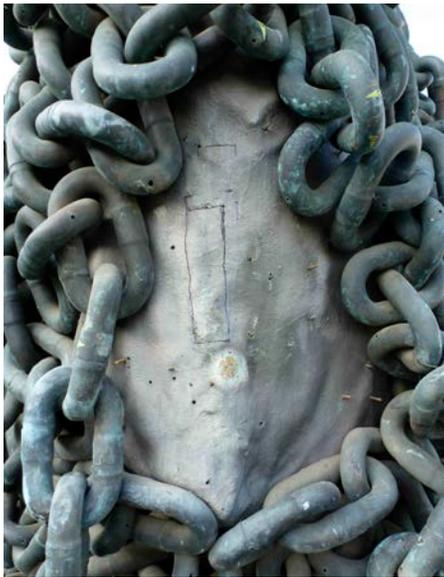
Image: Area cleared & marked for 2"x8" cut.

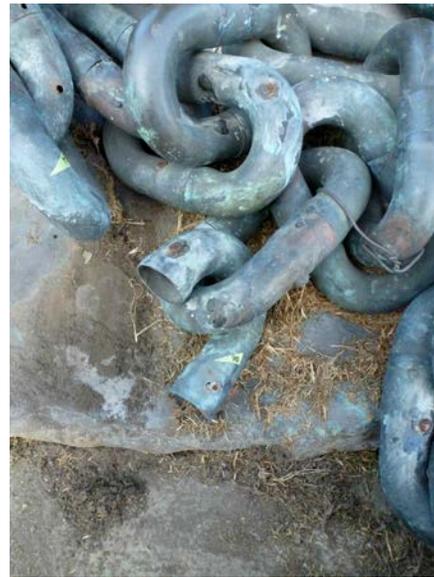
Image: Area cleared for potential cut, pending engineer approval.

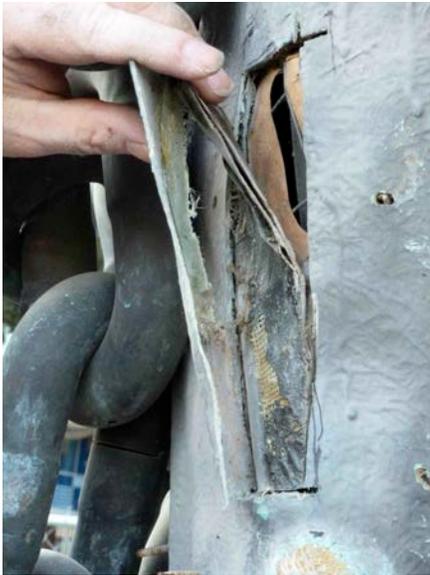
Image: Layers below fiberglass surface after cutting.

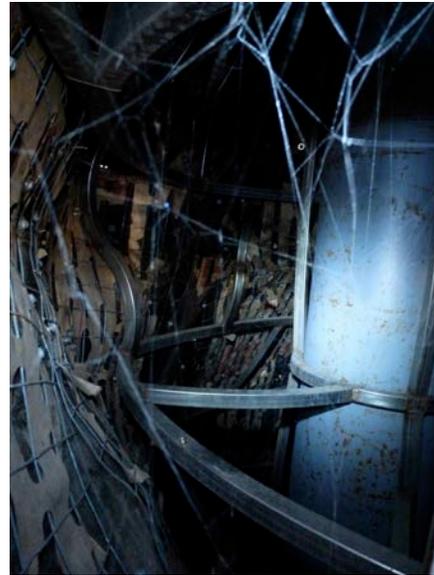
Image: Interior structure of sculpture.

Wire cutters were used to remove the chicken wire from the 2"x8" probe. Using a flashlight, conservators, as well as Malina and Jessica, were able to quickly inspect the interior of the sculpture and take several photographs. It appears that the chicken wire was formed over a stainless steel armature, which is connected to the central "flag pole". From our limited observation, it appears that the stainless steel armature had welded connections and did not exhibit any sign of rusting. Minimal surface corrosion was observed on the central "flag pole". After observing the interior, all parties agreed that no further cuts would be made until the engineers were on site and reviewed the sculpture.
