Pool – Maintenance & Repair

Historic Status: City of Santa Monica Historic Landmark

Current Condition DECK

Summary of Proposed Pool & Deck Tile Repair:

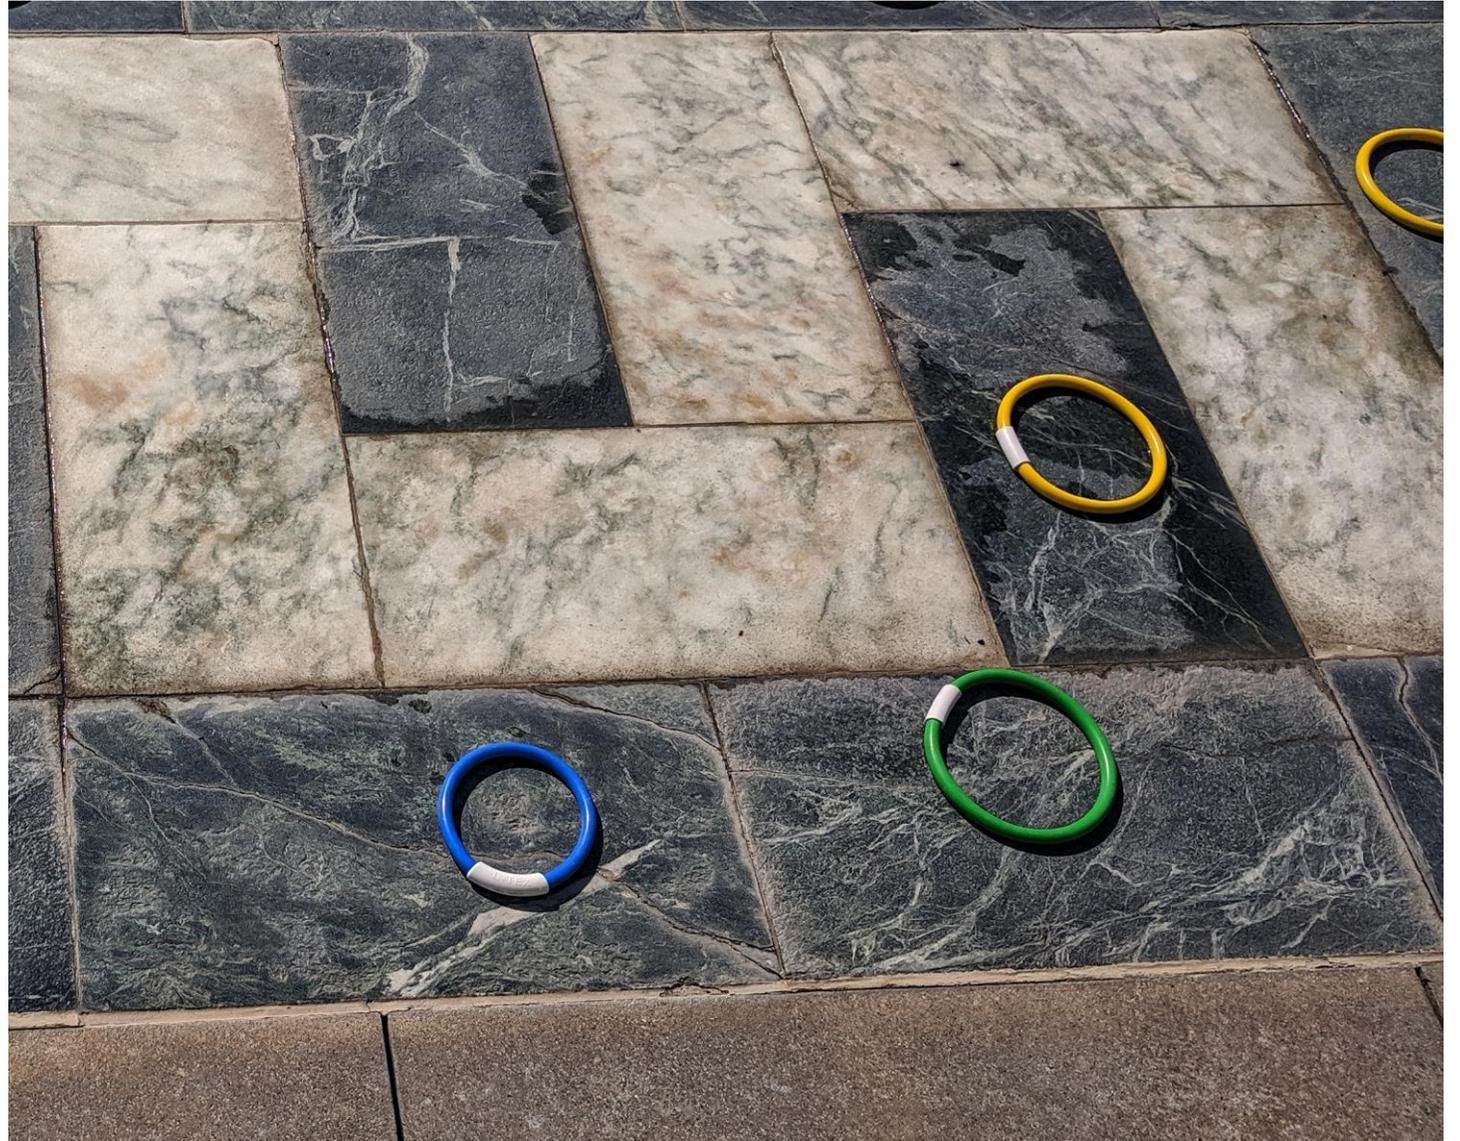
*Survey of green marble deck tile.
Dive rings were used to mark
deteriorated tiles to be replaced.*

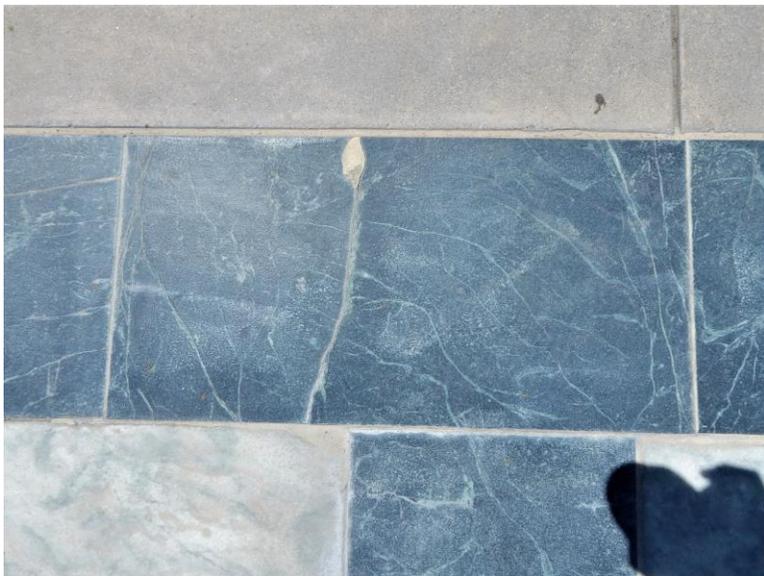
Cracking (Some Previously Repaired)

- **SPLITTING:** Fracturing of stone along naturally occurring planes of weakness – veining for the green marble.
- **CRUMBLING:** Detachment of aggregates of grains from the marble substrate. Generally limited in size.
- **CHIPPING:** Breaking off of small pieces from the edge of a piece.

- Cut tile to size on-site to match existing marble paver dimensions.
- Abrasively clean new tile to match texture/wear of existing tile.
- New grout at all replaced marble pavers.
- Re-set loose existing marble pavers.
- Clean to remove rust staining soiling.
- Apply Miracle Sealants Company “Miracle 511 Seal and Enhance” to all deck marble pavers.

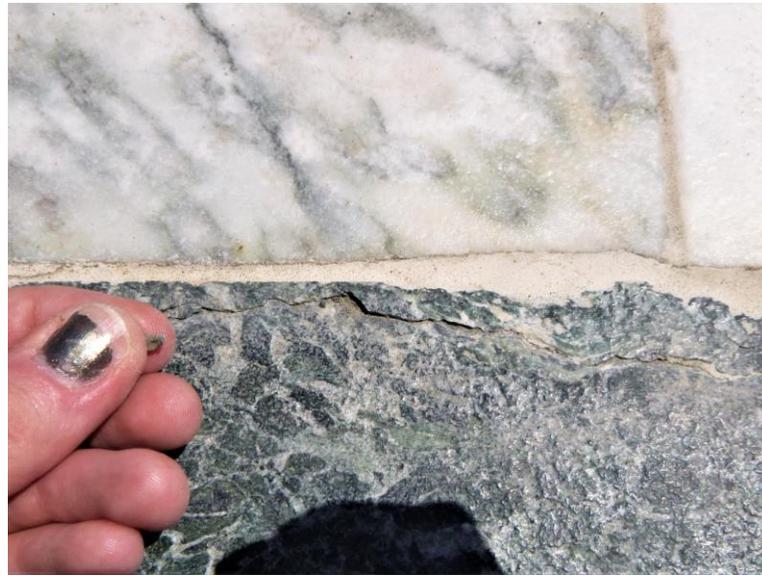
Crumbling / Chipping

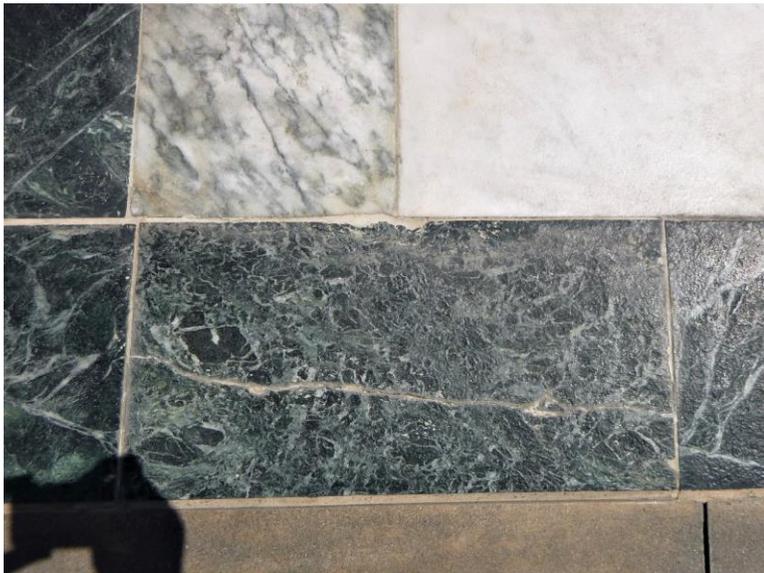
Splitting

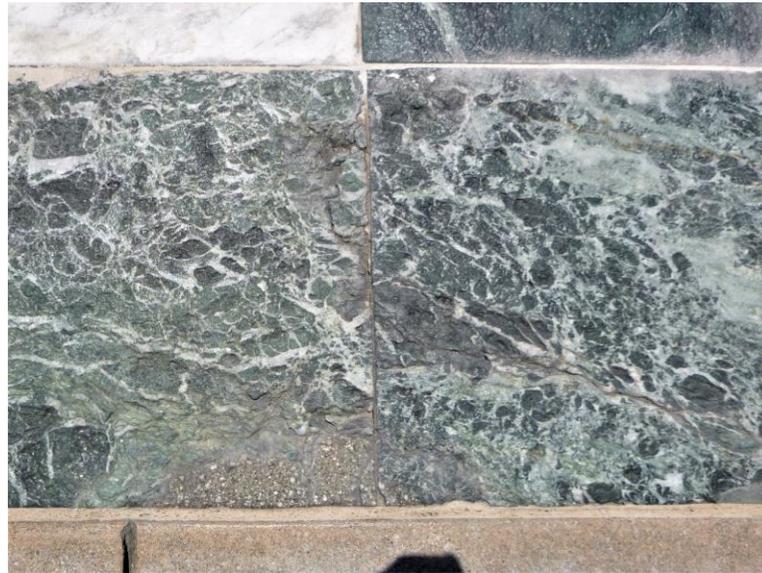
Crumbling / Chipping / Splitting

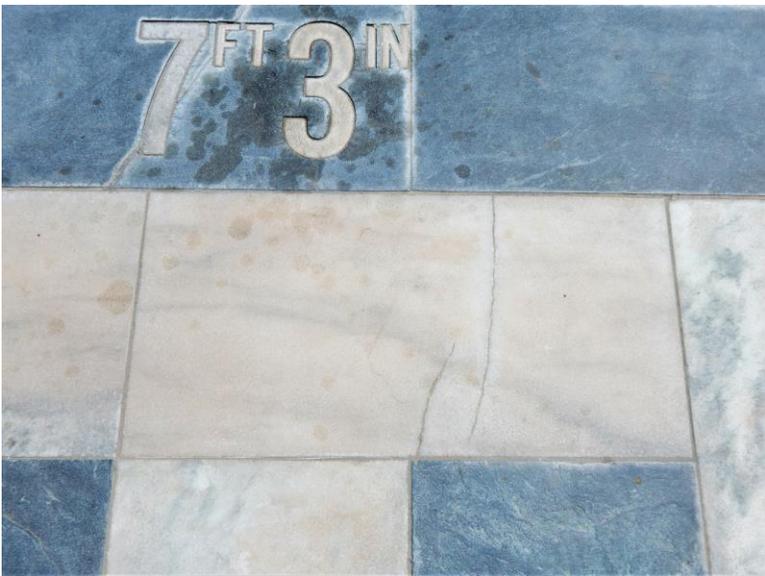
Cracking / Staining

- **SPLITTING:** Fracturing of stone along naturally occurring planes of weakness – veining for the green marble.
- **CHIPPING:** Breaking off of small pieces from the edge of a piece.
- **SUGARING:** Granular disintegration occurring mainly in white marbles.

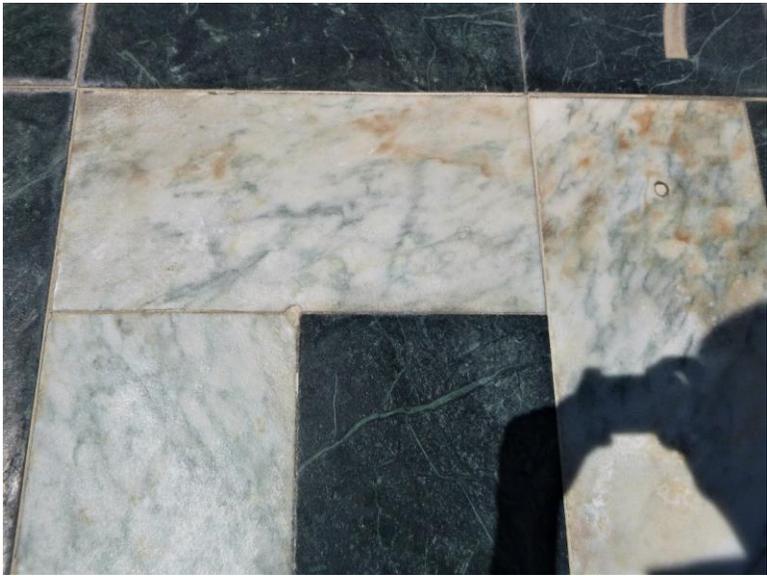
Staining

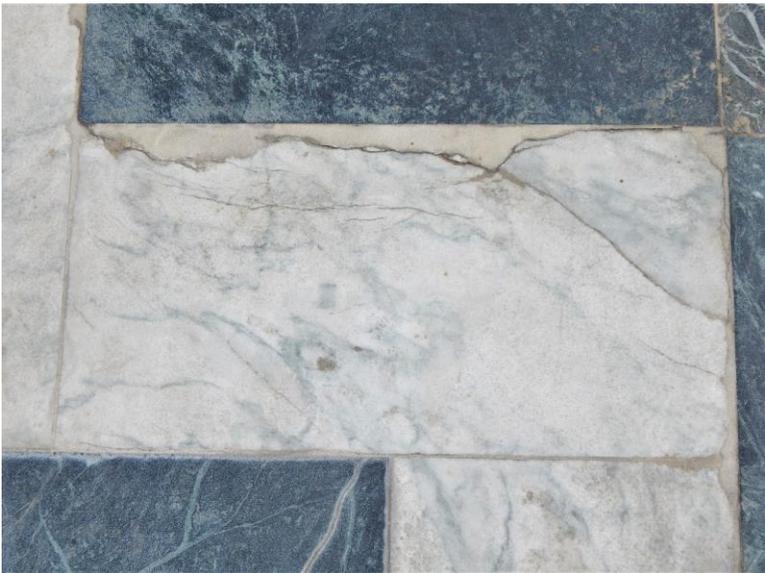
Splitting / Chipping (Previous Repairs)

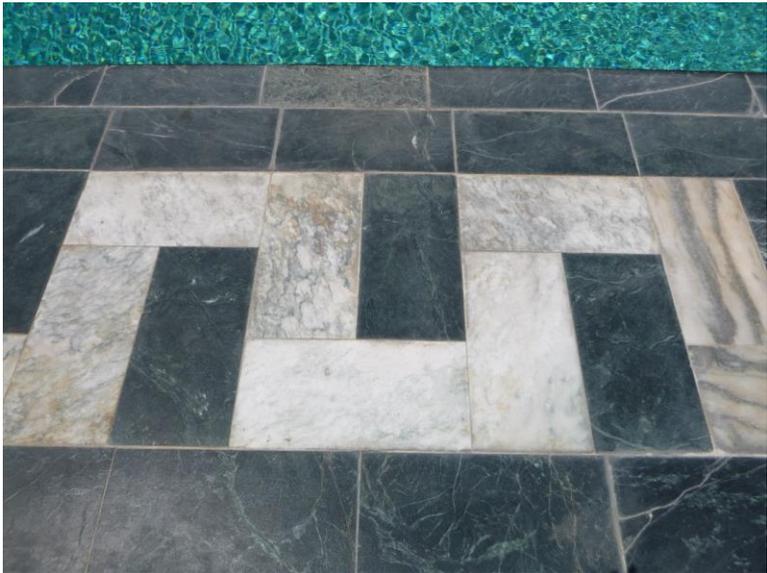
Non-Matching Replacement Marble

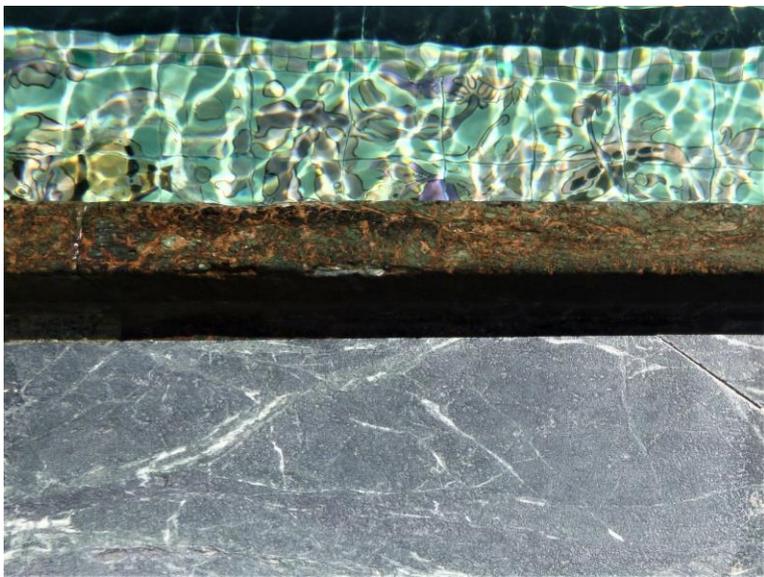
Differential Erosion / Staining

- **DIFFERENTIAL EROSION:** When erosion does not occur at the same rate. For the green marble, the veins erode faster than the green body of the stone. The veins also hold rust staining more prominently than the body.

- Carefully remove deteriorated mortar patches at L-shaped ‘scum’ gutter. Large patches to be repaired using marble Dutchman methods; smaller patches to be filled with patching material approved for use with marble, and to have integral color that is close to the color of the marble.
- Infill marble cracks with grout.
- Remove rust stains using chemical methods.

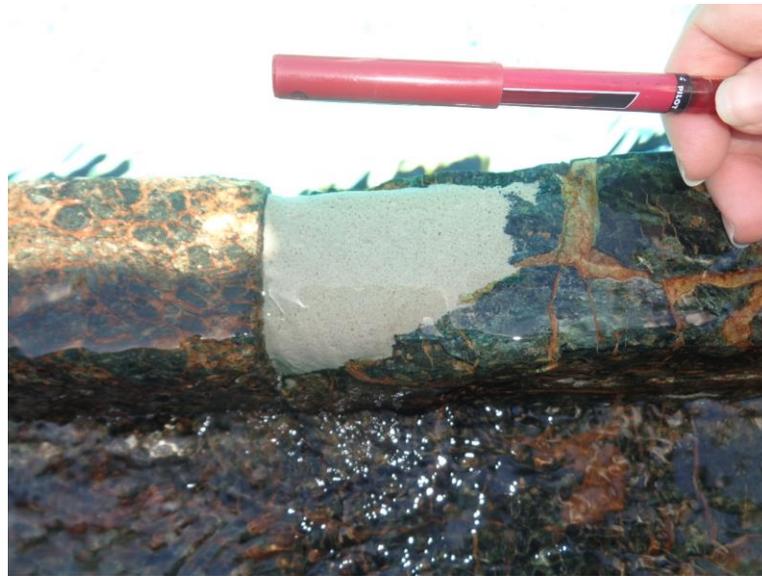
Non-Matching Repair

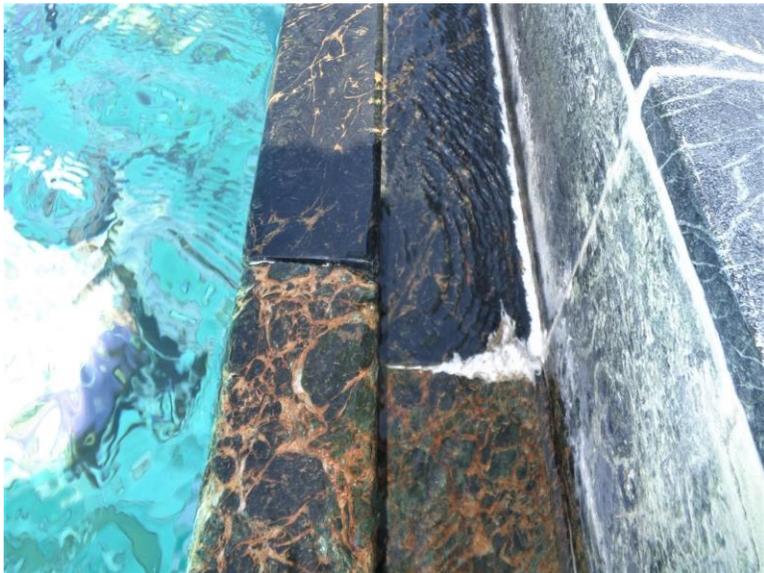
Crust / Staining

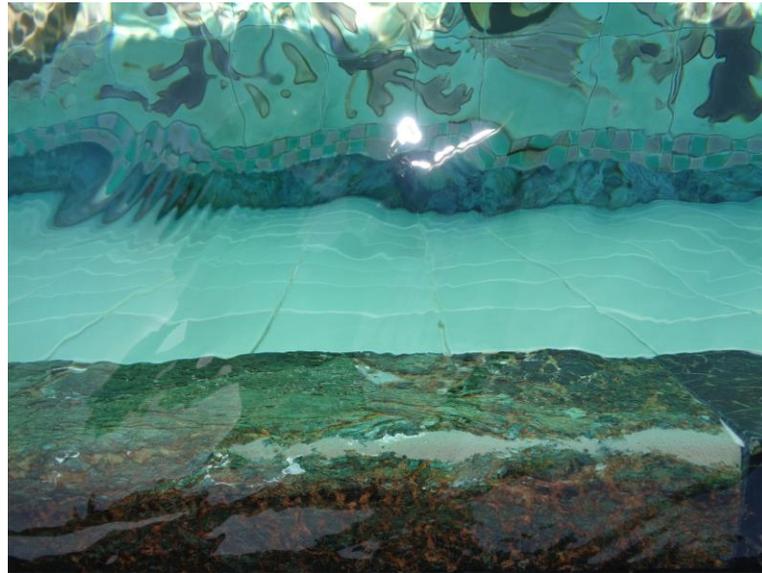
Non-Matching Repair / Differential Erosion

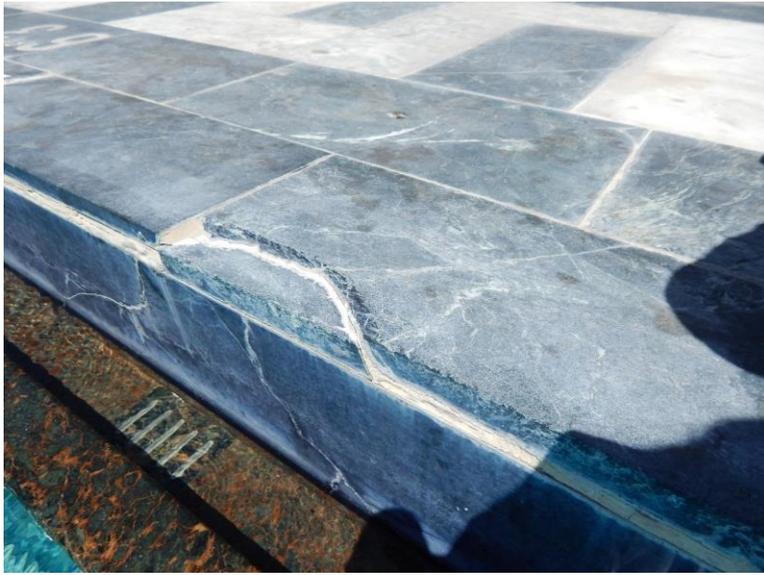
Cracking & Displacement of Fascia & Deck Cap

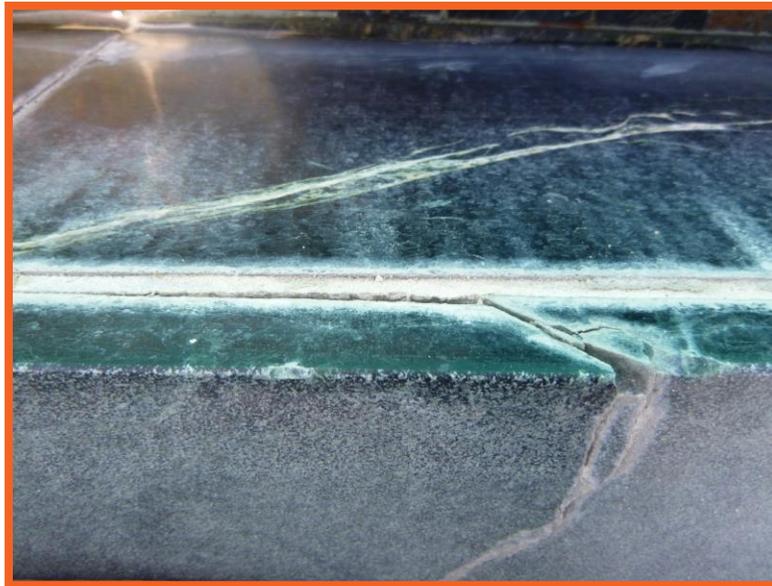
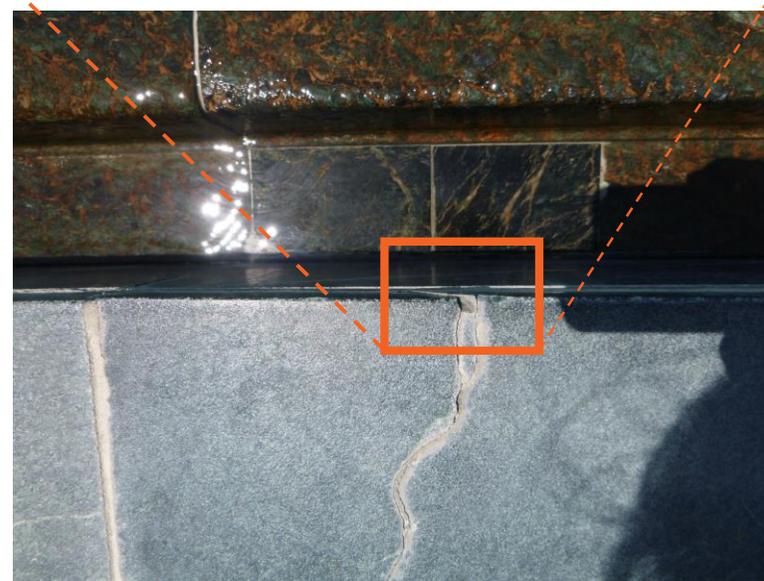
Cracking of Fascia & Deck Cap

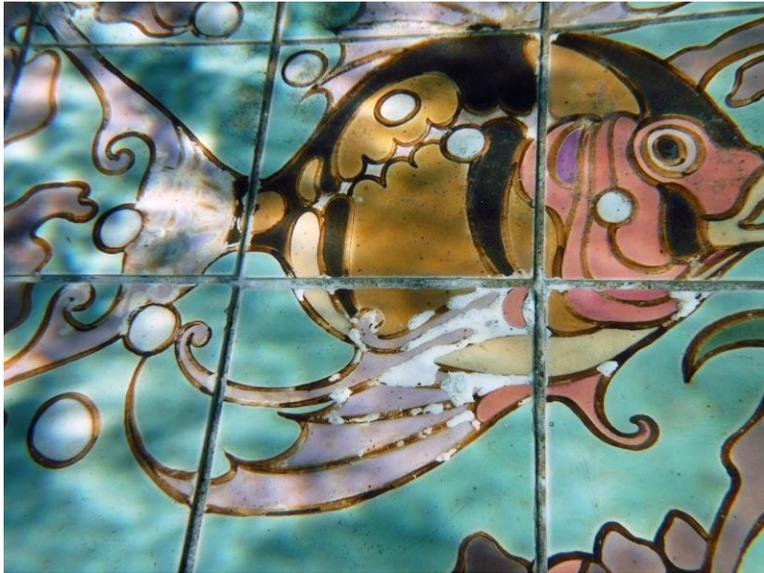
Missing / Spalled Glaze

- 1”x1” tessellated mosaic tiles: Full replacement (approximately 11,000 tiles).
- Fill cracks at ceramic tiles.
- In-paint glaze losses to all 6”x6” fish tile (approximately 1,400 tiles) using Edison Aquepoxy 250.
- New grout at tile joints through-out.
- Rust exploration/treatment: Contractor to carefully remove tiles at areas of heavy rusting to observe any corroded metal. Review condition with architect as some corroded metal should be replaced with stainless steel. Remove ferrous metal and apply rust inhibiting primer at areas of heavy rust. Remove rust stains using chemical methods.
- General cleaning of all pool tile.

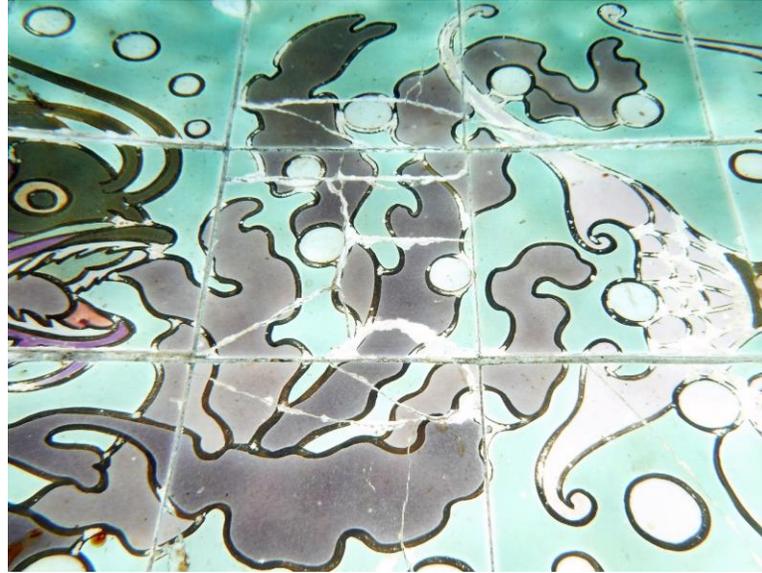
Cracked Tile & Fading Colors

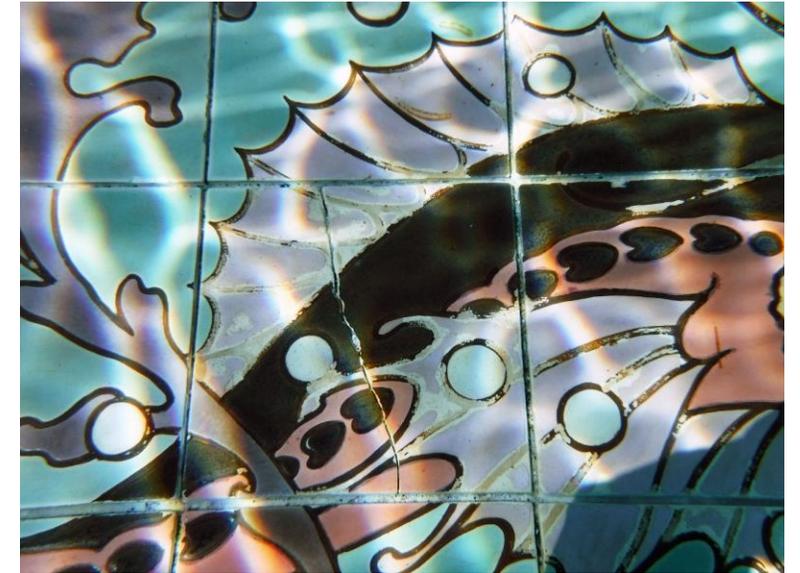
Cracked Tile (38 Tile out of 1,380)

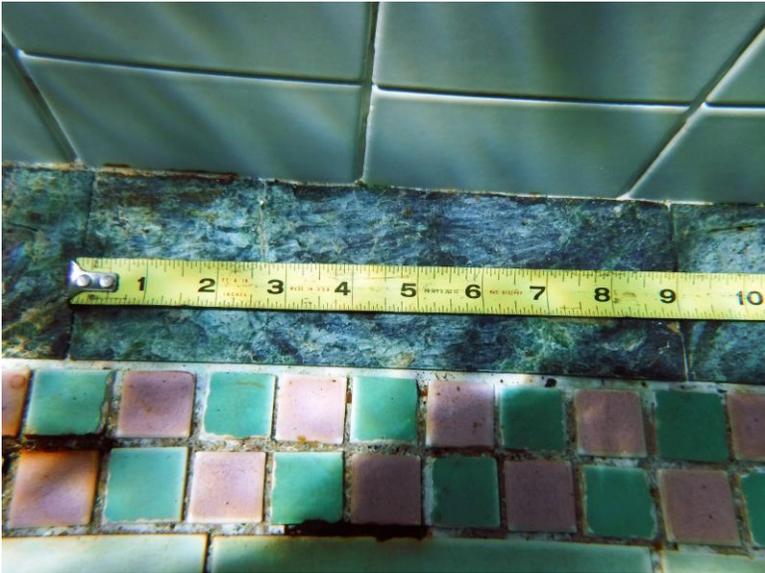
Glaze Loss at Edges & Rust Staining

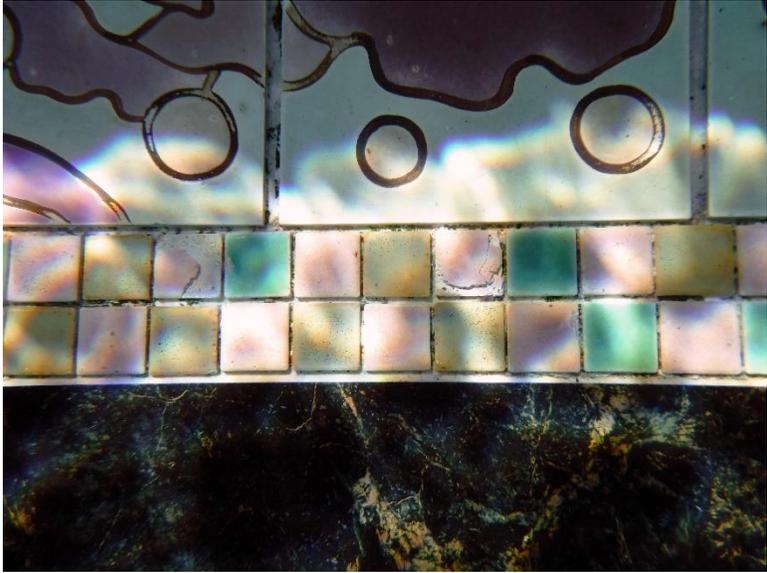
Glaze Loss (2,933 Tile out of 10,300)

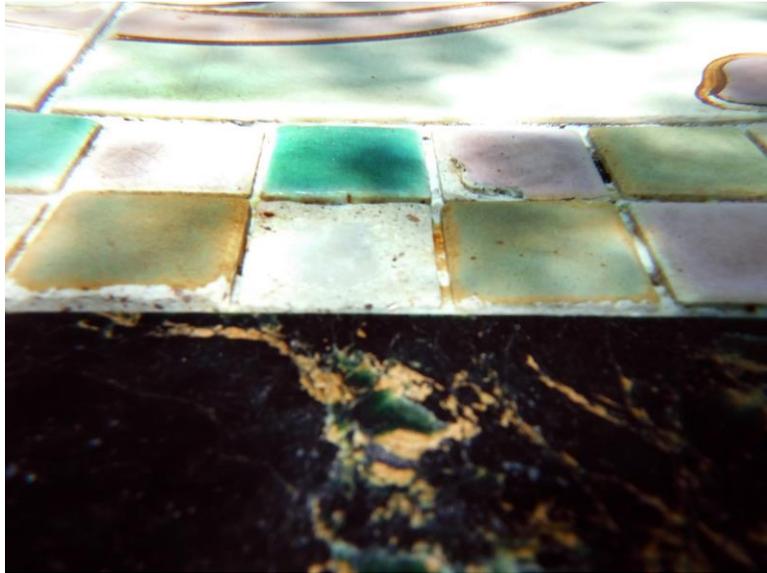
Glaze Loss / Non-Matching Tile
