Chattel, Inc. | Historic Preservation Consultants

MEMORANDUM

RE: Miramar Santa Monica, 101 Wilshire Boulevard, Santa Monica, California
Conformance Report Update

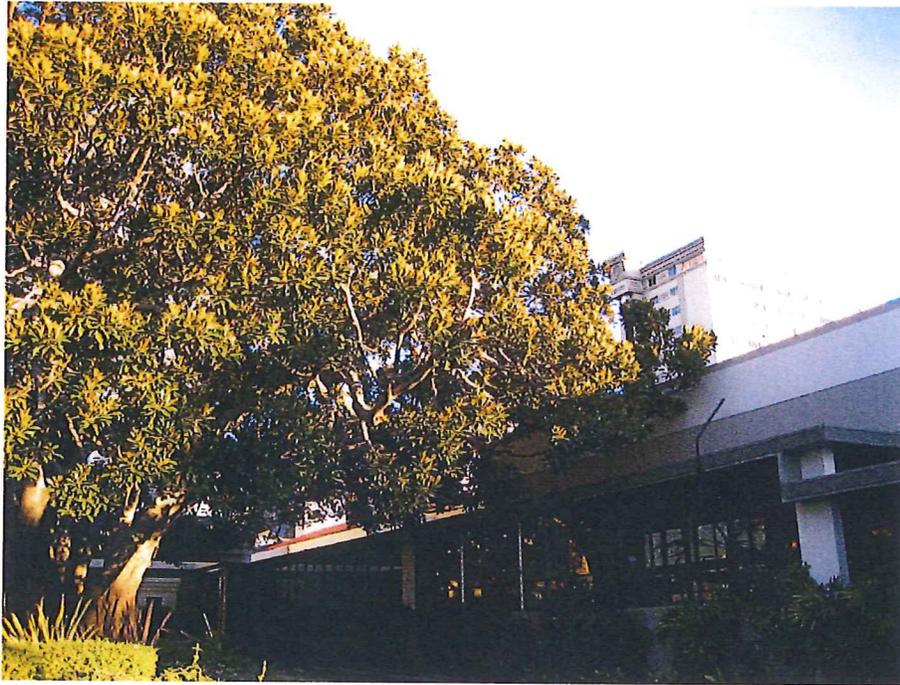
Canopy of tree impacting structure needs to be reduced

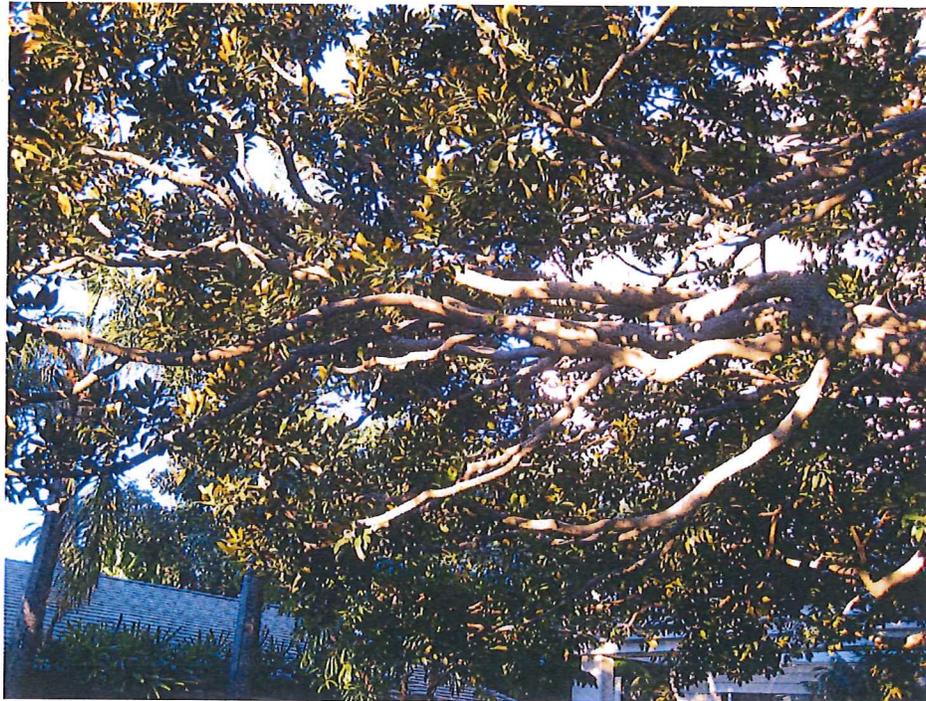
Extremely long branches carrying excessive weight are a hazard

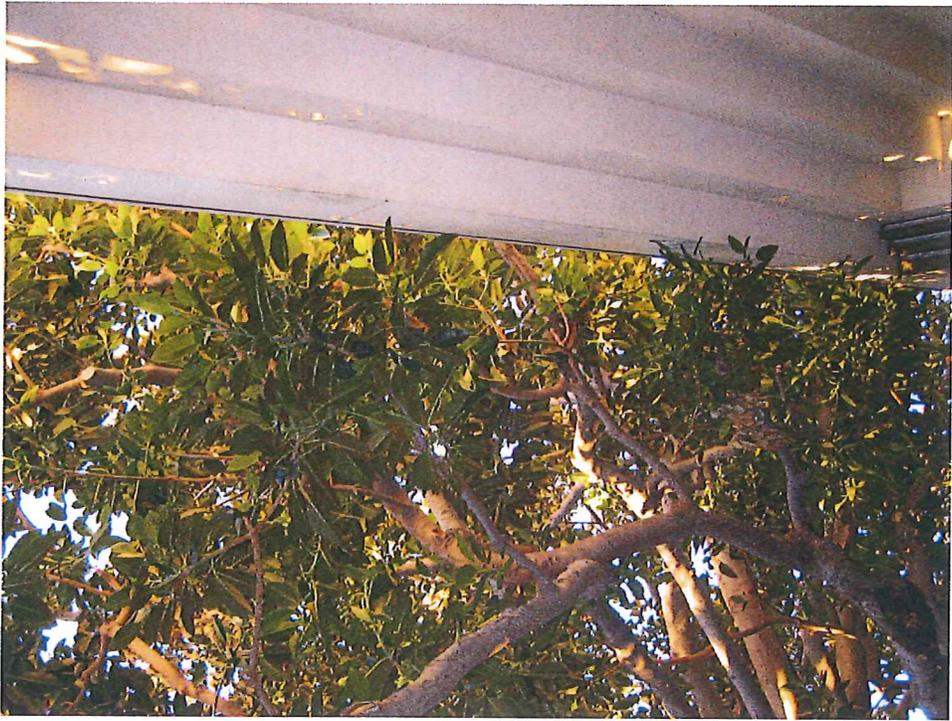
Branches growing inside of roofline need to be rebalanced

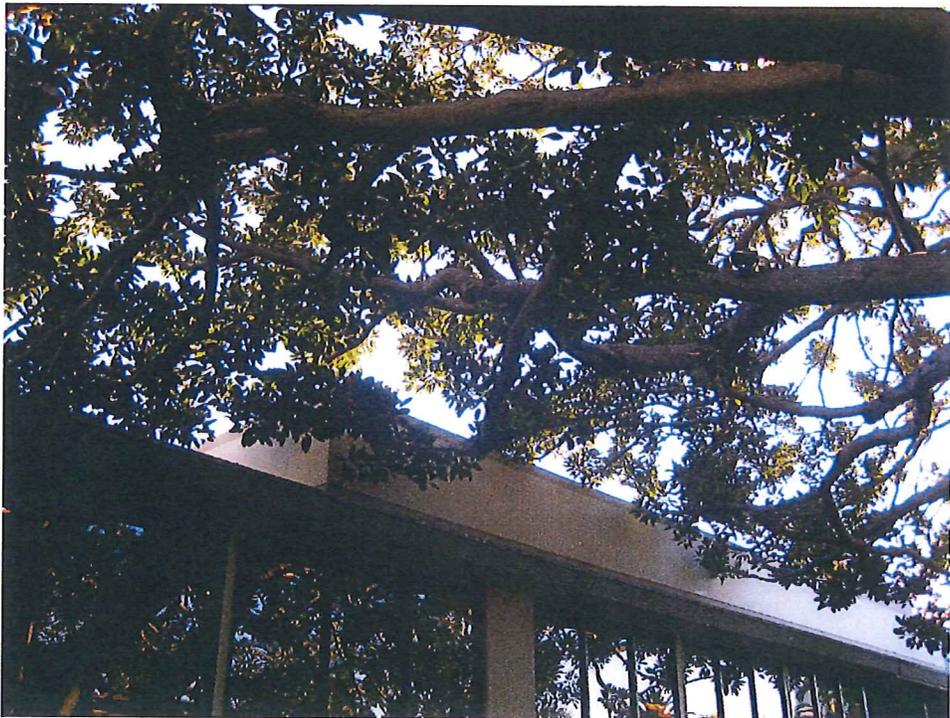
Selective pruning is needed to reduce the encroachment

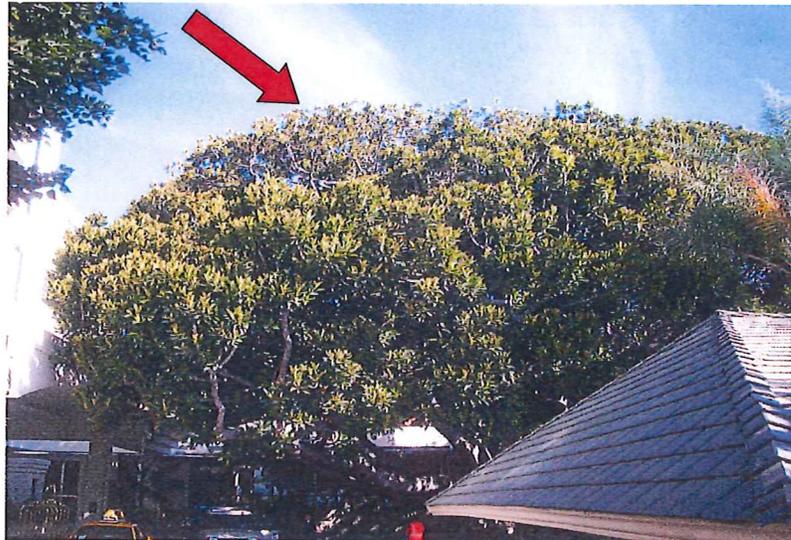
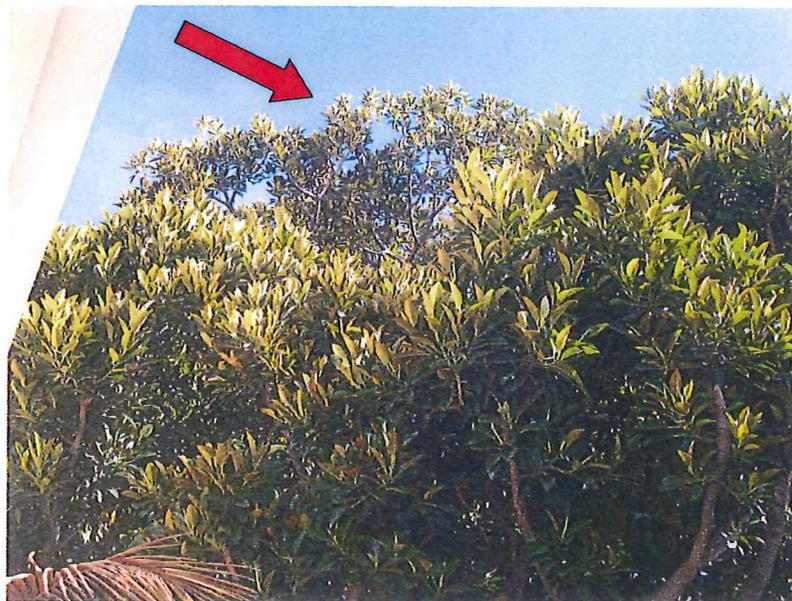
There is, however, a section on the back side of the tree (see photos #1 and #2 below) that does *not* show the same positive appearance. In this area, there is visual evidence of stunted growth, dwarfed leaf size, thinning canopy, lack of color and vigor.

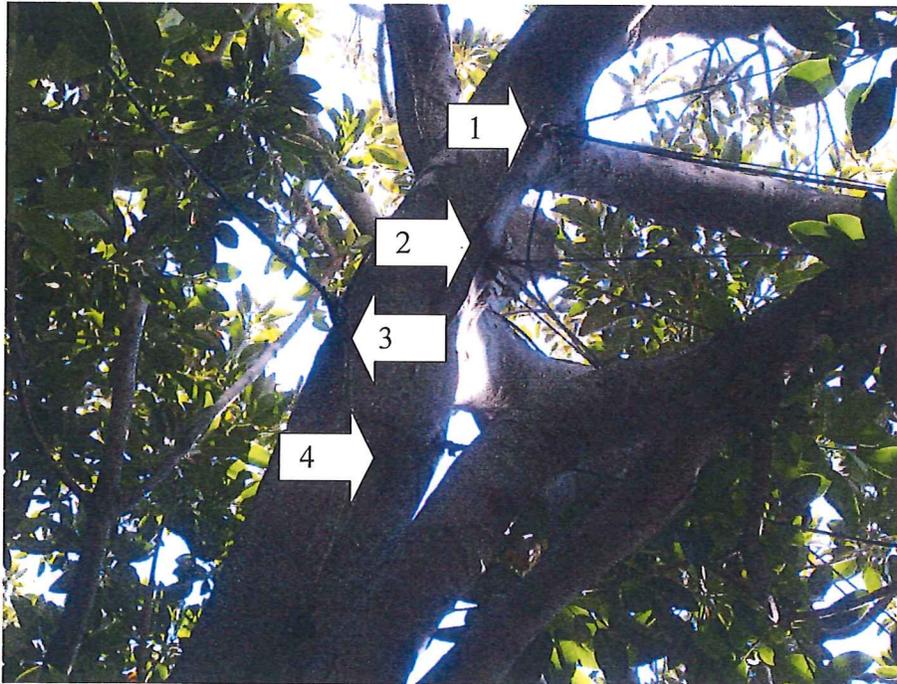
Photo #3

The area of decline is isolated to one main large “parent leader.” There are five points where cabling hardware has been installed for the purpose of support as shown in photo #3 and #4.

The limb shown in photo #3 has too many wounds in a confined area, restricting the proper function/flow of the vascular system. The compartmentalized tissue creates an abnormal “maze” like effect to the vascular system thus reducing the flow of nutrients. Therefore, the nutrients are not readily able to reach the upper canopy resulting in a poor performing or struggling upper canopy.

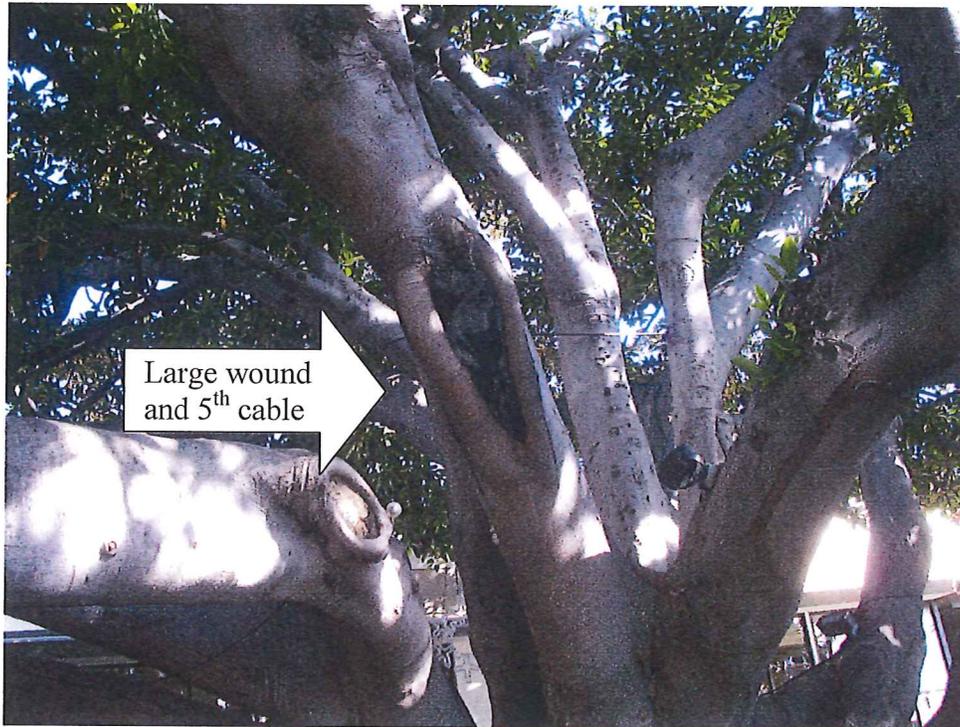
Photo #4

Another likely contributing factor to the poor performance of the limb is the large wound shown in photo #4 along the trunk caused from a previous broken lateral limb.

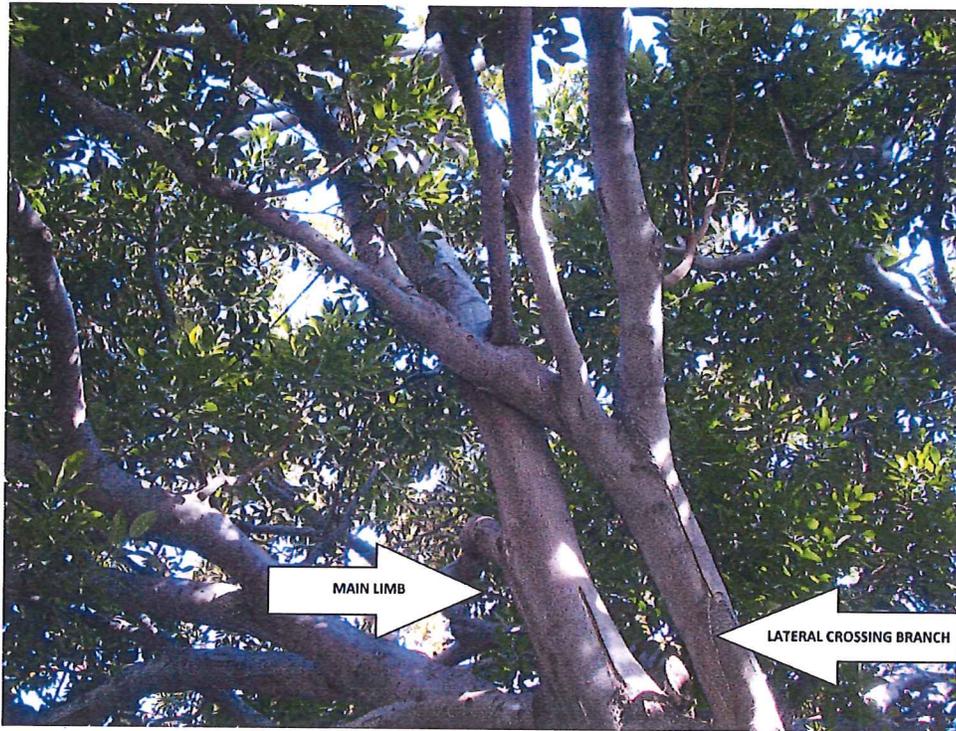
The last item of concern is a crossing lateral branch indicated on Photo #5 that is rubbing and exerting pressure against the main struggling parent limb.
