PIER INFRASTRUCTURE ASSESSMENT STUDY

Phase 1 - EXISTING CONDITIONS
VOLUME 1

Santa Monica Pier Infrastructure Assessment Study

Phase 1 – Existing Conditions Volume 1

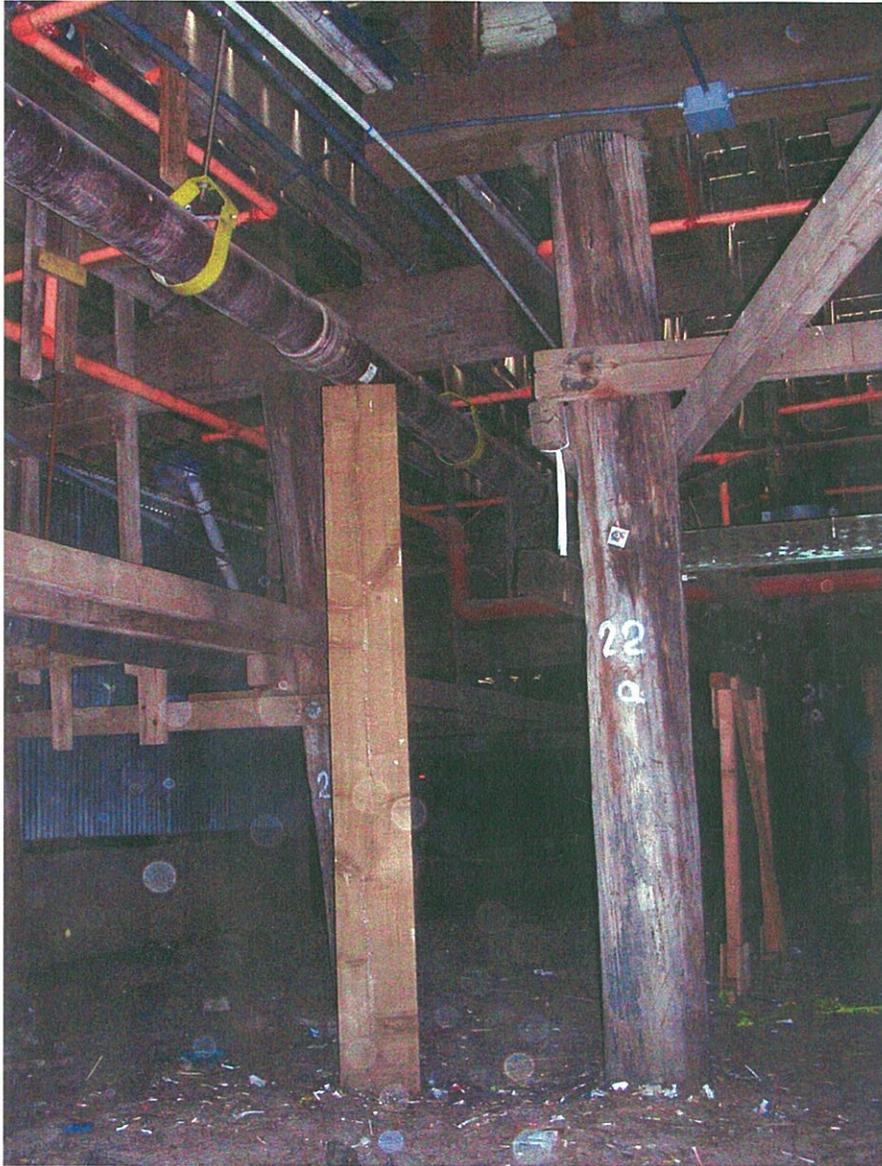
PHOTO 1

Potable water is supplied to various service points on the pier by a mainly fiber-glass reinforced pipe (FRP) loop with 8" diameter lines paralleling the north and south edges of the pier, connected by an 8" diameter line at the western edge of the Newcomb Pier along Bent 52. Various branches off of this loop supply the automatic fire sprinkler system (covered in another section of this report) protecting the pier as well as the service points at the restaurants, police and lifeguard buildings, and entertainment venues on the pier. The FRP loop is in good condition. The hangers are also in good condition for the most part, with adequate spacing. In several locations, however, lengths of lumber are being used to improperly support the line (see Photos 1, 2, and 3).

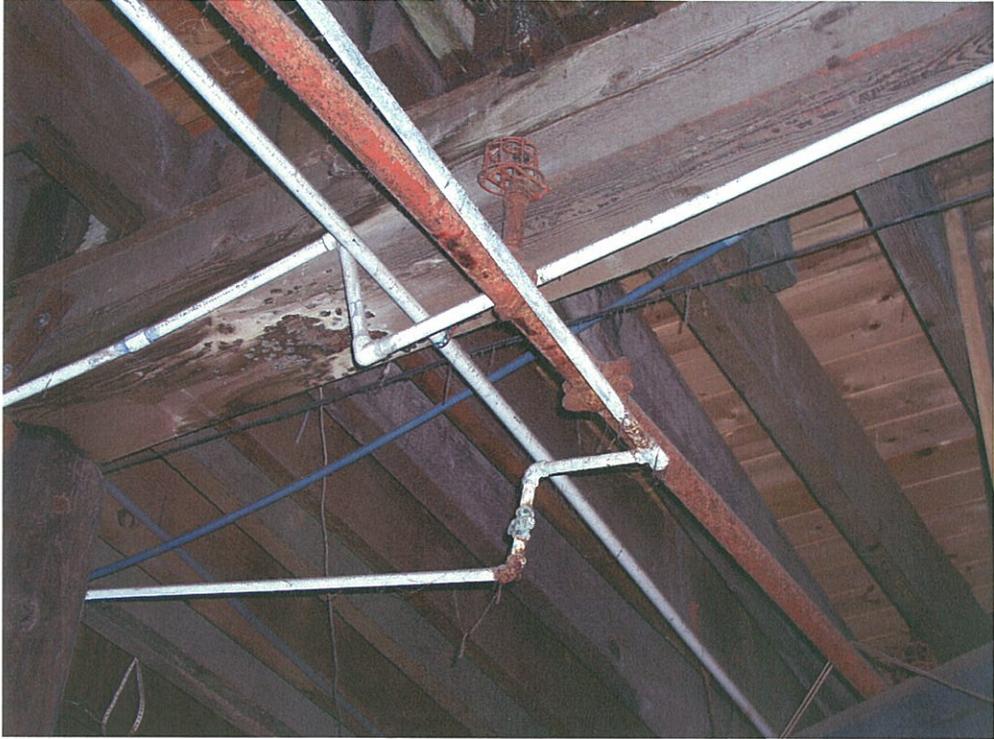
PHOTO 6

Generally, the various branches off of the potable water loop are in fair to good condition, although on small PVC branches it appears that the ease of installation and the

flexibility of the material resulted in improper and haphazard installation (see Photo 6), particularly along Bent 8 between pile rows "a" and "c", and out along the catwalks at the southwest corner of the Newcomb Pier. The small-to-medium diameter water piping in many areas is supported by galvanized or plastic "plumber's tape", or just wire, which is minimally adequate in most of the instances of its use, and is inadequate/poorly installed in others (see Photos 4 and 5). At sometime in the not-too-distant past, much of the old cast iron drainage system under the pier was replaced with new Acrylonitrile Butadiene Styrene (ABS) lines and stainless steel hangers. At the same time, water lines serving the plumbing fixtures that discharge into the new ABS drains were replaced with new copper lines. Consequently, there is a roughly equal amount of poorly used plumber's tape and properly installed hangers. One location was noted where duct tape was being used to support a water line from a natural gas line (see Photo 7).

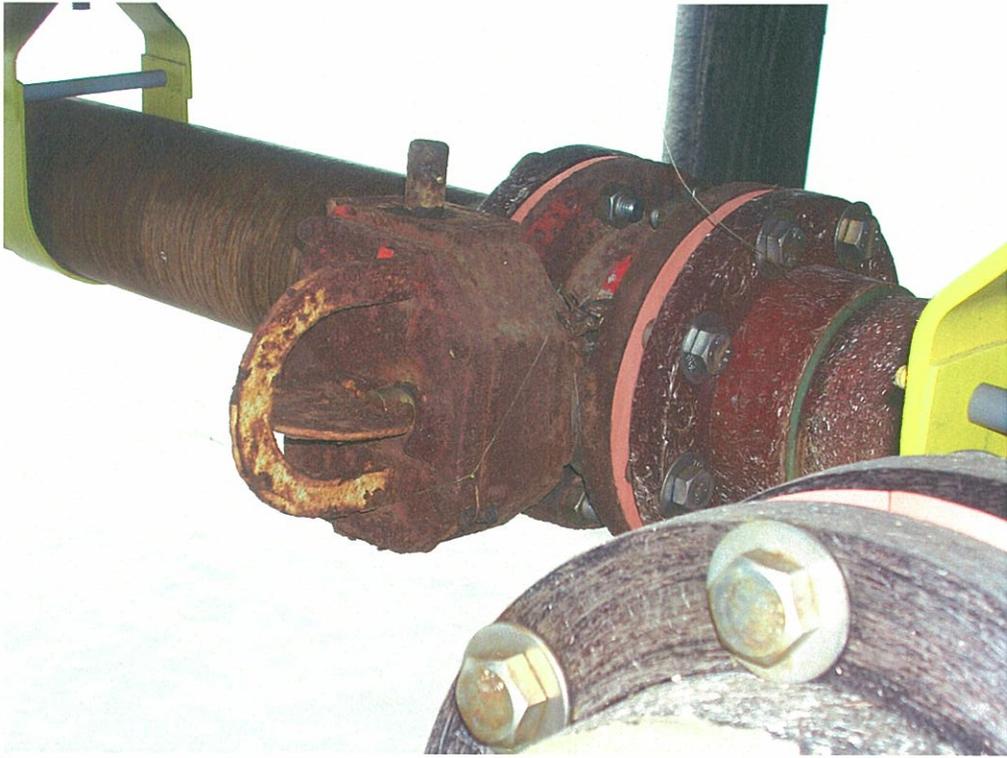
PHOTO 10

One large area where the water piping is in poor condition is under the main deck at the western (seaward) end of the pier. The exteriors of the copper branch lines there are heavily scaled and pitted. In addition, carbon steel hangers and supports were used almost exclusively on the potable water, natural gas, and fire lines in this area (see Photos 8 and 9). The moist marine conditions have caused heavy corrosion on the supports and hangers, with numerous hanger and support failures to be found. This will be discussed in other sections of this report as well. The failure of these supports place additional load on adjacent supports. The 8" diameter FRP main that supplies the end of the pier is in good condition, as are its hangers, but the actuators on the isolation valves out over the water are in general very corroded and their operability is questionable (see Photo 10).

Many of the copper water branch lines at the end of the pier are in poor to fair condition. Up to 30% of the branch piping may need replacing.

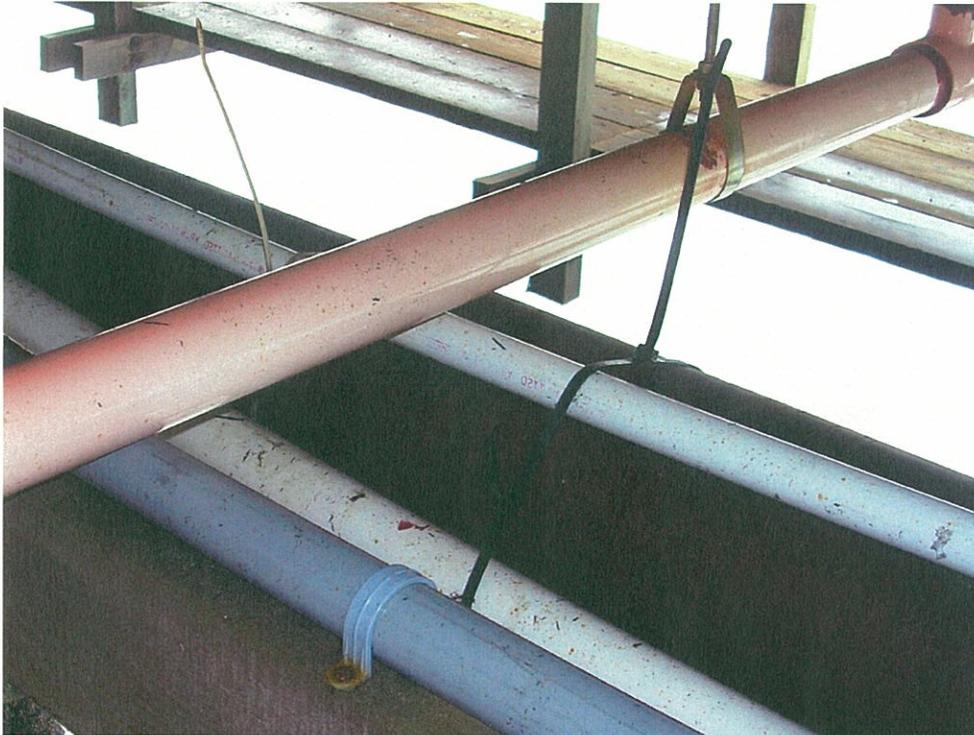
PHOTO 18

There are several "unique" styles of hanging and supporting piping that are currently in use on the sewer system. Some of them are adequate and meet code, and some are not. One example of non-compliance is a section of the main 6" sewer serving the eastern portion of the pier that is supported by a mismatched series of stacked wooden blocks (see Photo 16). In other areas, pieces of lumber are notched and mounted at angles to support a 4" branch. Plastic plumber's tape, as well as the more common galvanized plumber's tape, is also in use (see the left side of Photo 35, where plastic plumber's tape is supporting a sagging drain line). In at least one place a branch is supported by the end of a bolt protruding from the pier structure (see Photo 17). In another area, plastic zip ties are being used to "bundle" pipes together (see Photo 18).

Style and spacing of supports for the various piping systems should be standardized. Poorly installed or corroded plumber's tape hangers should be reconfigured to provide better support, or replaced altogether with new rod-type hangers. Hangers being used to support piping from other piping (see Photos 7 and 31) should be reconfigured so piping is supported by structural or foundational elements. All temporary supports such as duct tape, wire, plastic zip ties, stacked wooden blocks and pieces of lumber should be replaced with conventional hangers, supports, and brackets. All carbon steel hangers and supports seaward from the high tide line should be replaced by stainless steel or an approved corrosion-resistant material. This is *especially* critical on the natural gas lines and fire service lines over the water at the end of the pier. Most of these supporting elements are in imminent danger of failing. Some have already failed.

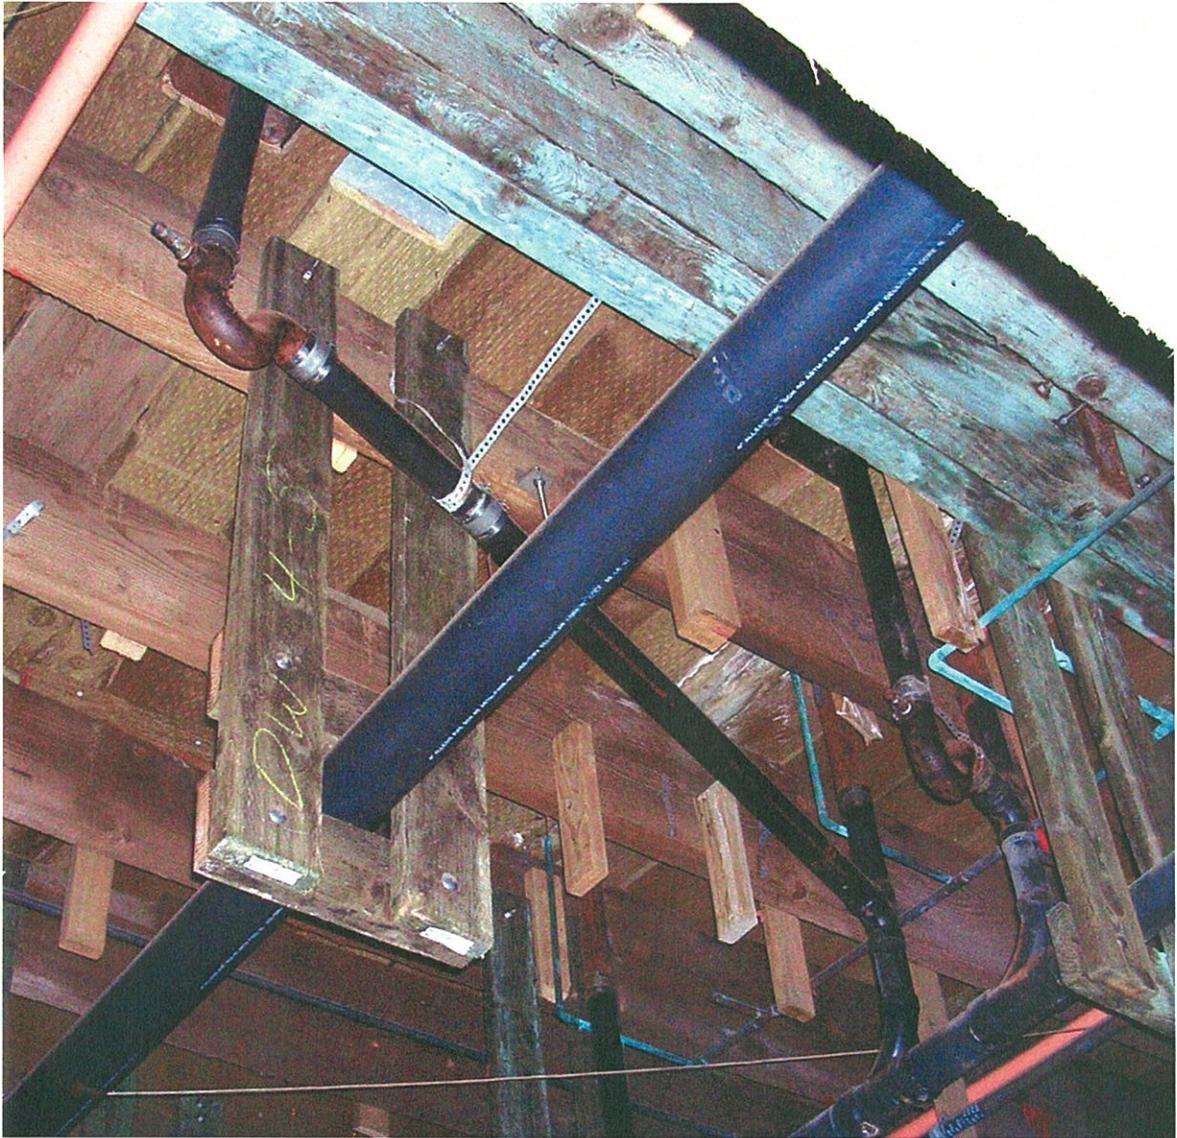
PHOTO 19

Lastly, there are several instances where a trap arm to a floor drain or floor sink has been installed at a length longer than allowed by code, which for a 2" trap is 5'-0" (see Photo 19).

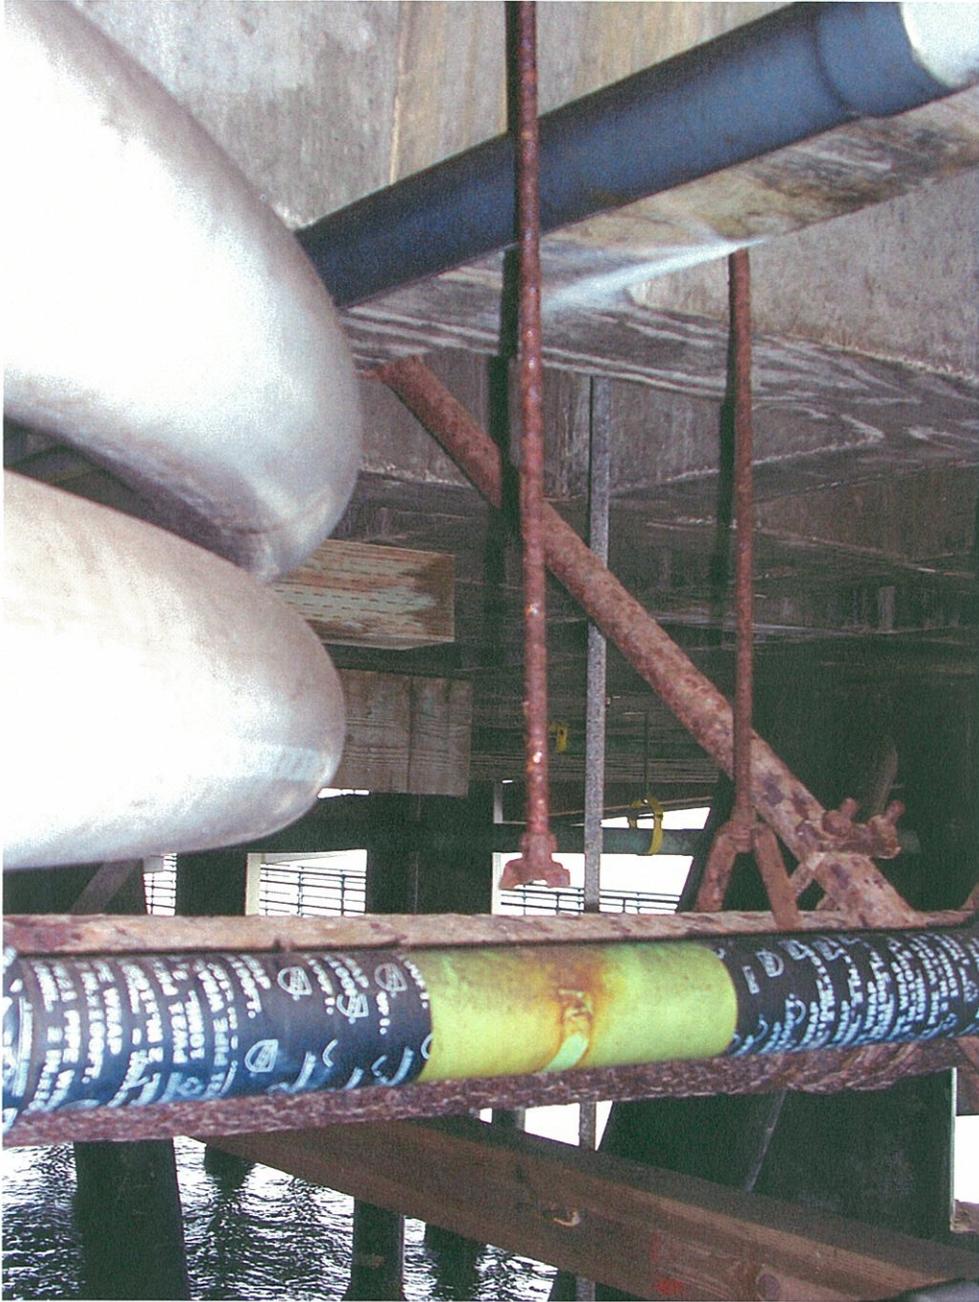
PHOTO 20

The onshore natural gas system--a mix of wrapped steel pipe and composite pipe--for the pier appears to be in overall good condition. There are areas where supports are more widely spaced than code requires, and areas where the wrapping prevented inspection of the surface of the pipe. One area of extreme concern was noted. At the offshore western end of the pier, under the main platform where the Mariasol Restaurant and the Lifeguard Building are located, the carbon steel hangers supporting the gas lines are badly corroded and many have already failed (see Photos 20-22).

Almost all the natural gas lines are in good condition, as are most of their hangers and supports. Some supports need to be added where spacing is inadequate, and as has been stated, all the carbon steel hardware on the end of the pier must be replaced.

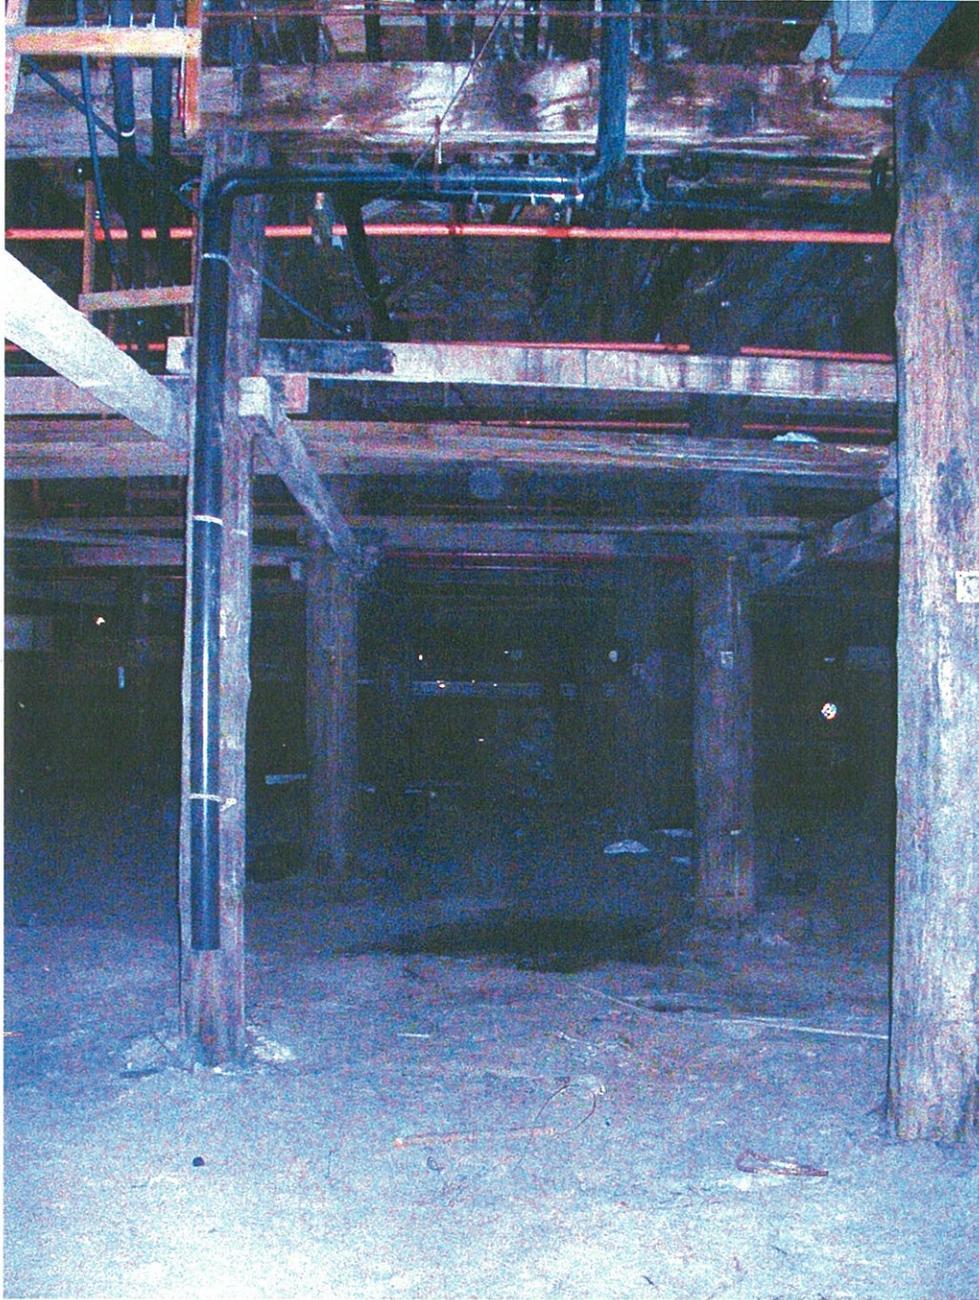
PHOTO 23

In a number of areas under the pier, downspouts from gutters and roof drains above the deck are discharging directly at the base of piles (see Photo 23), or discharging just under the deck, eroding the ground. Also, there are a number of 3" diameter ABS drains suspended below the deck that serve a gutter drain adjacent to the Aquarium. Those drains run west past the fenced Aquarium utility area and terminate with long flexible hoses (see Photo 24) that at one time appear to have been directed to a swale in the ground under the pier that collected the discharge from the 3" drains and routed it to

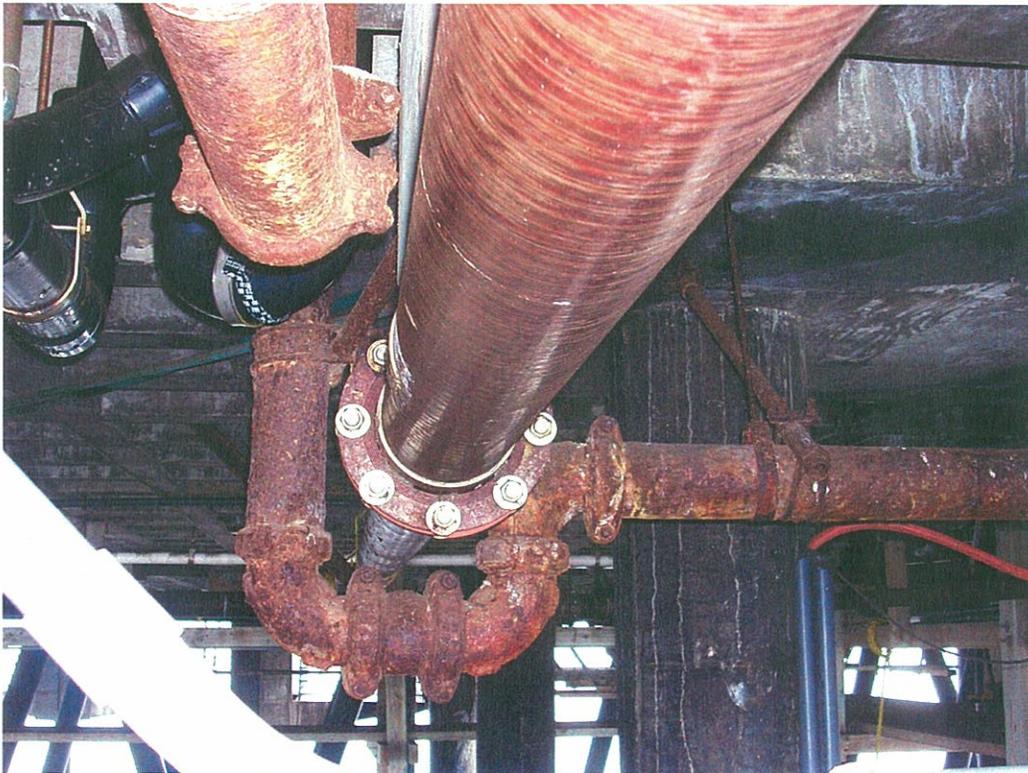
PHOTO 25

Almost all carbon steel (galvanized or not) hangers and supports and piping served by the catwalk system are heavily corroded and in danger of failing. Extreme corrosion was noted on hangers and seismic bracing, as well as piping and valves (see Photos 25 and 26).

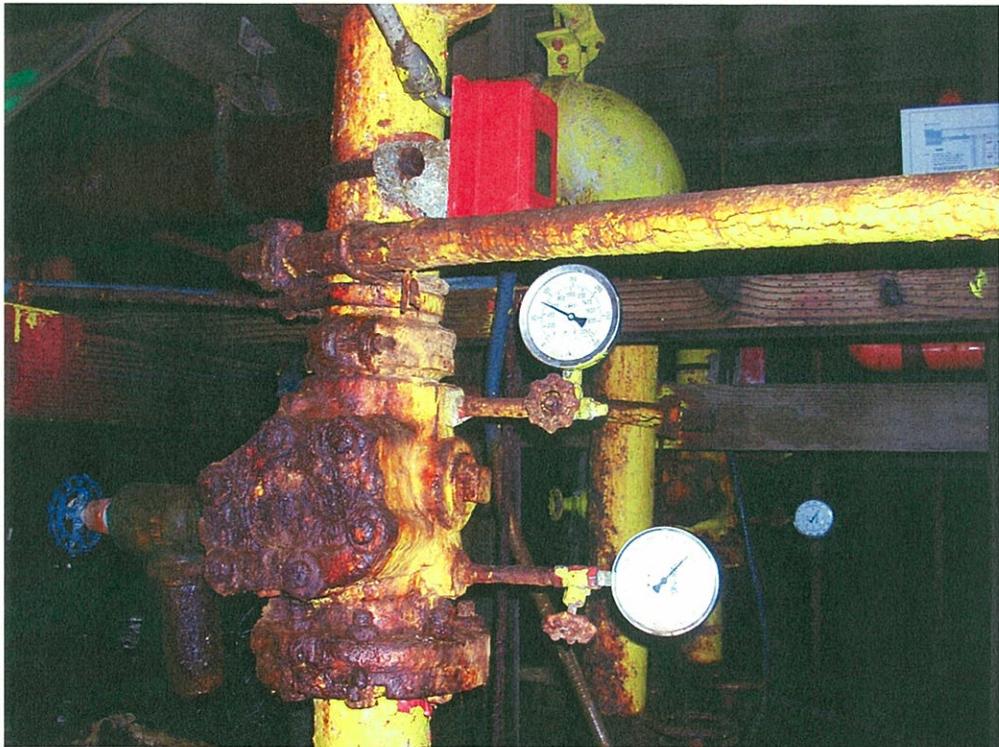
PHOTO 27

Fire sprinkler control valves for sprinkler zones 407 and 408 appear to be heavily corroded (see Photo 27). Corrosion was also noted on steel piping and supports serving fire hydrants above the deck (see Photos 28 and 33).

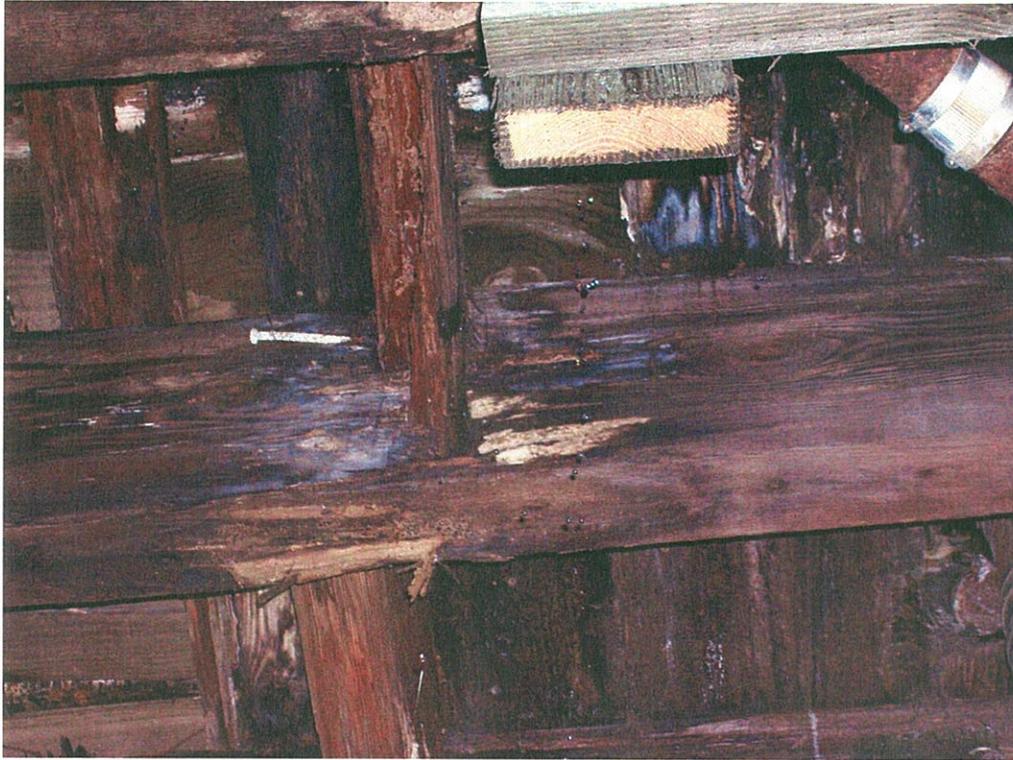
PHOTO 29

There are several scattered areas of active leaks through the deck, causing staining of the structure and possibly compromising the integrity of piping supports, deck planking, and substructure in those areas. Some of them appear to be from hose wash down activity by the various vendors, but in one instance it appears to come from leaking pipes in a restroom above. In this particular location, structural damage is occurring (see Photos 29 and 30).

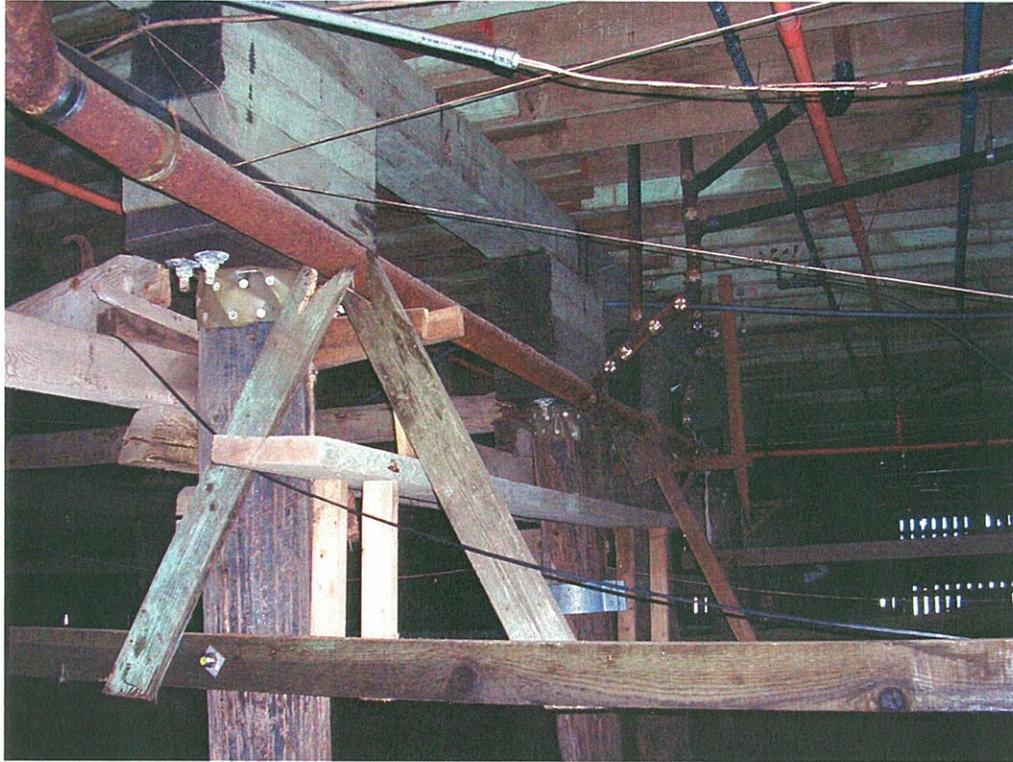
PHOTO 32

Some of the older cast iron sewer lines that were not replaced with PVC are near the end of their usefulness, and should be replaced (see Photo 32).

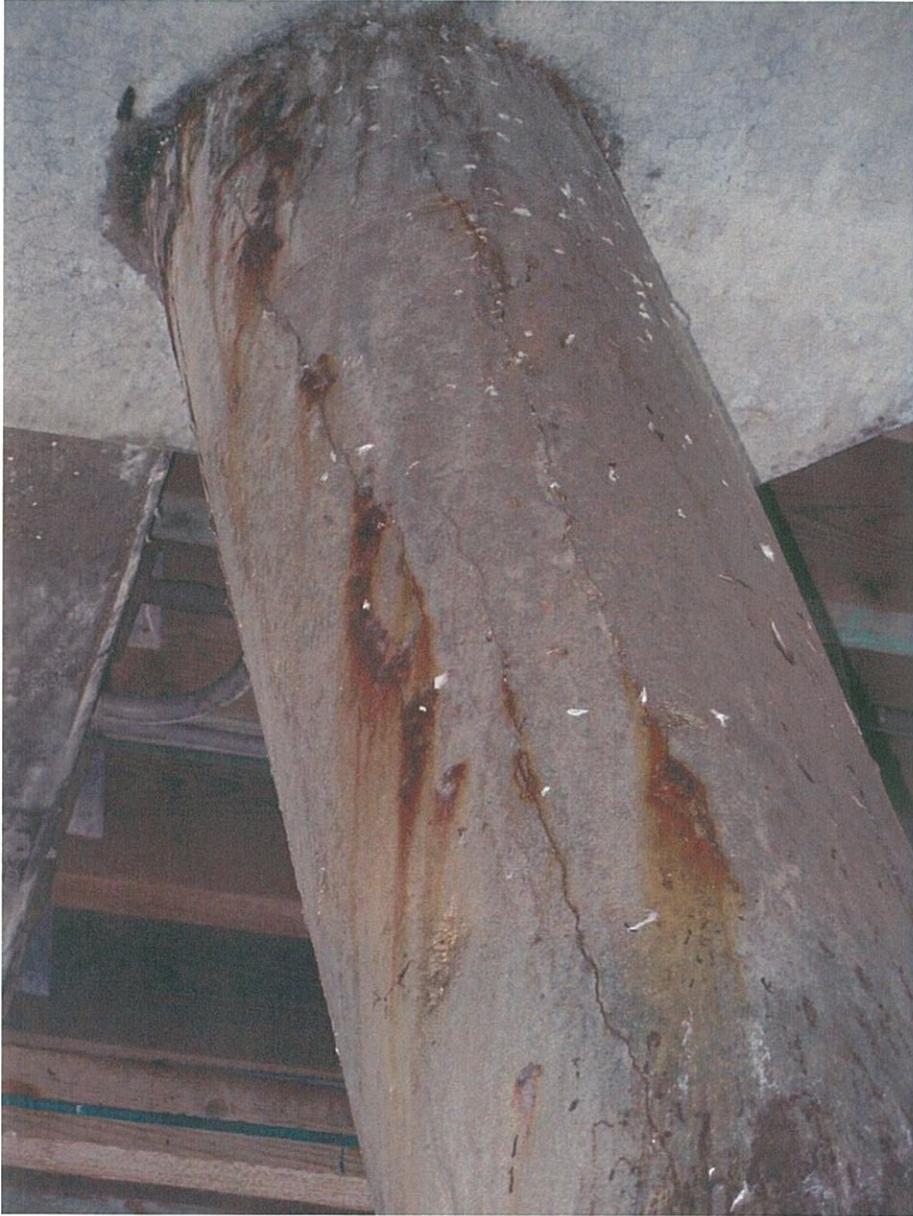
None of the offshore piles showed damages requiring immediate attention. However, there is evidence of significant corrosion in some of the concrete piles under the Newcomb Pier especially piles at Bent 46 Pile Row y (two batter piles). While immediate attention is not required, repairs should be scheduled within the next couple of years.

Northwest Face of West Pile at Bent 46 Pile Row y

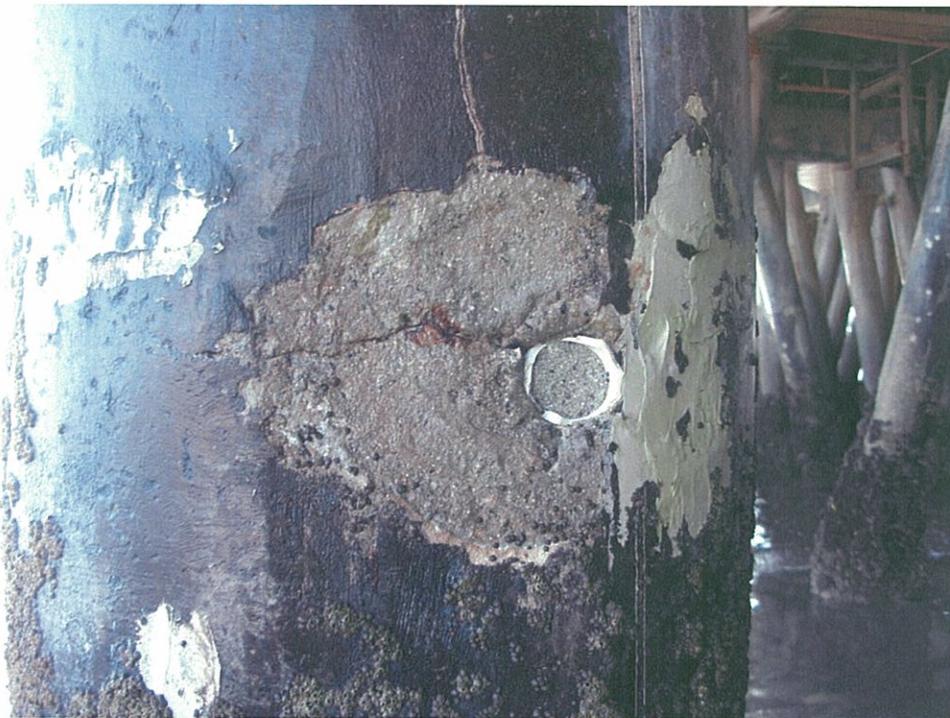
Pile 46aa Crack at Jet Inlet

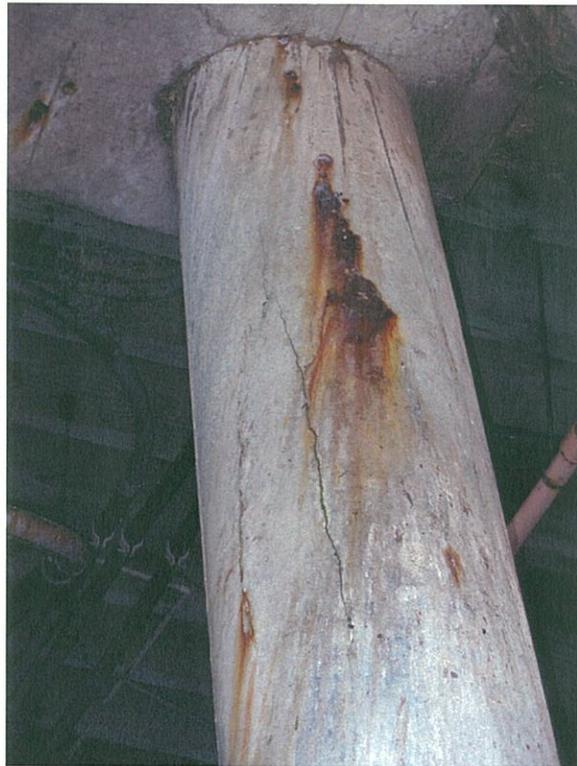
West Pile at Bent 46 Pile Row y
