PIER INFRASTRUCTURE ASSESSMENT STUDY
Phase 2 - UPGRADE STUDIES
NOVEMBER 17, 2008

Santa Monica Pier Infrastructure Assessment Study

Phase 2 – Upgrade Studies

November 17, 2008
JN 5332-02

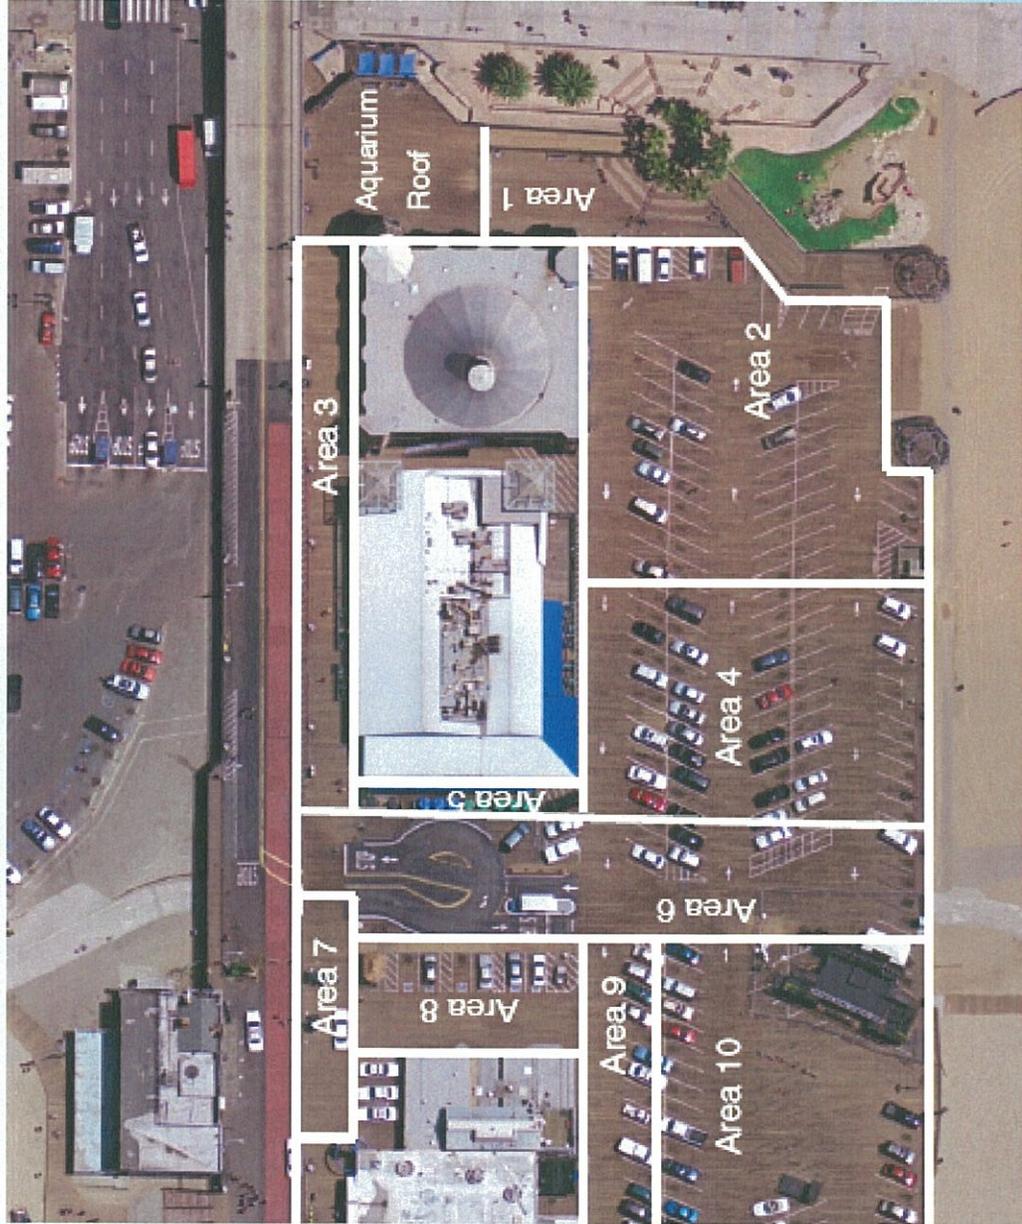
Figure 1

In this zone the stringers are 3"x10" at 18" on center (o.c.). The calculated capacity for this area is 51.5 psf and a maximum vehicle weight of 4,200 pounds. This is less capacity than the adjacent aquarium roof, and less than the code capacity for pedestrian assembly areas of 100 psf. It is recommended that this area be upgraded by adding additional 3"x10" at 18" o.c. These could be centered between the existing stringers or placed next to them. Either configuration would double the capacity. The estimated cost for this upgrade is approximately \$ 133,000.

In this zone the stringers are 3"x12" at 22" o.c. with 2" nominal decking. The calculated capacity for this area is 64.5 psf and a maximum vehicle weight of 5,500 pounds. To meet the recommended H-15 truck capacity, the stringers in this area must be removed and replaced with 16" deep stringers. In most cases the pile caps have an additional 4" thick member on the top which could be removed to maintain the same top of stringer elevation. In cases where this 4" member does not exist, then the pile caps would need to be lowered. To accommodate the transverse aisle at the East end of the parking lot, the stringers between Bent 4 and 6 are recommended to be 6"x16" at 16" o.c. with at least 3" nominal decking. For the longitudinal aisles and parking spaces from Bent 6 to Bent 12 the stringers are

Area 1: 51.5 psf
2 Ton Vehicle

Area 2: 64.5 psf
2.75 Ton Vehicle

Aquarium Roof:
86 psf

recommended to be 4"x16" at 16" o.c. with at least 3" nominal decking. The estimated cost for this upgrade is approximately \$1,506,000.

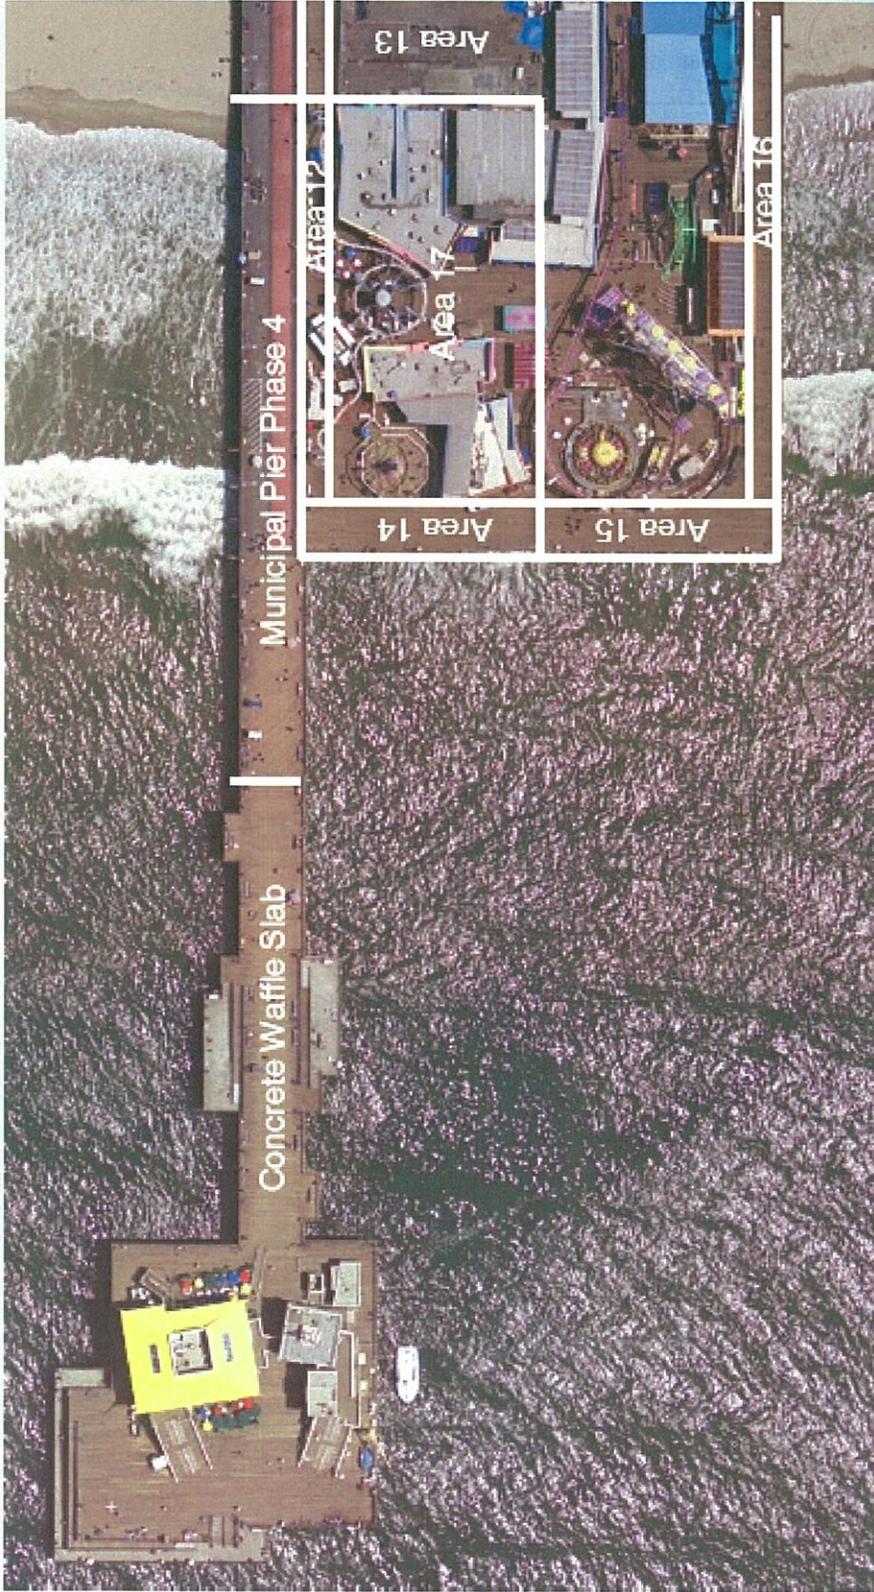
Figure 3

The existing capacity of this area based on the transverse truck loading is 220 psf or a 9 Ton truck. In order to support the recommended 15 Ton truck load in the transverse direction the existing stringers should be supplemented with 6"x16" stringers between each existing. The estimated cost for this upgrade is approximately \$ 210,000.

The existing capacity of this area based on the longitudinal truck loading is 220 psf or a 12.4 Ton truck. In order to support the recommended truck loading in the longitudinal direction the existing stringers should be supplemented with 3"x16" or 4"x16" stringers between each existing. The estimated cost for this upgrade is approximately \$ 385,000.

Area 14: 214 psf 7.7 Ton Truck	Area 15: 220 psf 9 Ton Truck	Area 16: 220 psf 12.4 Ton Truck	Municipal Phase 4: 175 psf 7.3 Ton Truck
-----------------------------------	---------------------------------	------------------------------------	---

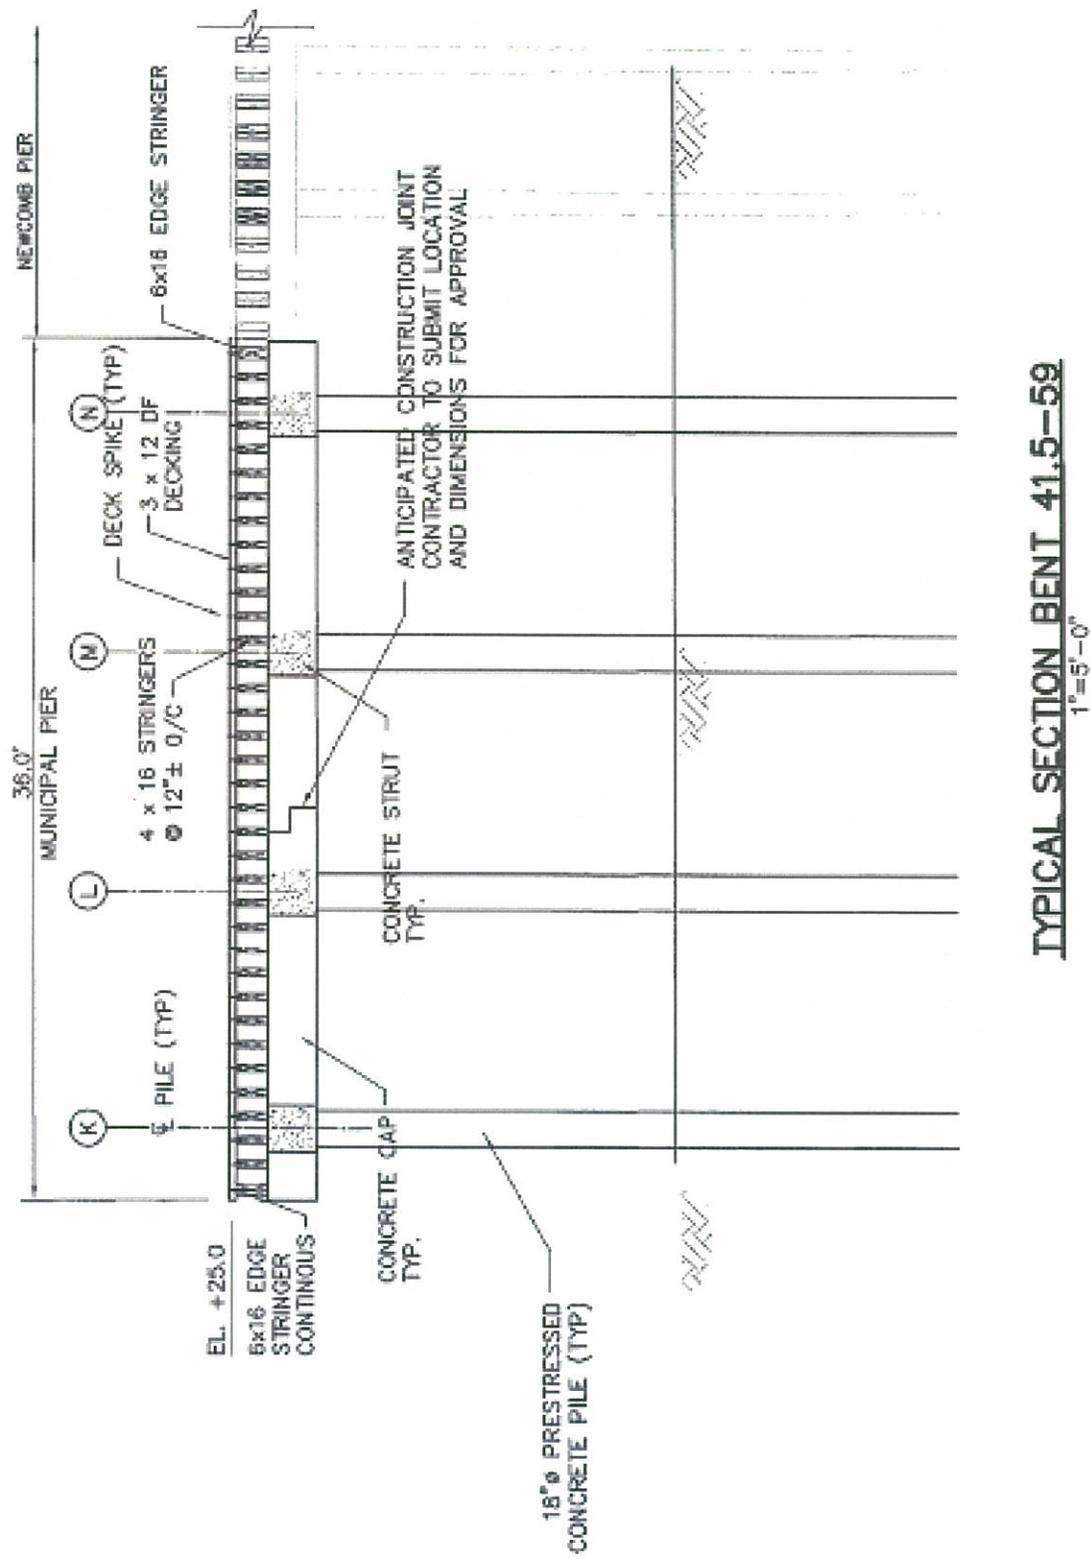
Figure 4

The new structure will have prestressed concrete piles, cast-in-place concrete pile caps and longitudinal struts and no cross-bracing. The stringers and decking will be the same as used on the Phase 3 upgrade of 2006; 4"x16" stringers at 12" o.c. with 3"x12" decking. A typical cross-section is shown in Figure 4.

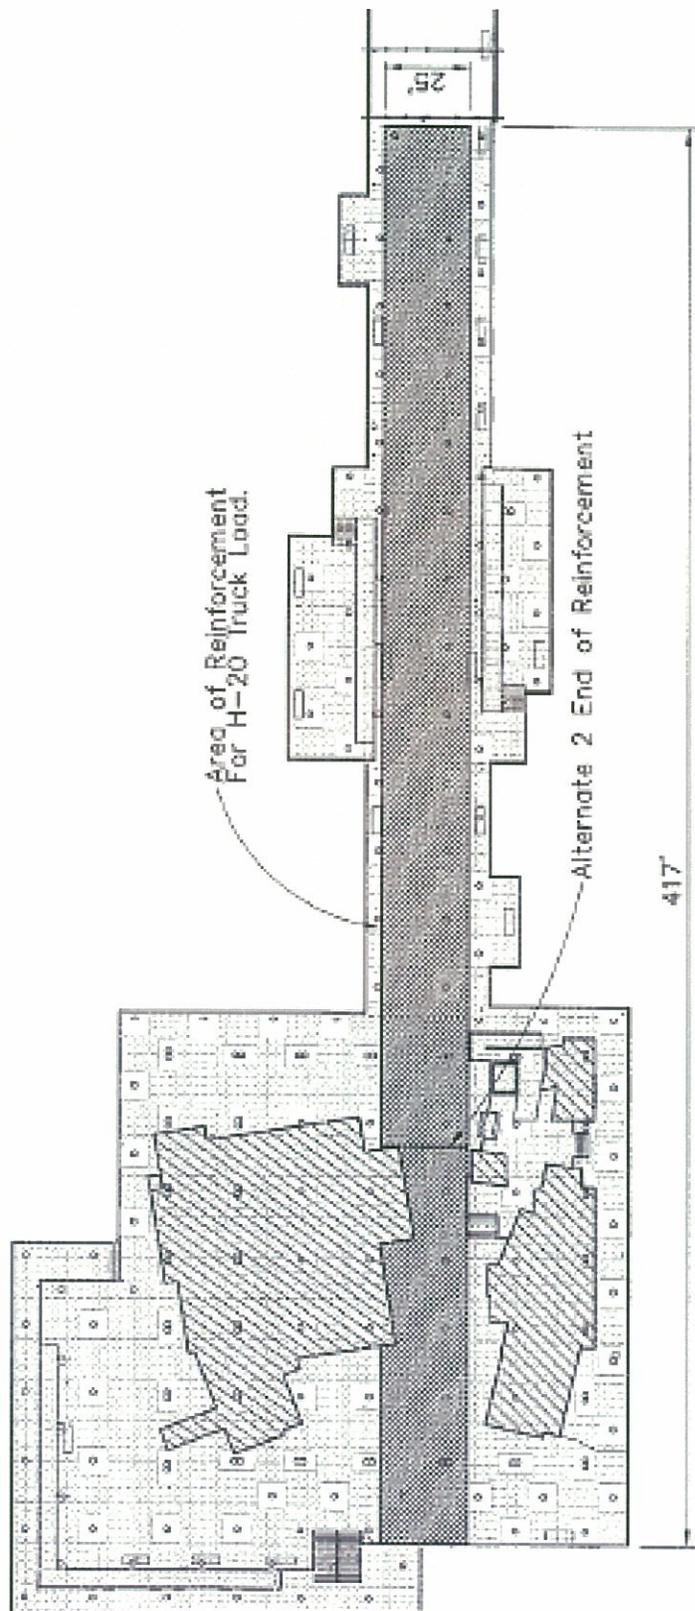
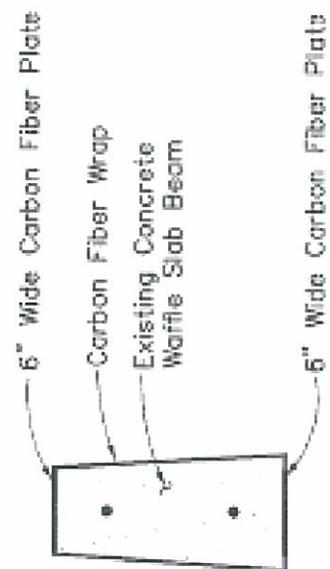
Figure 5

The existing decking is also inadequate to handle the wheel loads of an H-20 vehicle. Moffatt & Nichol recommend using an imported hardwood such as EKKI or Greenheart, which will handle the greater load using the same thickness of wood as the existing decking.

CONCEPT DRAWING
WAFFLE SLAB REINFORCEMENT
FOR H-20 TRUCK LOADS

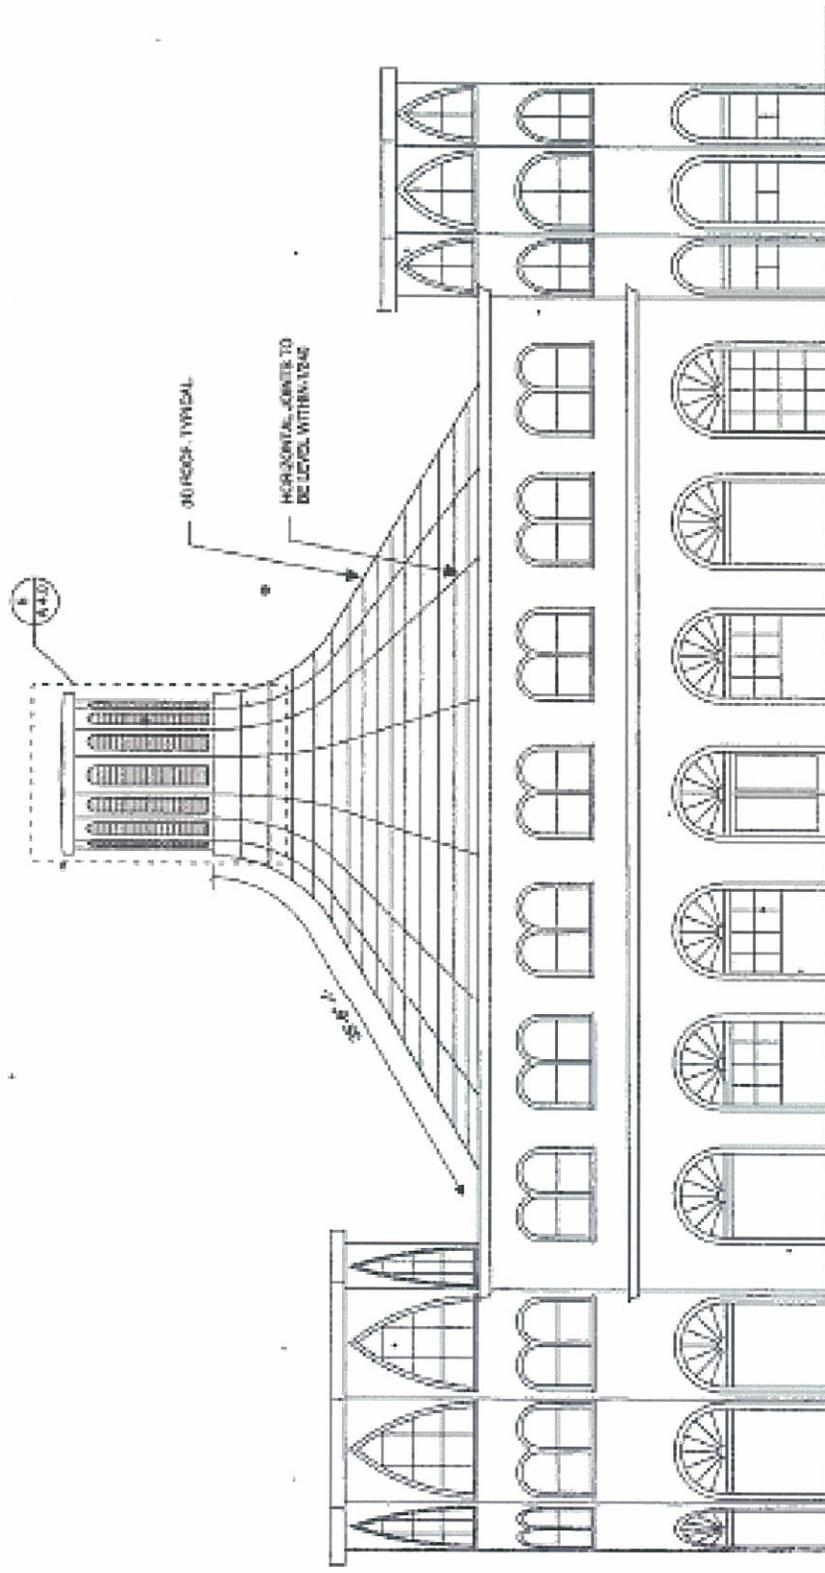
Figure 11

Approximately 10 years ago the roof of the historic carousel building was repaired and the cupola partially restored. Although plans were prepared for the “Onion” dome top of the cupola, it was not constructed at that time.

Construction of the missing “Onion” dome is included as part of the total pier upgrade program. Drawings of the carousel building elevation both with and without the “Onion” dome are shown on the Figures 11 and 12 respectively.

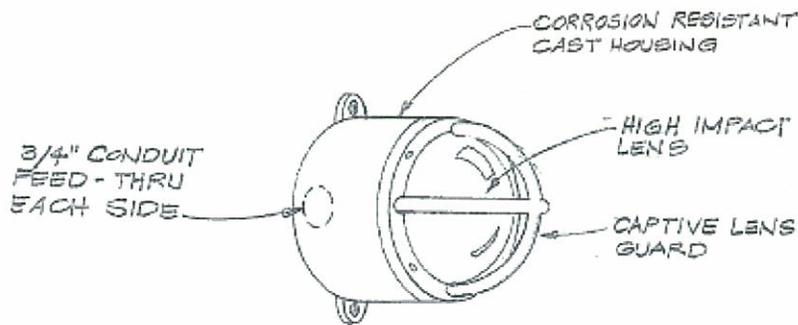
**SANTA MONICA PIER
NECKLACE LIGHT FIXTURE**

The existing Pier necklace lighting system is not operational and should be removed or replaced. It was recommended that the system be replaced with a custom vandal resistant LED fixture. See Figure 13. The estimated construction cost for this system is \$442,000. In meeting with the City it was determined that a proposed hard-wired marine grade LED system exceeds the budget for the Necklace Light system. It was suggested that an alternative might be a deck mounted solar powered LED fixture system. After further review of available fixtures and systems it appears that solar powered fixtures may not be an acceptable alternative for both operational reliability and maintenance reasons.

Approximately 750 fixtures at 5'- 0" O.C. to outline Pier Structure.
