December 6, 2011  
Project No.: 110876.1

Subject: Chain Reaction Sculpture Investigation and Material Testing  
Santa Monica, CA

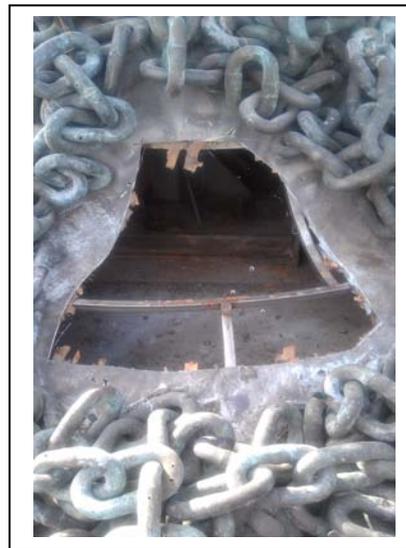
To minimize damage to the sculpture fiberglass shell, small cut-outs or drilled holes through the shell were made on November 16, 2011 at random locations along the base to determine and/or verify the inner structure composition per the provided sketch on the structural calculations (included in Appendix A) by inserting a boroscope through the holes and cut-outs to view the existing contents and conditions of the sculpture's inner structure. Results indicated the fiberglass shell is supported (or stiffened) by an inner skeleton frame fabricated from 1-inch square stainless steel tubing formed and welded in sections to the shape and curvatures of the shell as shown in Figure 1 below.

Based on the man-sized access hole opening cut at the base shown in Figure 1 above, there exists at the center of the sculpture a main vertical steel tubular member, approximately 13 inches in diameter (wall thickness of  $\frac{7}{16}$  inch as tested by our EPOCH 600 ultrasonic flaw detector manufactured by Olympus) running all the way to the top. The bottom of the round tubular member is welded to a 42-inch square base plate of approximately  $1\frac{1}{2}$  inches thick and anchored to the concrete foundation with 1-inch diameter anchor bolts (8 bolts total). The round tube member is reinforced all around with  $\frac{1}{4}$ -inch thick triangular welded gusset plates (total of 8 gussets). Corrosion was apparent on the gusset plates and more severe on the anchor bolts and nuts as shown in Figures 2A and 2B below.

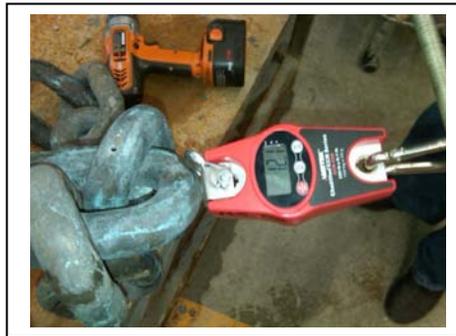
Figure 3 – Test Set Up

Three undamaged self-tapping screws were obtained from the base of the sculpture that may have resulted from extra screws during construction of the sculpture or loose over time and fell to the bottom. For the purpose of our laboratory testing, the three screws were driven into the hollow copper chain links (obtained from the site) at a minimum of 3/4-inch penetration to simulate attachment of the chain links to the sculpture fiberglass shell (Note: By inspection, the screws were driven from the inside of the sculpture through the fiberglass shell and into the copper chain). Tensile tests were conducted using a hand-held calibrated dynamometer as shown in Figure 3 below to determine the screw pull out strength from the copper chain. Results of the testing are summarized in Table 2 below:

Test No.	Maximum Load (lbf)	Failure Mode
1	121	Screw pullout from chain
2	132	Screw pullout from chain
3	109	Screw pullout from chain
<i>Average</i>	<i>120</i>

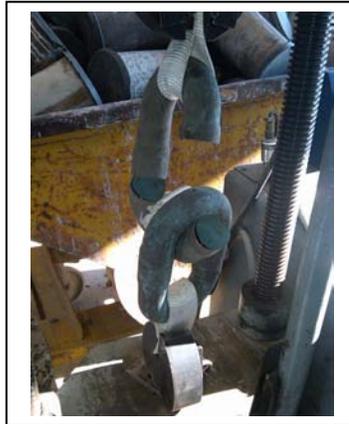
Figure 4A – Test Set Up

Two linked copper chain section obtained from the jobsite was placed in the tensile testing machine and loaded in tension to determine the ultimate pullout strength from each other (see Figure 4A). The maximum load obtained was 789 pounds; failure was the spot welds at the two halves section shown in Figure 4B below.
