Santa Monica Pier

Architectural Conditions Assessment

submitted by
Wallace Roberts & Todd, LLC

February 8, 2008

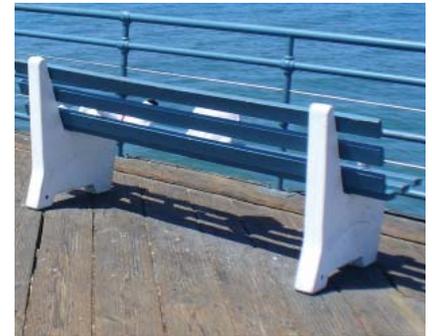
Bench Type 1

Maintenance: Concrete supports require painting to maintain a clean finish, wood slats require regular painting and sanding or replacement if damaged.

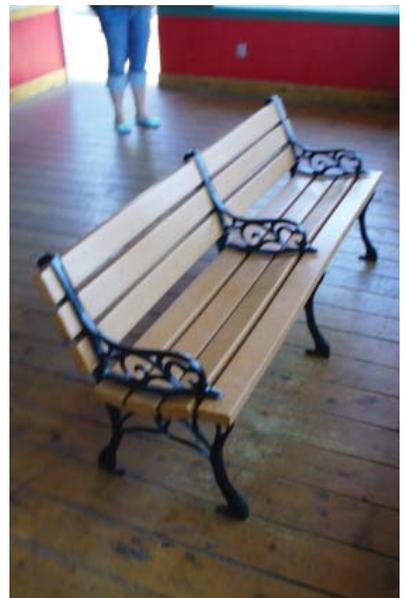
Bench Type 3

Maintenance: The benches are inside the Observation Deck and are in excellent shape. Composite boards are easily replaced if they were to become damaged.

Functionality/Placement: This bench design captures the “Victorian” character of the carousel, but does not blend well with the more rustic pier aesthetics at the western end. No other benches or site furnishings found on the Pier match this style. The bench appears lighter and less solid than the exterior benches.

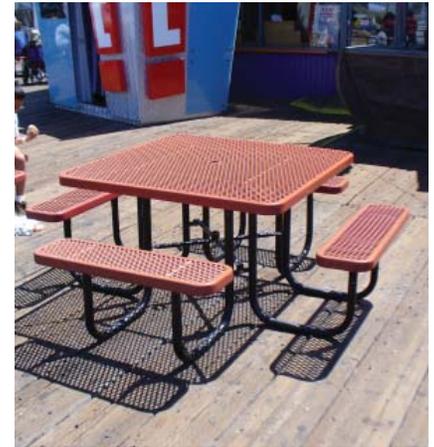
Table Type 1

Durability: The tables all seemed to be withstanding the ocean/salty conditions. There was no observed rust and the tables appeared to be fairly new.

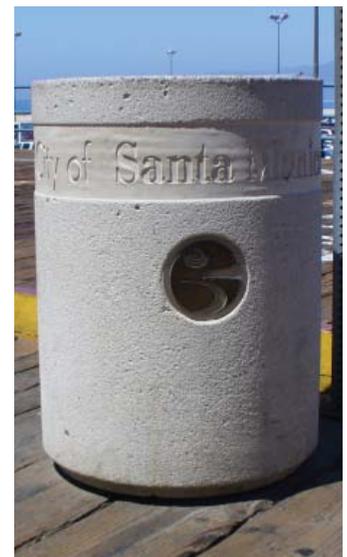
Trash Receptacle 2: Santa Monica logo

Maintenance: Requires little maintenance, weight makes it difficult to move or take, which is why Maintenance expressed their preference for this receptacle.* There is no rust and weathering, but on-going cleaning is necessary.

Durability: The receptacle appears to be very durable concrete construction, with few signs of wear or need of for replacement.

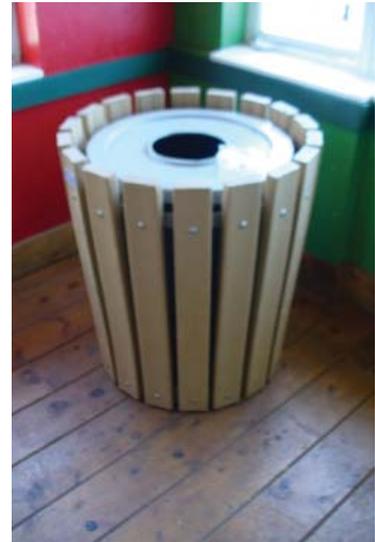
Trash Receptacle 5: Recycled Content Receptacle

Maintenance: The receptacle is inside the enclosed observation deck and is in excellent shape. Composite boards can easily be replaced if they were to become damaged.

Functionality/Placement: This receptacle design captures the “Victorian” character of the carousel, but does not blend well with the more rustic pier aesthetics at the western end. The receptacle appears lighter and less solid than the exterior receptacles.

Durability: Composite boards may be subject to scratching and carving. The lightweight construction of this receptacle appears to be much less durable than other site furnishings located outside.

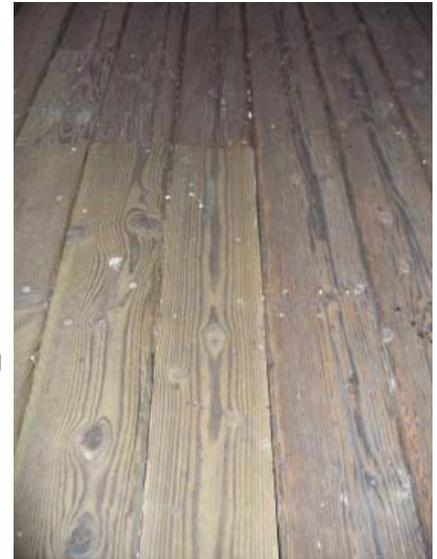
Decking Type 1: Pedestrian

Comfort: The wood decking is comfortable to walk on provided it has been adequately maintained.

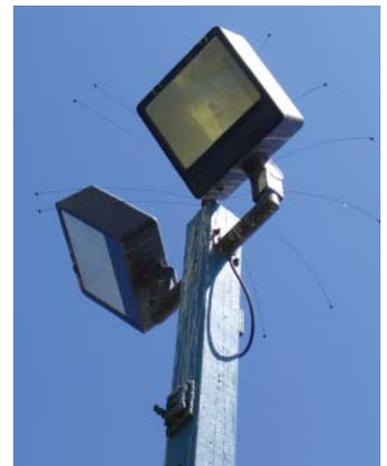
Lighting Type 3: Wooden Fixture

Durability: The wooden pole is very weathered looking. It also has a shorter lifespan than its metal counterparts and more susceptible to vandalism; concrete or fiberglass may be more desirable for durability.

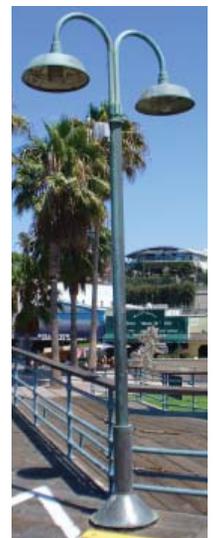
Lighting Type 5:
Bell Fixture

Durability: The metal seems to be very durable for this situation if painted surface is maintained to prevent rust.

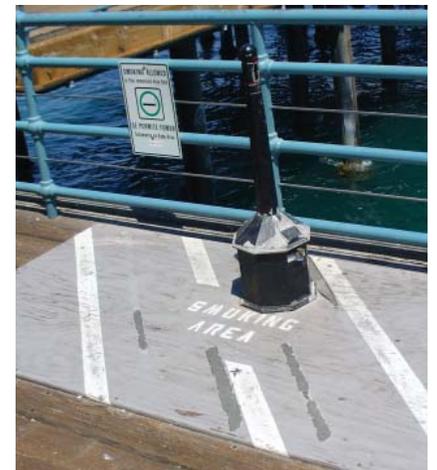
Feature 2: Smoking Areas

Durability: Smoking stations appear to address a designated need but are not integrally designed as part of the pier. They appear to be a temporary solution.

General Observations of Smoking Areas: Recommendations for more compatible smoking receptacles and smoking areas will be identified in the Urban Design Recommendations.

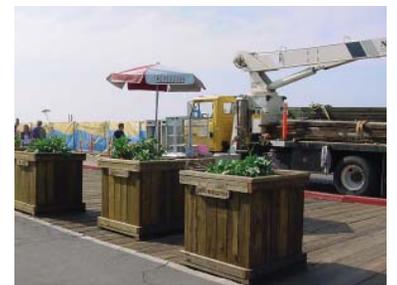
Feature Type 6: Security Barriers

Functionality/Placement: Sited to create a traffic barrier.

General Observations: These security barriers are large, and block pedestrian flow. Bollards that require little maintenance could serve the pier better and are recommended in the pier guidelines. If planters are to be used, we suggest that they follow the design guidelines.

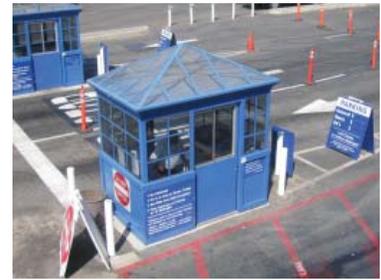
Feature Type 7: Parking Kiosk

Functionality/Placement: The pedestrian path, designated by a chain link fence, is not in character with the pier and appears temporary, but the function is appropriate for protection from vehicular activity. Options such as bollards and differential flooring material can serve the same purpose and create a safe walking space for pedestrians. The Design Guidelines state that the pier is to develop a unique, pedestrian oriented environment with ease of access and user friendliness as a prime design consideration. Improvements to the pedestrian circulation will create a better pedestrian environment.

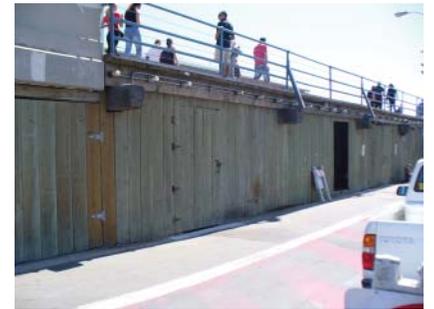
Feature type 10: Pier Skirting

General Observations: The skirting was constructed to prevent unauthorized access under the pier and security, while the existing Design Guidelines suggest whimsical treatment. Our observation is that the skirting/fencing should not compete with the festive activity on the pier and should remain 'background'.

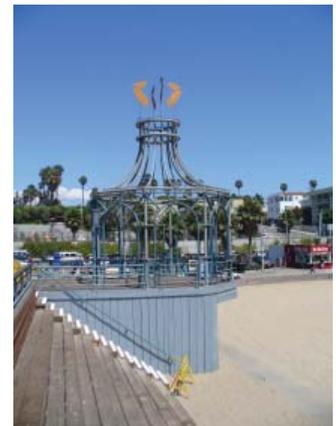
Feature Type 12: Gazebo

Functionality/Placement: Main seating for the volleyball courts is provided by the bleachers to the south of the parking lot. While the gazebos fit in with the character of the pier, they are architectural "follies".

General Observations: The Gazebos were intended to be rest areas for visitors, but lack seating, cover and functionality. In consultation with the City the Urban Design Study, will make recommendations as to how these amenities can be enhanced.
