CAROB ASSESSMENT
City of Santa Monica

PREPARED FOR:
City of Santa Monica
Public Landscape Division
2600 Ocean Park Blvd.
Santa Monica CA 90405

PREPARED BY
HortScience, Inc.
2150 Rheem Drive, Suite A
Pleasanton CA 94588

March 2008

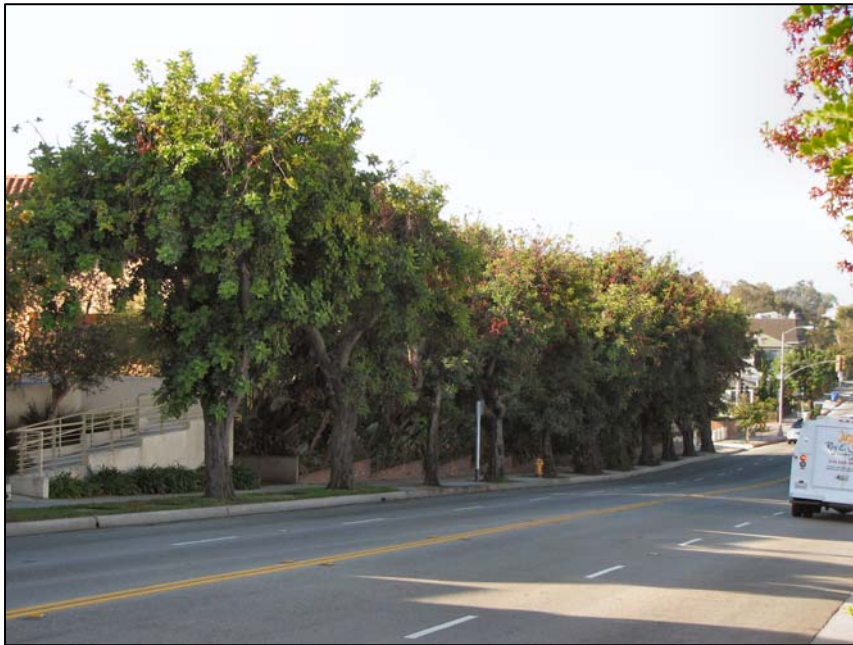
Photo 1. Examples of carobs in Santa Monica. **Below left:** tree #955 was in good condition with a full, dense crown. Note absence of irrigated lawn & sprouts along lower trunk. **Below right:** tree #791 was in poor condition with sparse foliage & twig dieback.
