Pool – Maintenance & Repair

Historic Status: City of Santa Monica Historic Landmark

Current Condition DECK

Summary of Proposed Pool & Deck Tile Repair:

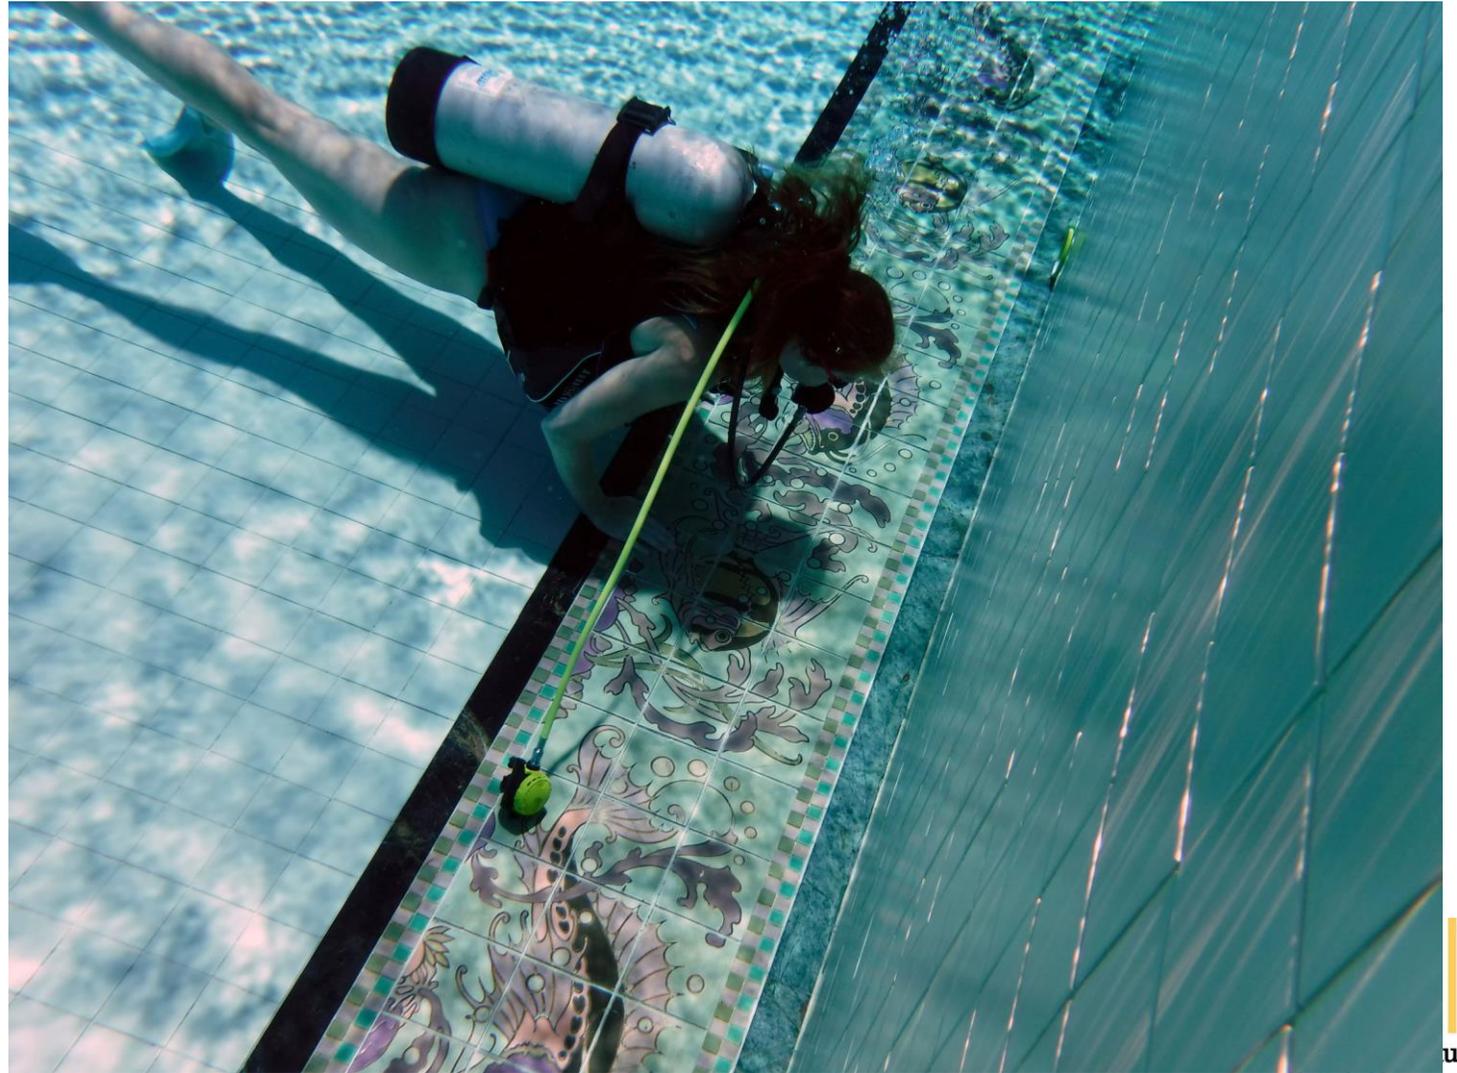
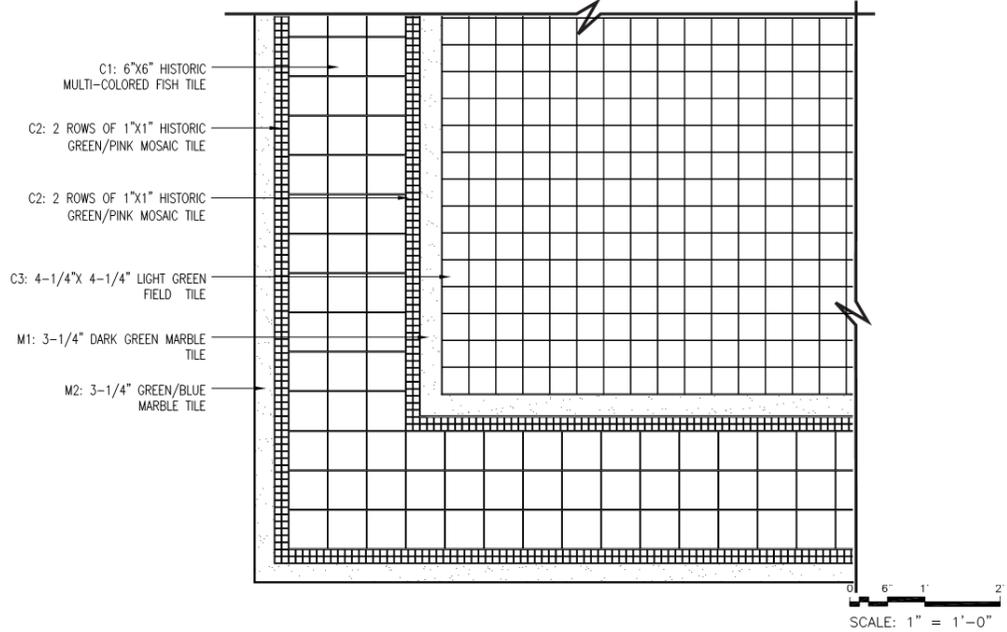
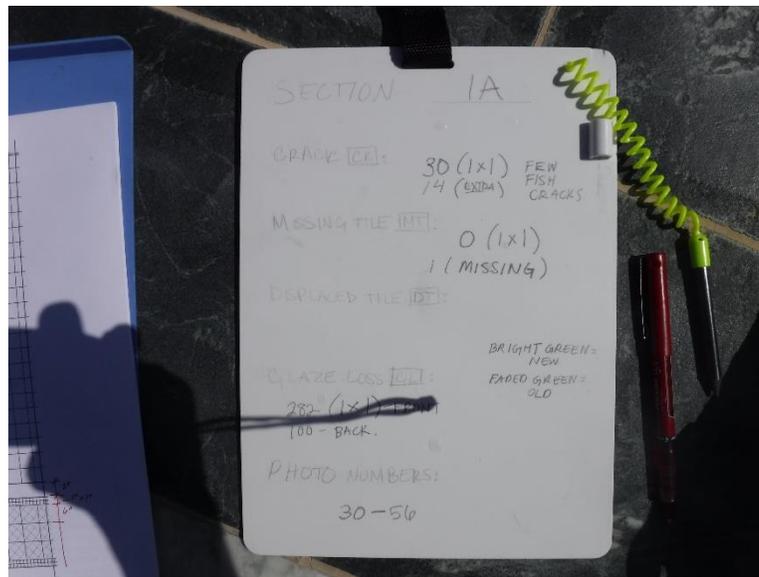
Condition is based upon a visual assessment by City of Santa Monica divers, guided & coordinated by Page & Turnbull.

A grid was used to record deterioration observed by the divers. Information was reported from divers to staff on the deck, who recorded data on a grease board. (right)

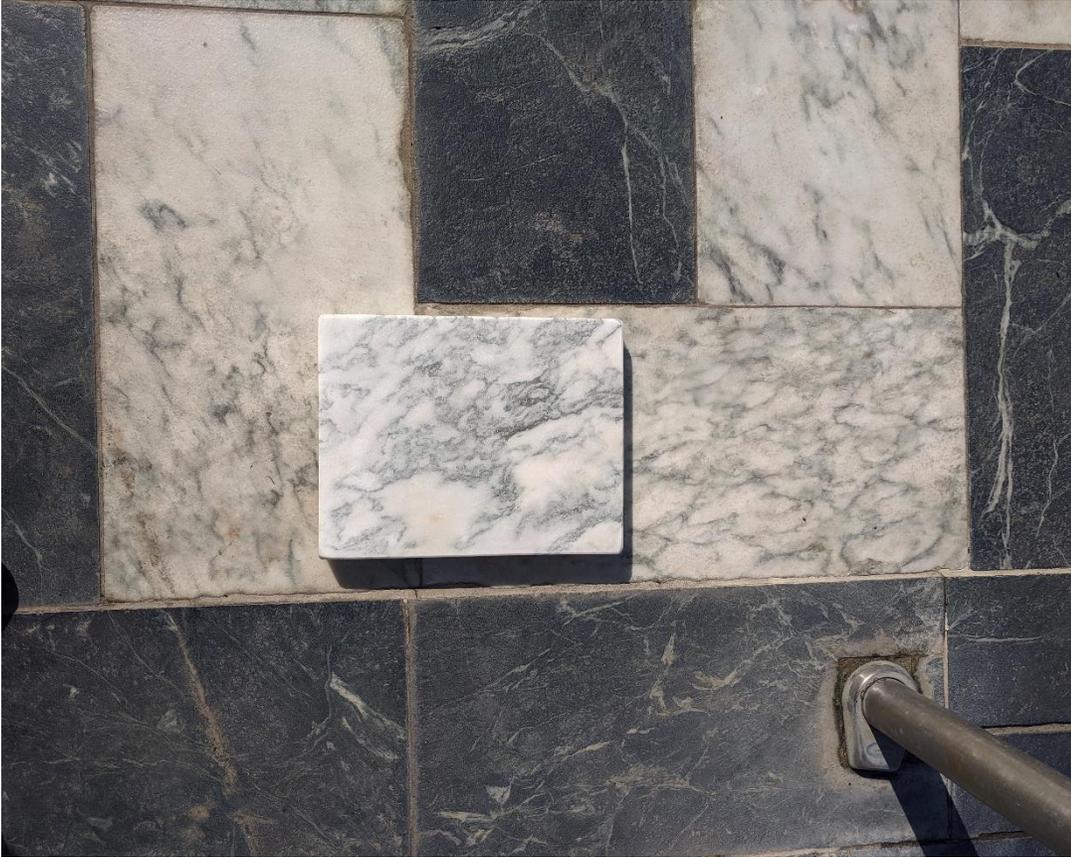
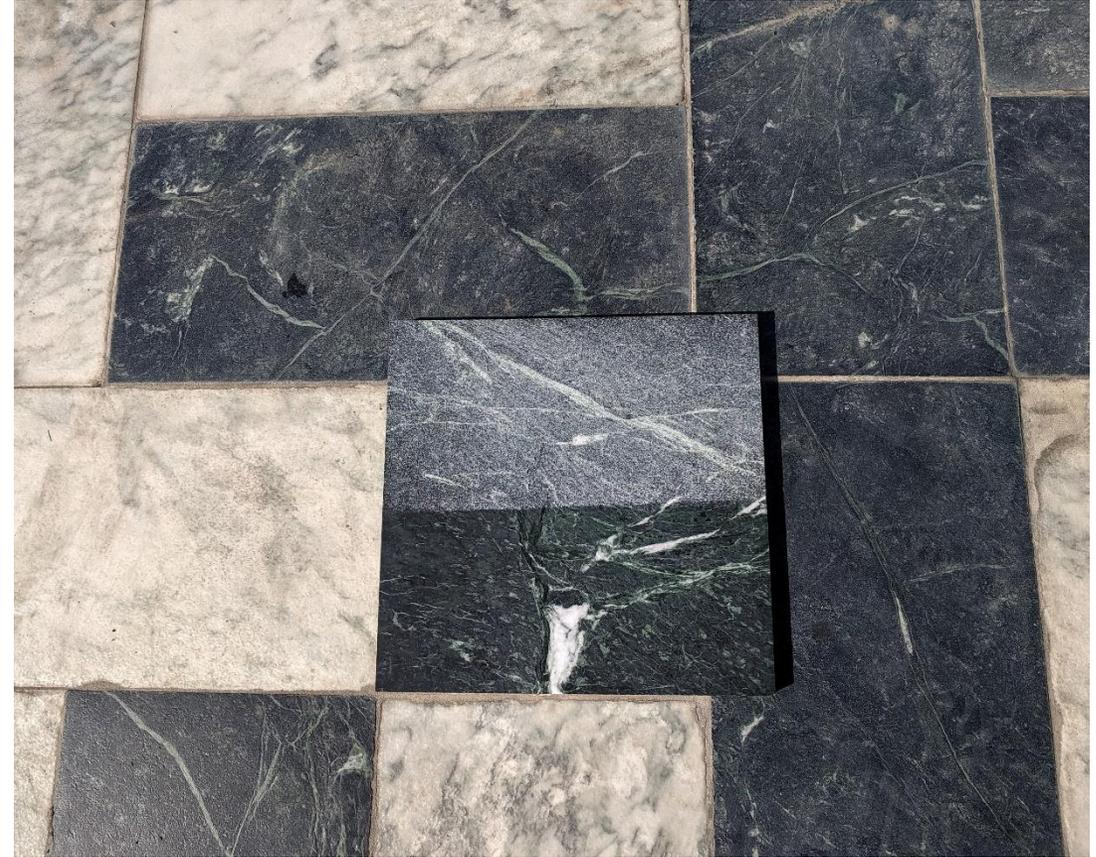
Proposed Repairs - Deck

Replace Deteriorated Deck Marble in 2 Phases

- In-kind replacement most heavily damaged white and green marble deck tile and green marble gutter fascia
- Purchase and store additional marble tile for future phase of in-kind replacement
- In-kind replacement of 1" x 1" mosaic tile at pool bottom
- Repair of hand-painted fish tiles at pool bottom
- Clean all pool and deck tile with a mild chemical cleaner. Spot clean rust stains with poultice.
- Re-grout all joints.
- Seal marble surfaces.

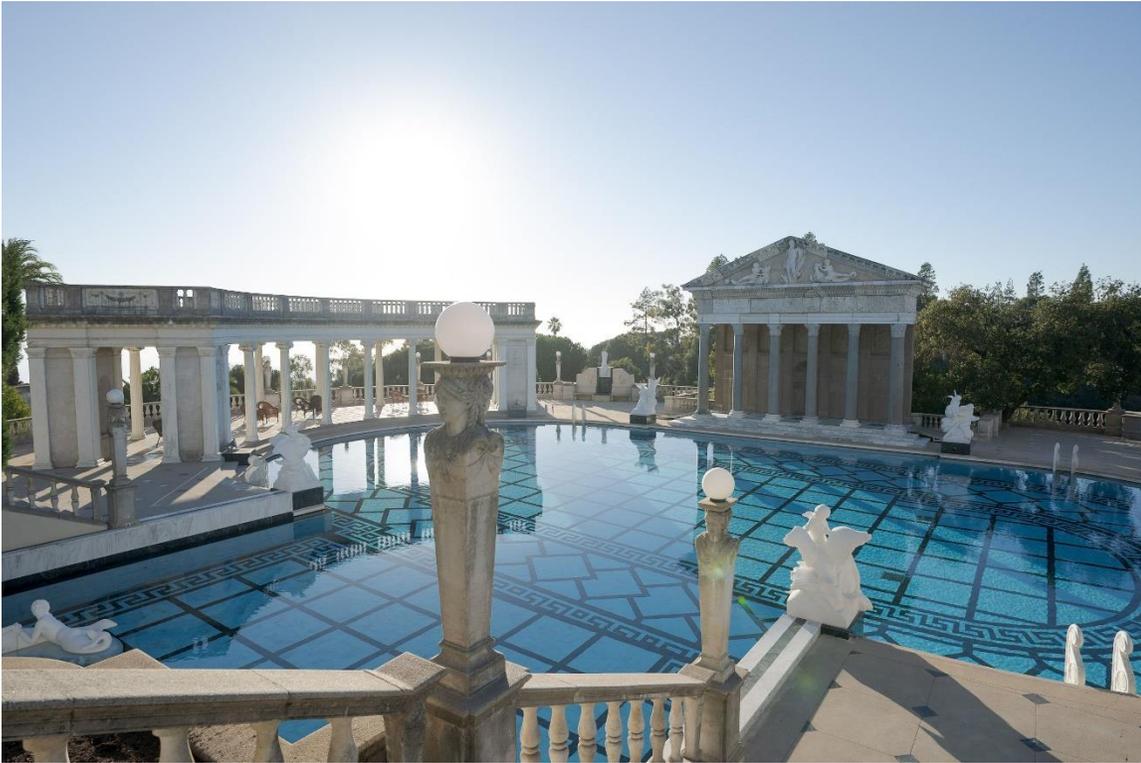
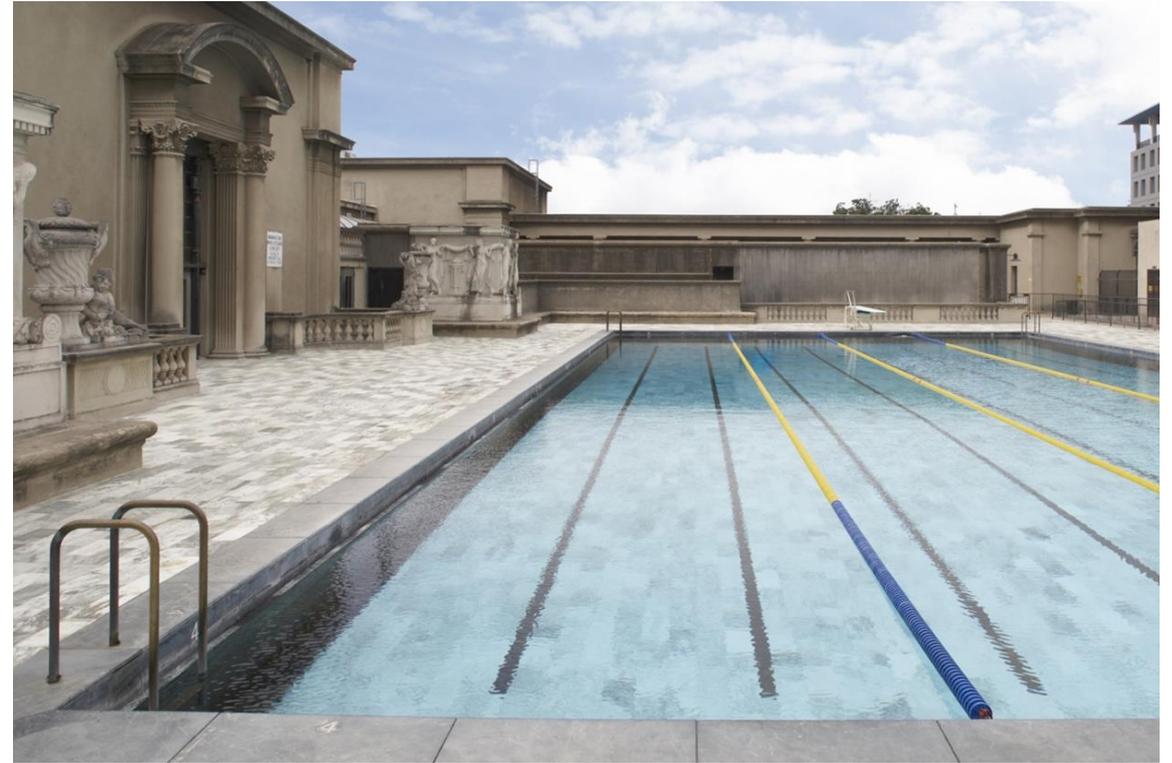
Same marble used as replacement at the Neptune Pool and Hearst Gymnasium UC Berkeley*

* Pools also designed by Julia Morgan and funded by the Hearst Family.
