PIER INFRASTRUCTURE ASSESSMENT STUDY

Phase 1 - EXISTING CONDITIONS
VOLUME 1

Santa Monica Pier Infrastructure Assessment Study

Phase 1 – Existing Conditions Volume 1

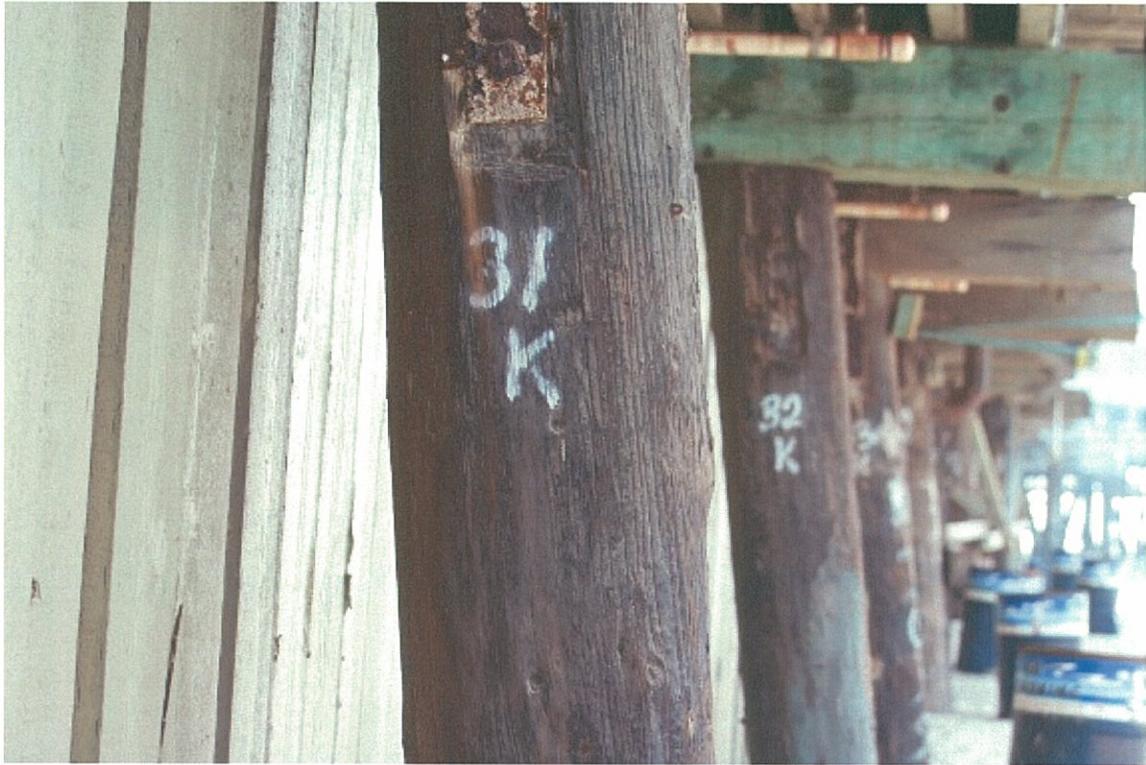
Typical Municipal Pier Pile Number

To facilitate the inspection effort and to have a common location reference, a new pile numbering system was established and reference numbers painted on piles. In some cases every pile in a bent was marked, and in some cases, every second, third or fourth pile was marked. To eliminate confusion with prior numbering schemes, old markings on the piles were painted out using black paint. The new numbers were painted in white. In this numbering system the pile bents are numbered consecutively starting at “1” for the first pile bent at the East end of the Newcomb Pier. The piles in each bent are assigned a letter designation with the Municipal Pier piles being assigned upper case letters while Newcomb Pier piles being assigned lower case letters to distinguish between the two structures. See the following photos plan (4 parts) for the numbering system. All elements inspected have their location designated with respect to the pile numbering system. Also shown for reference on the plan is a second set of bent numbers representing the old system. They are the top set of numbers and include negative numbering.

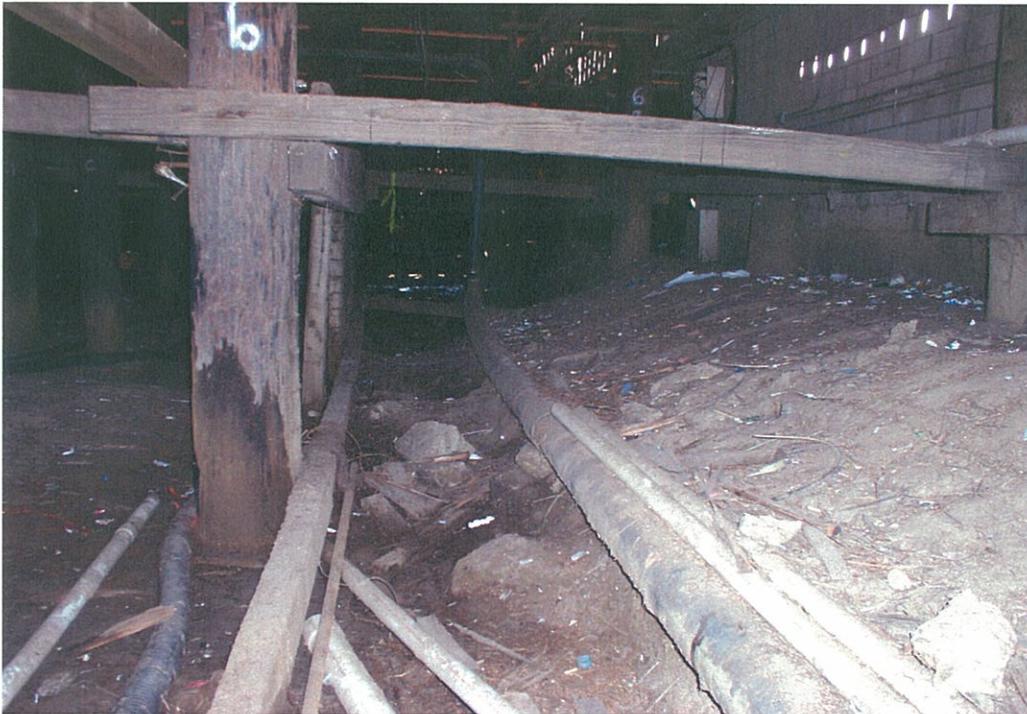
PHOTO 11

On the east side of the bike path, where the 6" main is nearing the end of its run and is close to the ground, it is being deflected by bearing pressure from a dirt slope next to the line (see Photo 11). The deflection is also affecting a 4" branch that is coming into the main vertically. Another issue that occurs on both the east and west 6" mains is periodic 4" diameter risers that come from small grates at the deck level (see Photo 12). They were either intended to be vents, or they are area drains to collect surface storm runoff. As vents, they are required by code to be run 10' above the deck level. As area drains, they are not allowed by code to drain into the sanitary sewer system. Either way, they are in violation of code unless a waiver has been granted by the City of Santa Monica or approved by the City inspector.

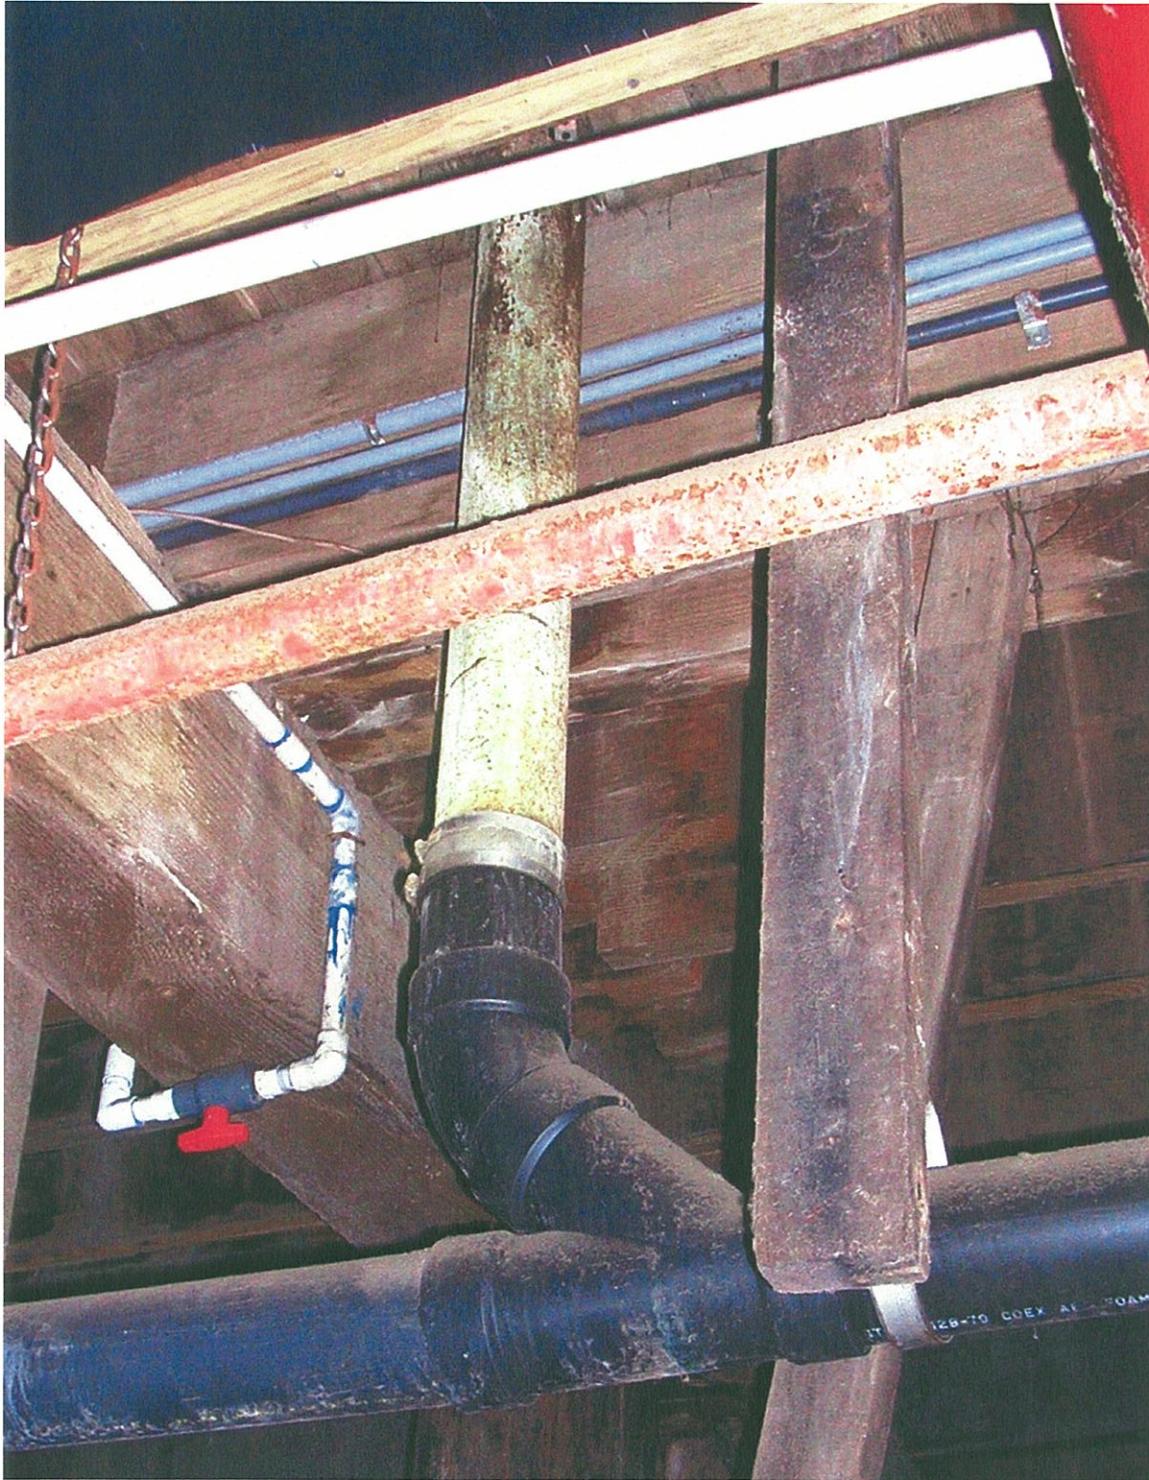
PHOTO 13

The piping in most of the sewer system under the pier appears to have been upgraded in the recent past. What was once a cast iron system has been replaced by an ABS system with new stainless steel hangers. Existing cast iron risers coming down through the deck were cut a foot or so below the deck (see Photo 13), and the old cast iron branch piping downstream of these points was replaced. As a result most of the hangers are "new" as well. In some places the sewer lines are supported by plumber's tape. In other places, the old carbon steel hangers are still in place, with the ABS piping threaded through the old hangers and new hangers installed adjacent to the old hangers. New hangers were installed on existing cast iron lines as well, with the old hangers remaining in place (see Photo 14). In several areas, old cast iron piping that is no longer in service is still hanging below the deck. (see Photo 15).

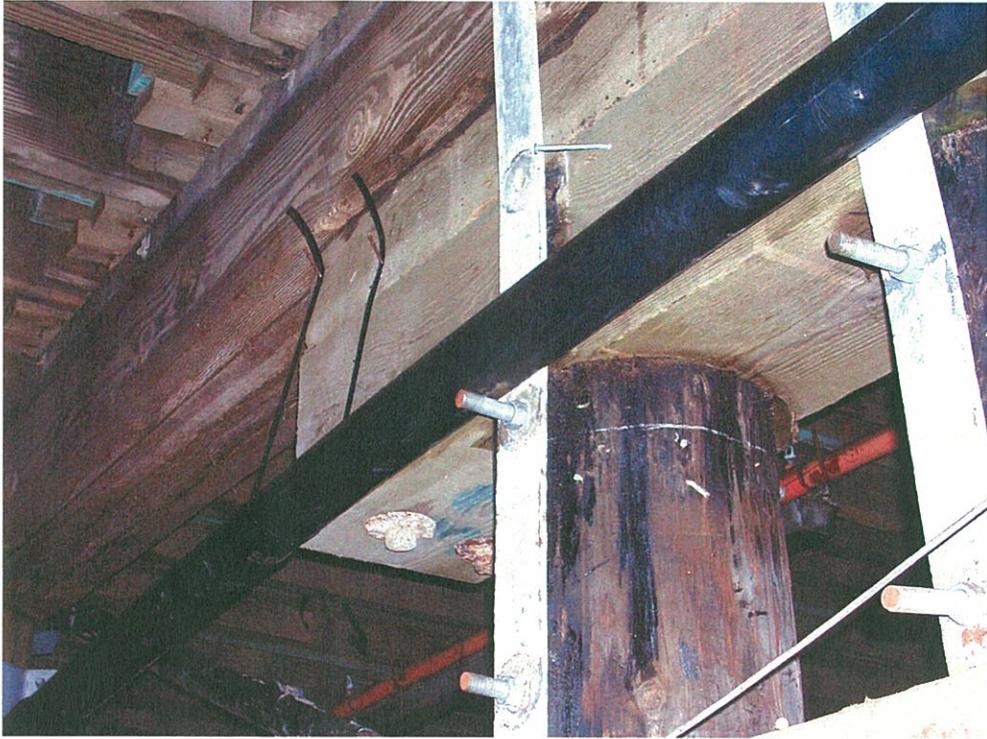
PHOTO 17

There are several "unique" styles of hanging and supporting piping that are currently in use on the sewer system. Some of them are adequate and meet code, and some are not. One example of non-compliance is a section of the main 6" sewer serving the eastern portion of the pier that is supported by a mismatched series of stacked wooden blocks (see Photo 16). In other areas, pieces of lumber are notched and mounted at angles to support a 4" branch. Plastic plumber's tape, as well as the more common galvanized plumber's tape, is also in use (see the left side of Photo 35, where plastic plumber's tape is supporting a sagging drain line). In at least one place a branch is supported by the end of a bolt protruding from the pier structure (see Photo 17). In another area, plastic zip ties are being used to "bundle" pipes together (see Photo 18).

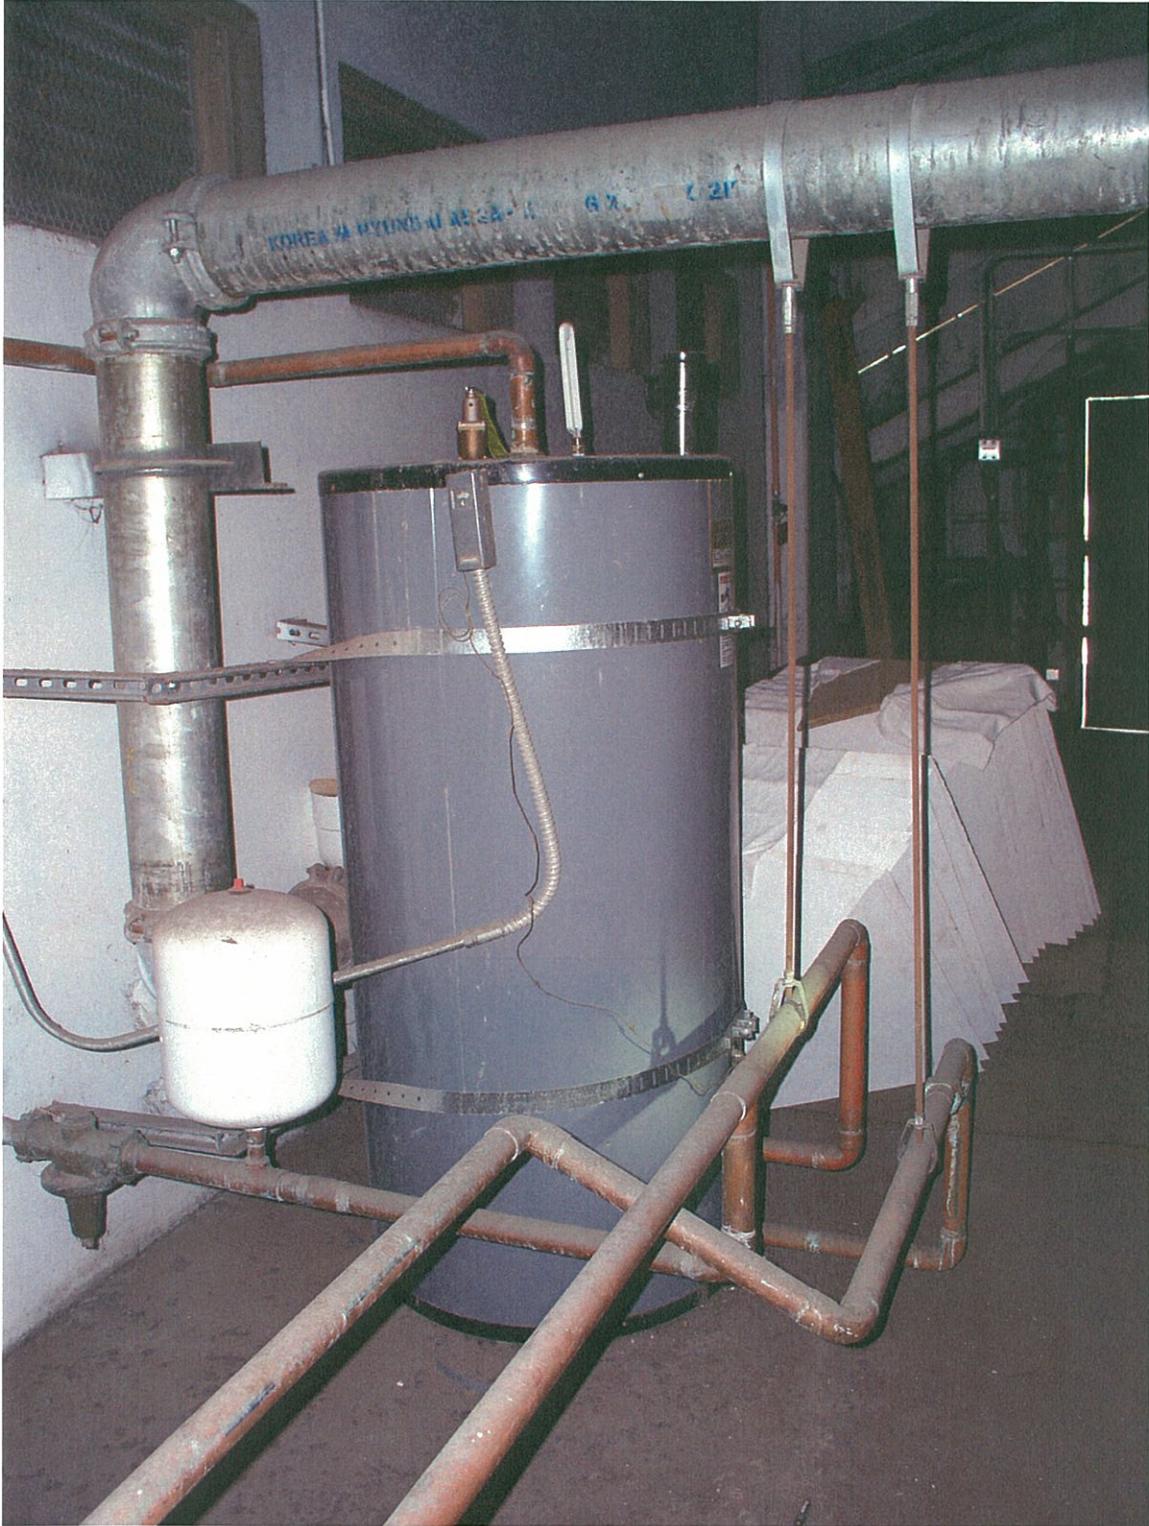
PHOTO 31

Style and spacing of supports for the various piping systems should be standardized. Poorly installed or corroded plumber's tape hangers should be reconfigured to provide better support, or replaced altogether with new rod-type hangers. Hangers being used to support piping from other piping (see Photos 7 and 31) should be reconfigured so piping is supported by structural or foundational elements. All temporary supports such as duct tape, wire, plastic zip ties, stacked wooden blocks and pieces of lumber should be replaced with conventional hangers, supports, and brackets. All carbon steel hangers and supports seaward from the high tide line should be replaced by stainless steel or an approved corrosion-resistant material. This is *especially* critical on the natural gas lines and fire service lines over the water at the end of the pier. Most of these supporting elements are in imminent danger of failing. Some have already failed.
