PIER INFRASTRUCTURE ASSESSMENT STUDY
Phase 2 - UPGRADE STUDIES
NOVEMBER 17, 2008

Santa Monica Pier Infrastructure Assessment Study

Phase 2 – Upgrade Studies

November 17, 2008
JN 5332-02

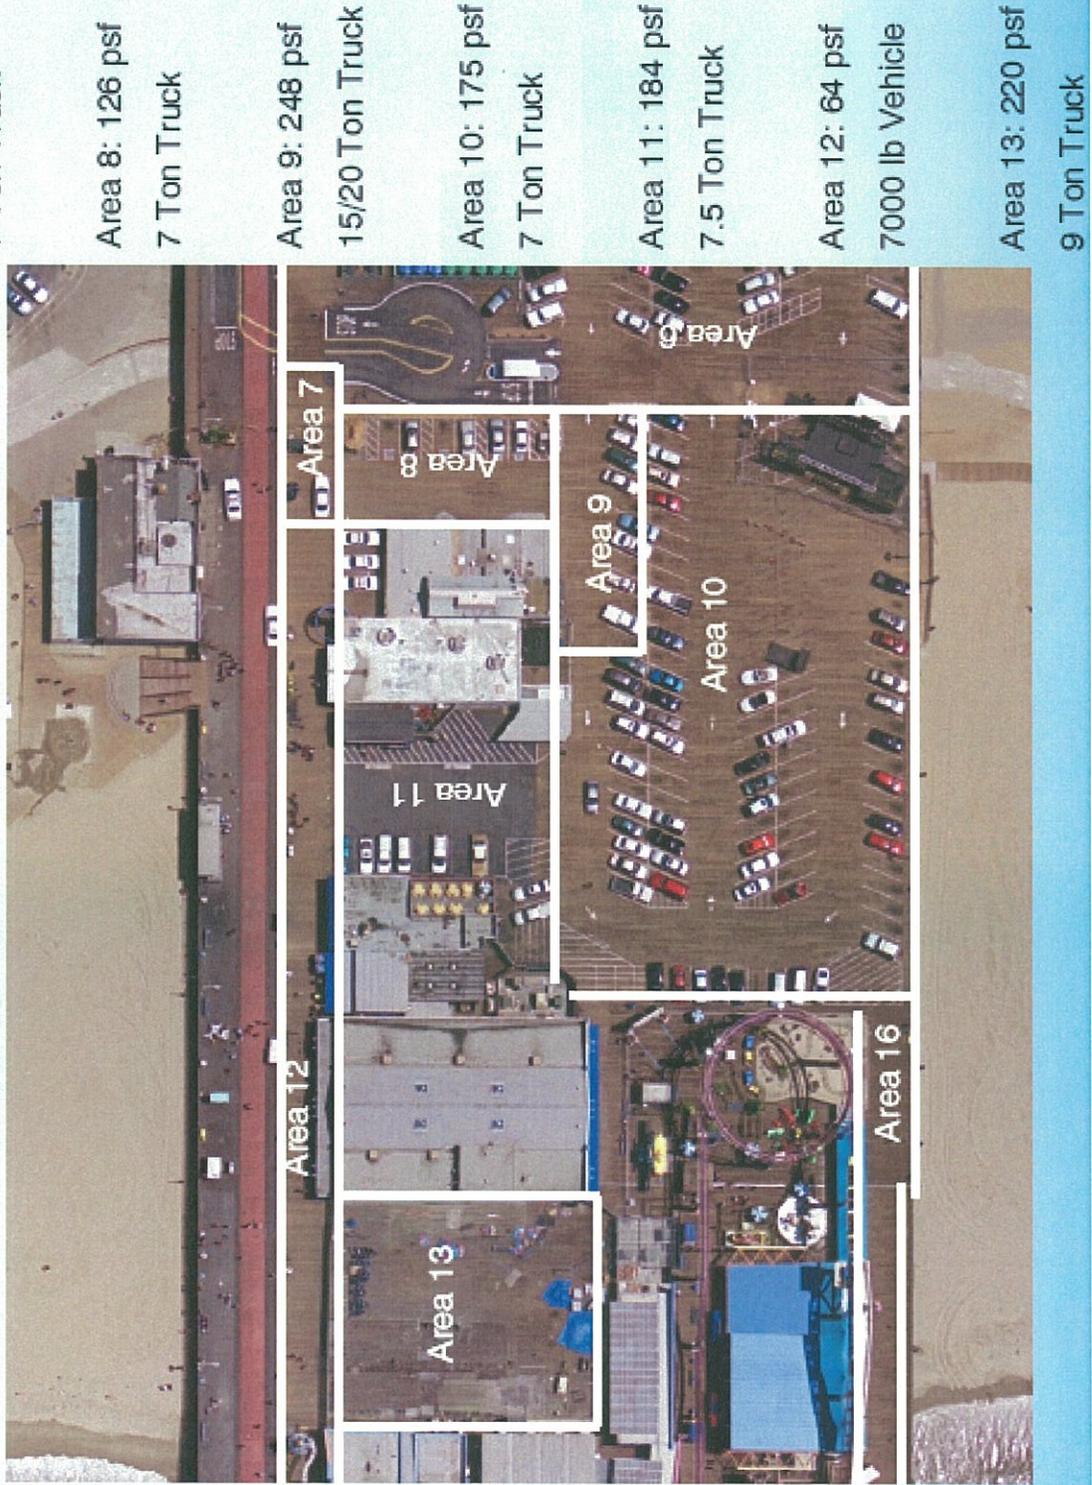
Figure 2

Specific recommendations based on areas: See Figure 1 - 3 for area locations.

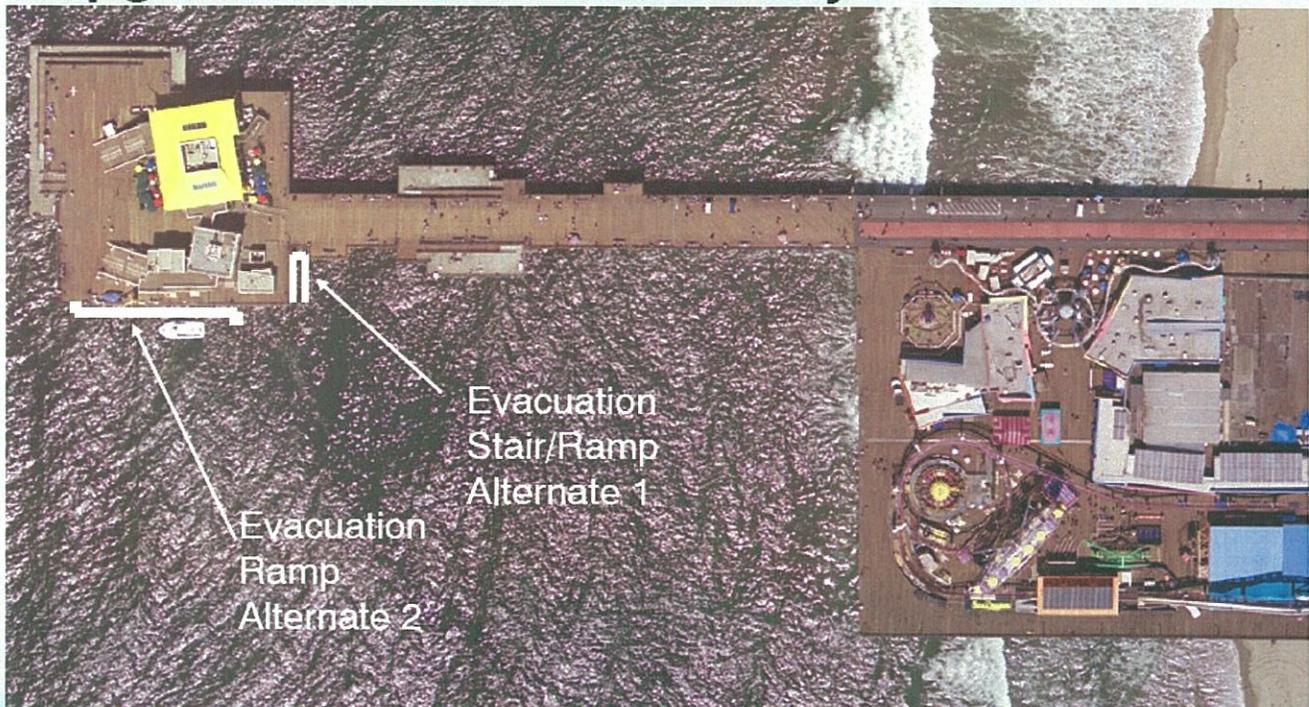
To provide this needed facility two alternatives are presented. Both alternatives can be stowed at deck level away from wave action and lowered when necessary to allow evacuation of people from the pier deck to waiting boats. Both alternatives also feature an independent pile/dolphin fender system. See Figure 6 for the locations of both alternatives.

In an Interdepartmental Communication from Mike Braaten, Sergeant of the SMPD Harbor Patrol, to Mark Cuneo, Principal Engineer with the Santa Monica Department of Civil Engineering and Architecture, preference was stated for Alternative 1 of the Emergency Evacuation Ramp. This preference is based on how the location of the ramp would effect the ongoing day-to-day operations of the SMPD Harbor Patrol. The full memorandum is included in the appendix of this report.

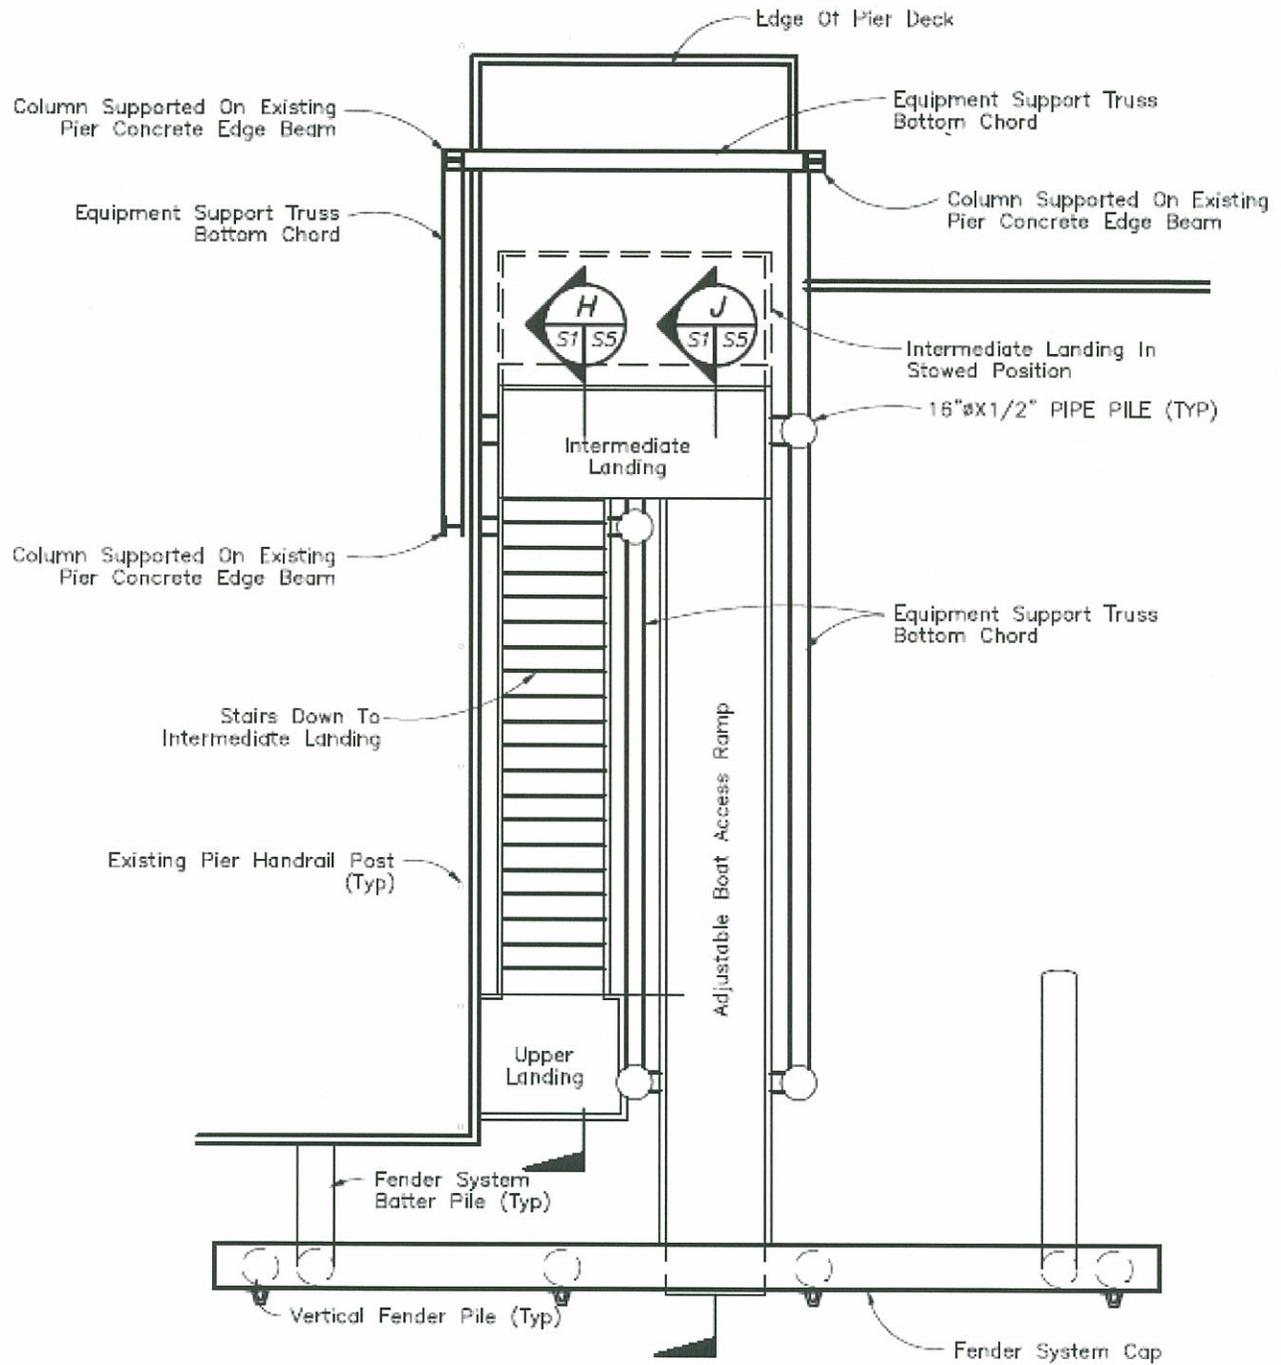
Figure 7

A preliminary layout was prepared using a similar facility constructed on the Imperial Beach Pier as a model. The preliminary layout is shown on Figures 7 & 8.

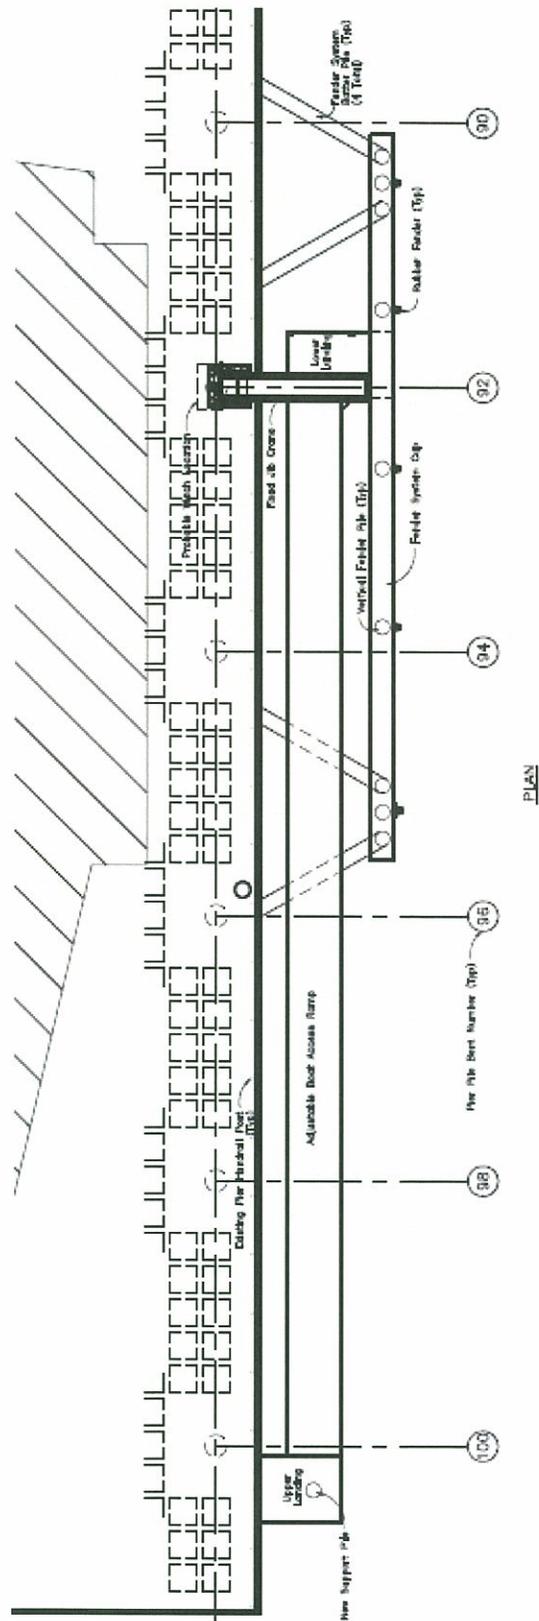
Figure 9

A preliminary layout was prepared using a similar facility constructed on Stearns Wharf in Santa Barbara as a model. The preliminary layout is shown on Figures 9 & 10.
